MFC Auction House
M57 Pretoria Rd, Glenmarais, KEMPTON PARK
Gauteng

DEKRA MFC
M57 Pretoria Rd - 1619
KEMPTON PARK - GT
08610 33572

CONDITION REPORT

Report No: 2016237217

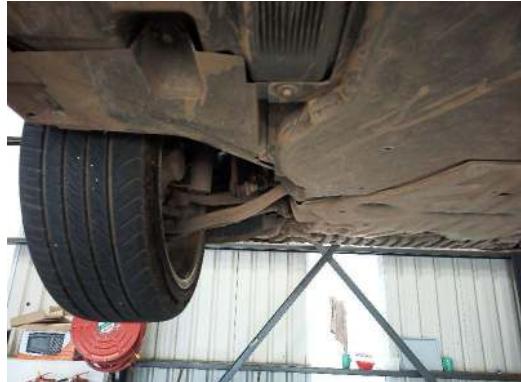
LF TYRE TREAD

Size	Load/Speed Index	Manufacture	Model	Type*	Production Date	Tread Depth (mm)
Front Left	225/40R18	92W	Hilo	Radial	V	0321	3 mm
Front Right	225/45R18	95Y	Continental	Contisport	V	0219	0 mm
Rear Left	255/35R18	94W	Lanigator	Radial	V	3921	3 mm
Rear Right	255/35R18	94Y	Michelin	Radial	V	1218	1 mm

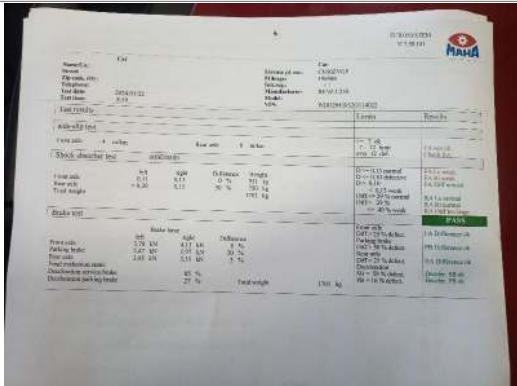
BRAKE REPORT

Left	Right	Axe Weight [KG]	Deceleration [m/s ²]
	Braking Force [kN]	Braking Force [kN]		
Front	3.78	4.13	-	
Rear	3.05	3.15	-	
Emergency / Parking	2.47	1.97	-

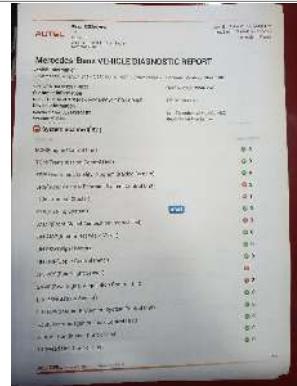
DIAGNOSTIC REPORT PAGE 1

During the diagnostic no active error messages were detected. (See also attached Diagnostic Report. For more information regarding the Fault Codes (DTC) and the recommended rectifications please contact the workshops of the vehicle manufacture).

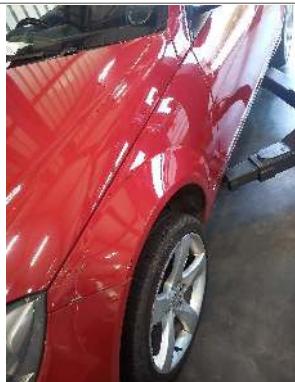
Damage	Repair Way
Tail Light Left Defective	Replace
Dim Light Left Defective	Replace
Sun Roof Switch Defective	Repair
Sun Roof Defective	Repair
Seat Front Left Damaged	Repair
Seat Front Right Damaged	Repair
Number Plate Front Deformed	Repair
Number Plate Rear Defective	Repair
Front Bumper Damaged	Repair
Bonnet Damaged	Repair
A • Pillar Left Damaged	Repair
Front Fender Left Damaged	Repair
Front Fender Right Damaged	Repair
Rear Fender Left Damaged	Repair
Rear Fender Right Damaged	Repair
Door Front Left Damaged	Repair
Door Front Right Damaged	Repair
Boot Lid / Hatch door Damaged	Repair
Rear bumper Damaged	Repair
Stabilizer Mounting Front Left Damaged	Replace
Stabilizer Mounting Front Right Damaged	Replace
Tyre Front Right Worn	Replace

General Comments: VEHICLE ELECTRONICS MALFUNCTIONING. EXCESSIVE NOISE FROM FRONT AND REAR SUSPENSION. Lights: Auto lights malfunctioning.
Body • Exterior: Minor dents and scratches and stone chips to some body panels. Signs of repair work done to some body panels.
