CONDITION REPORT

Report No:
2016962636
DATE
30/07/2025

MFC Auction House
M57 Pretoria Rd, Glenmarais, KEMPTON PARK
Gauteng

Vehicle Type	PASSENGER VEHICLE	Registered Owner	
Manufacturer	MERCEDES-BENZ	Registration Number	JZ11GGGP
Model	VITO	Register Number	
VIN	WDF44770323599001	Date Of First Licensing	
Engine Number		Last COR	
Doors	5	License Expiry Date	31/05/2026
Color	SILVER	Power / Displacement	
Year Model		Paint Finish	TWO COAT METALLIC
Km Reading	154,720 KM	Fuel	DIESEL
Cab / Body Type	STATION WAGON	Transmission	AUTOMATIC

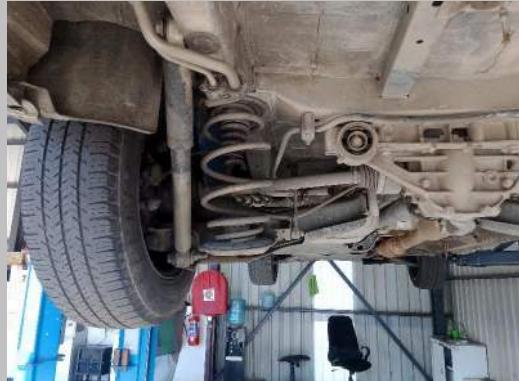
LR TYRE TREAD

Tyres and Rims: Spare tire making model not visible. spare wheel fitted to left rear.

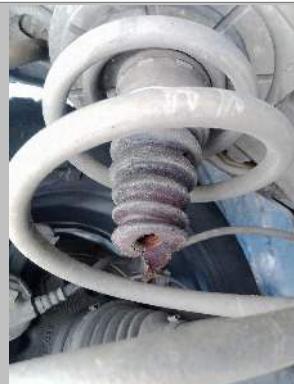
Rebound Rubber Rear Axle Left Damaged	Replace
Control Arm Bush(es) Front Axle Left Welded	Replace
Control Arm Bush(es) Front Axle Right Worn	Replace
Tyre Front Right Worn	Replace
Tyre Rear Left Excessive Wear & Tear	Replace
Tyre Rear Right Worn	Replace
Spare Tyre Damaged	Replace
Rim Front Left Cracked	Replace
Rim Front Right Damaged	Replace
Rim Rear Left Deformed	Repair
Rim Rear Right Cracked	Replace
Rim Spare Wheel Damaged	Replace
Belly plates Damaged	Replace
Center Prop Shaft Rubber(s) Loose / Excessive Play	Repair
Rear tyres size differs	Replace

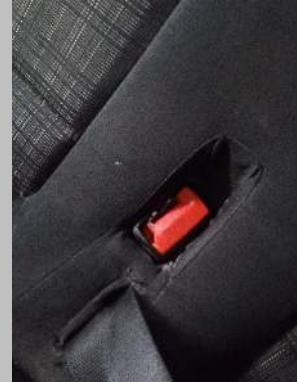
Damage	Repair Way
Engine Oil Leak	Repair
Central Air Vent Damaged	Replace
Windscreen Wiper Damaged	Replace
Seat Front Right Torn / Cut	Repair
Seat Rear Damaged	Repair
Seat Belt Rear Middle Damaged	Repair
Door Handle Front Right Damaged	Repair
Carpet Rear Damaged	Repair
Side Mirror Left Damaged	Repair
Side Mirror Right Damaged	Repair
Front Bumper Damaged	Repair
Bonnet Damaged	Repair
Front Fender Left Damaged	Repair
Front Fender Right Damaged	Repair
Rear Fender Left Damaged	Repair
Rear Fender Right Damaged	Repair
Door Front Left Damaged	Repair
Door Front Right Damaged	Repair
Door Rear Left Damaged	Repair
Door Rear Right Damaged	Repair
Boot Lid / Hatch door Damaged	Repair
Rear bumper Damaged	Repair
Windscreen Damaged	Replace
Brake disc 1. Axle left Worn	Replace
Brake disc 1. Axle right Worn	Replace
Brake disc 2. Axle left Worn	Replace
Brake disc 2. Axle right Worn	Replace
Brake Pad/Shoe 2. Axle left Worn	Replace
Brake Pad/Shoe 2. Axle right Worn	Replace
