MFC Auction House
M57 Pretoria Rd, Glenmarais, KEMPTON PARK
Gauteng

DEKRA MFC
M57 Pretoria Rd - 1619
KEMPTON PARK - GT
08610 33572

VEHICLE INSPECTION

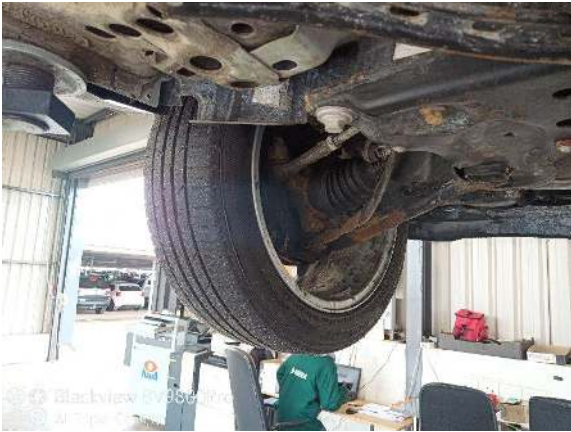
LF TYRE TREAD

Size	Load/Speed Index	Manufacture	Model	Type*	Production Date	Tread Depth (mm)
Front Left	205/50R17	93W	Dunlop	Sp sport	V	3621	3 mm
Front Right	205/50R17	89V	Yokohama	Advan	V	3215	0 mm
Rear Left	205/50R17	93W	Gt radial	Champiro	V	1921	2 mm
Rear Right	205/50R17	89V	Apollo	Alnac	V	2821	1 mm
Spare	205/60R16	92H	Continental	Contact	V	3019	5 mm
