| Manufacturer | FORD | Registration Number | KDL218NW |
| Model | FOCUS 1.5 ECOBOOST TREND 5-DR POWERSHIFT [2015-2018] | Register Number | |

## CONDITION REPORT

Report No: 2016670339

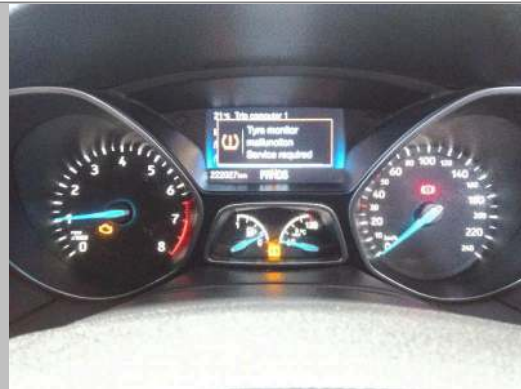
DASHBOARD (W/ ENGINE RUNNING)

| Damage | Repair Way |
|---|---|
| Engine Management Lights Set | Repair |

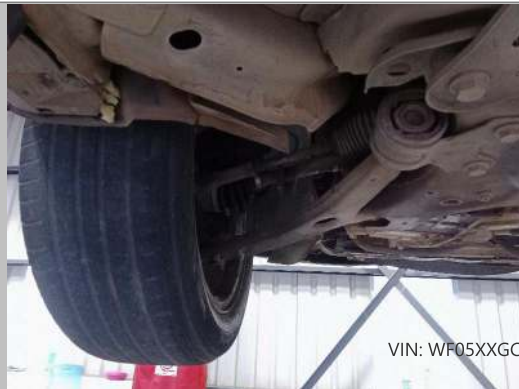
LF TYRE TREAD

| Damage | Repair Way |
|---|---|
| Tyre Front Left Worn | Replace |

| | Size | Load/Speed Index | Manufacture | Model | Type* | Production Date | Tread Depth (mm) |
|---|---|---|---|---|---|---|---|
| Front Left | 215/50R17 | 91V | Hankook | Radial | V | 1813 | 0 mm |

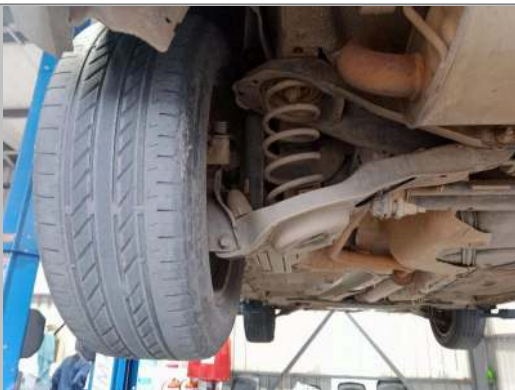
LR TYRE TREAD

| Damage | Repair Way |
|---|---|
| Tyre Rear Left Worn | Replace |

| | Size | Load/Speed Index | Manufacture | Model | Type* | Production Date | Tread Depth (mm) |
|---|---|---|---|---|---|---|---|
| Rear Left | 225/55R17 | 101Y | Continental | Contipremium | V | 0416 | 0 mm |

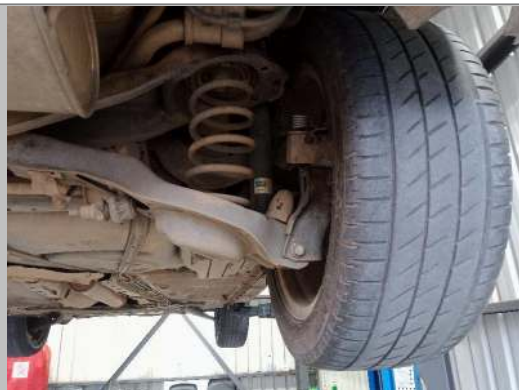
RR TYRE TREAD

| Damage | Repair Way |
|---|---|
| Tyre Rear Right Worn | Replace |

| | Size | Load/Speed Index | Manufacture | Model | Type* | Production Date | Tread Depth (mm) |
|---|---|---|---|---|---|---|---|
| Rear Right | 235/45R17 | 97W | Cachland | Radial | V | 4821 | 0 mm |

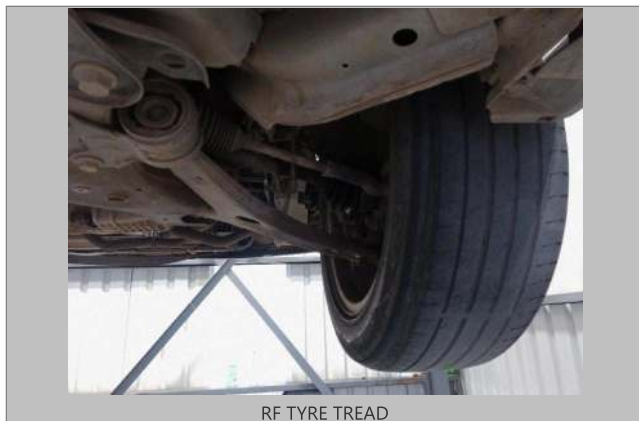
RF TYRE TREAD

| Damage | Repair Way |
|---|---|
| Tyre Front Right Worn | Replace |

| | Size | Load/Speed Index | Manufacture | Model | Type* | Production Date | Tread Depth (mm) |
|---|---|---|---|---|---|---|---|
| Front Right | 225/50R17 | 98W | Nexen | Radial | V | 4120 | 0 mm |

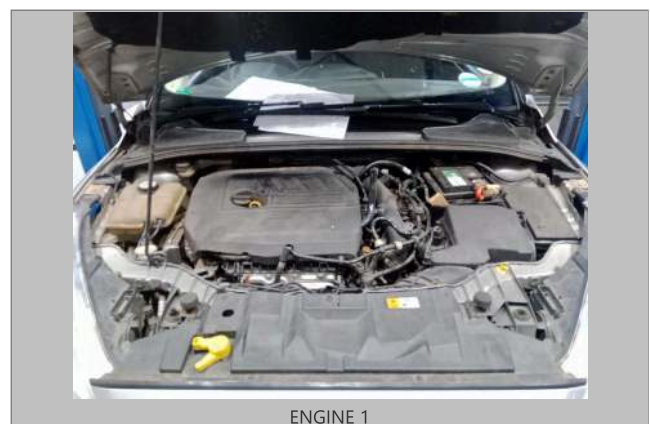
ENGINE 1

| Damage | Repair Way |
|---|---|
| Engine Oil Sweat | Repair |
