## CONDITION REPORT

Report No: 2016395361

DATE  
27/05/2024

| Manufacturer | FORD | Registration Number | HY11HTGP |

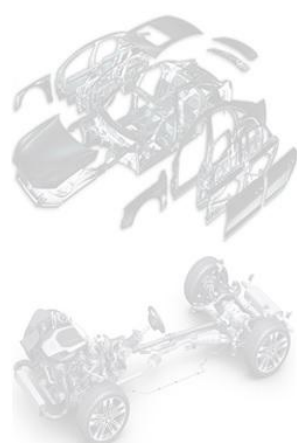
| Damage | Repair Way |
|---|---|
| Door Front Right Paintwork • Scratched | Repair |
| Door Rear Right Paintwork • Scratched | Repair |
| Rear bumper Paintwork • Scratched | Repair |
| Engine light on | Repair |
