## CONDITION REPORT

Report No: 2016403928

| Manufacturer | FORD | Registration Number | DV83MHGP |
| Model | FOCUS ST | Register Number | |

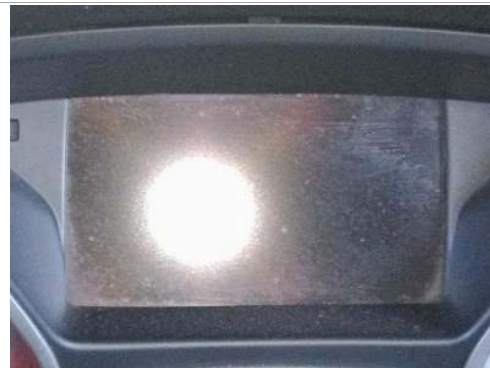
ODOMETER

Cluster malfunction can not see mileage  
Diagnostic report pick up the mileage  
Aftermarket air filter fitted  
Body exterior  
Body exterior  
Water leak

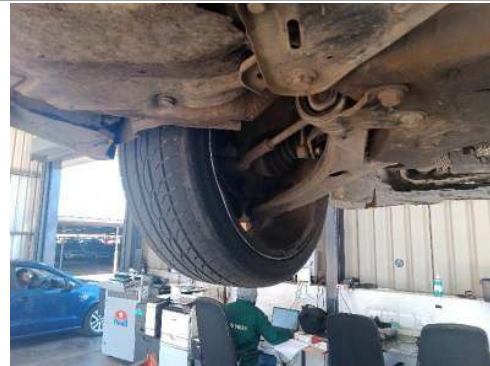
LF TYRE TREAD

| Damage | Repair Way |
|---|---|
| Tyre Front Left Smooth | Replace |

| | Size | Load/Speed Index | Manufacture | Model | Type* | Production Date | Tread Depth (mm) |
|---|---|---|---|---|---|---|---|
| Front Left | 225/40R18 | 92W | Timax | Eco sport 59 | V | 5119 | 0 mm |

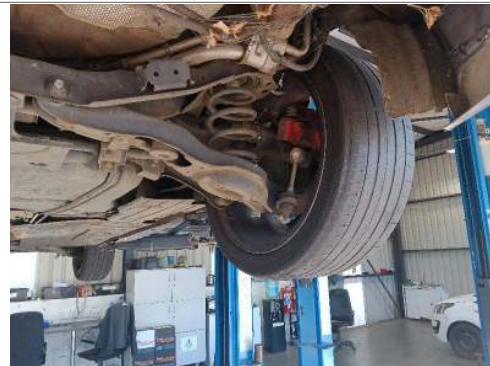
RR TYRE TREAD

| Damage | Repair Way |
|---|---|
| Tyre Rear Right Smooth | Replace |

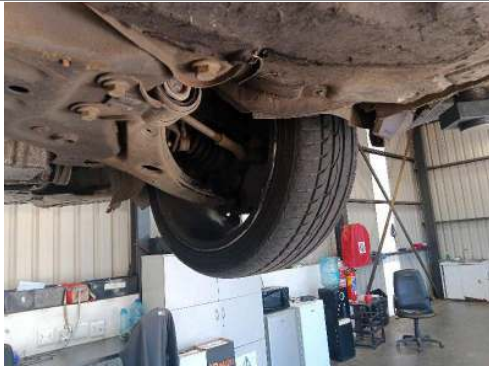
RF TYRE TREAD

| | Size | Load/Speed Index | Manufacture | Model | Type* | Production Date | Tread Depth (mm) |
|---|---|---|---|---|---|---|---|
| Front Right | 225/40R18 | 92W | Timax | Eco sport 59 | V | 3719 | 4 mm |

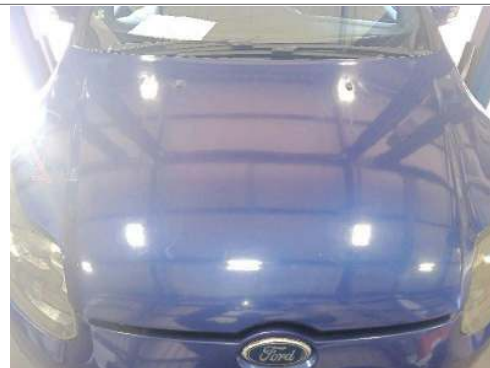
| Damage | Repair Way |
|---|---|
| Bonnet Paintwork • Scratched | Repair |
