## CONDITION REPORT

Report No:  
2017304536  
DATE  
29/09/2026

| Manufacturer | FORD | Registration Number | HBS917L |
| Model | FOCUS | Register Number | |

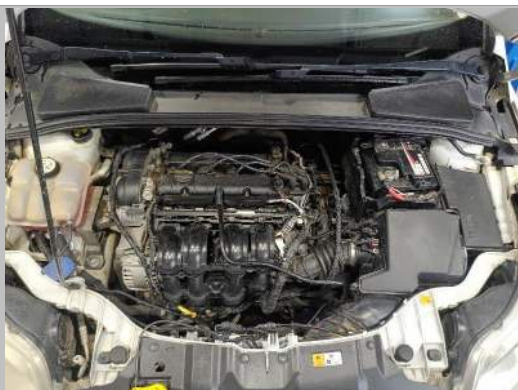
ENGINE 1

| Engine Oil Leak | Repair |

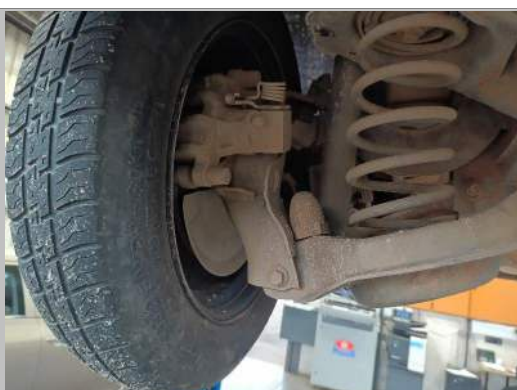
LR TYRE TREAD

| Rear tyre size differs | Replace |

| | Size | Load/Speed Index | Manufacture | Model | Type* | Production Date | Tread Depth (mm) |
|---|---|---|---|---|---|---|---|
| Rear Left | T125/90R19 | 98M | Hankook | Temporary | V | 0712 | 3 mm |

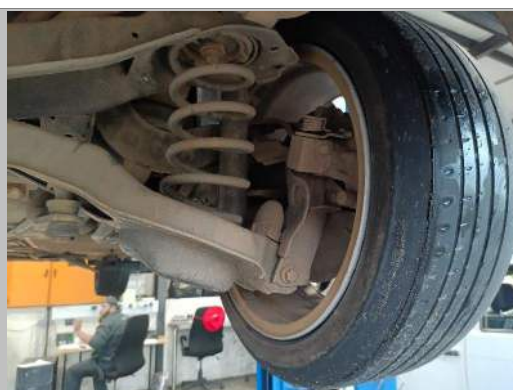
RR TYRE TREAD

| Tyre Rear Right Excessive Wear & Tear | Replace |

| | Size | Load/Speed Index | Manufacture | Model | Type* | Production Date | Tread Depth (mm) |
|---|---|---|---|---|---|---|---|
| Rear Right | 215/45R17 | 91W | Aptany | Sport | V | 1924 | 0 mm |

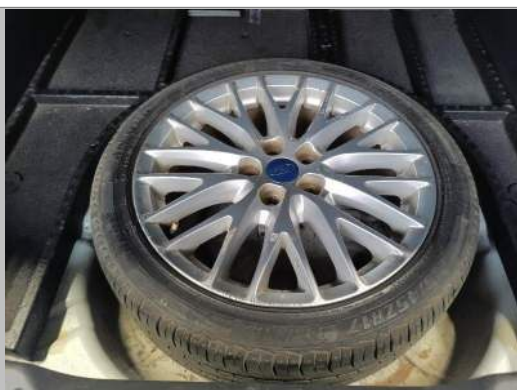
Sparewheel

| Spare Tyre Smooth | Replace |

| | Size | Load/Speed Index | Manufacture | Model | Type* | Production Date | Tread Depth (mm) |
|---|---|---|---|---|---|---|---|
| Spare | 215/45R17 | 91W | Annaite | AN606 | V | 0000 | 0 mm |
