## CONDITION REPORT

Report No: 2016304290

MFC Auction House  
M57 Pretoria Rd, Glenmarais, KEMPTON PARK  
Gauteng

Vehicle Type	PASSENGER VEHICLE	Registered Owner	MFC AUCTION HOUSE
Manufacturer	MINI	Registration Number	JP36MXGP
Model	COOPER S	Register Number	
VIN	WMWMM320X0TN78817	Date Of First Licensing	
Engine Number		Last COR	
Doors	4	License Expiry Date	31/07/2022
Color	BROWN	Power / Displacement	
Year Model		Paint Finish	TWO COAT METALLIC
Km Reading	161,102 KM	Fuel	PETROL
Cab / Body Type	STATION WAGON	Transmission	MANUAL

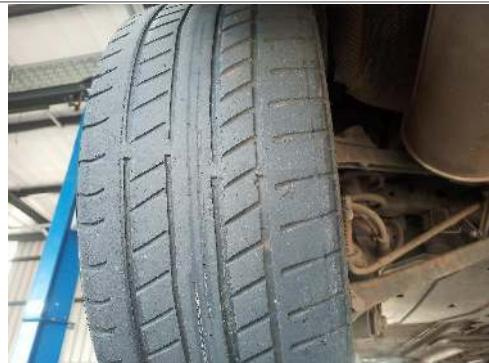
Tyre Rear Left

Size	Load/Speed Index	Manufacture	Model	Type*	Production Date	Tread Depth (mm)
Front Left	205/45R17	88W	Pacek	Radial	V	0615	1 mm
Front Right	205/45R17	88W	Pacek	Radial	V	0615	1 mm
Rear Left	225/45R17	94W	Wanli	Radial	V	3119	0 mm
Rear Right	205/45R17	88W	Achilles	Radial	V	0513	0 mm
