MFC Auction House
M57 Pretoria Rd, Glenmarais, KEMPTON PARK
Gauteng

DEKRA MFC
M57 Pretoria Rd - 1619
KEMPTON PARK - GT
08610 33572

VEHICLE INSPECTION

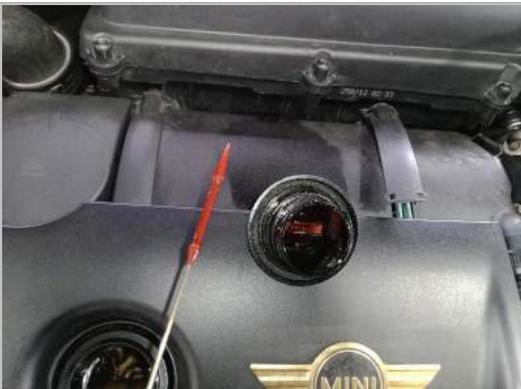
Oil cap and dipstick

| Damage | Repair Way |
|---|---|
| Engine Oil Leak | Repair |

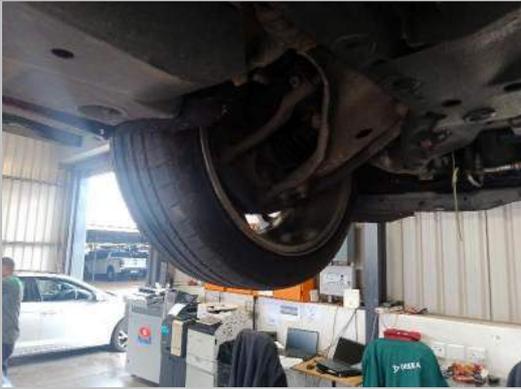
LF TYRE TREAD

| | Size | Load/Speed Index | Manufacture | Model | Type* | Production Date | Tread Depth (mm) |
|---|---|---|---|---|---|---|---|
| Front Left | 205/45R17 | 88W | Goodyear | Eagle | V | 4422 | 3 mm |

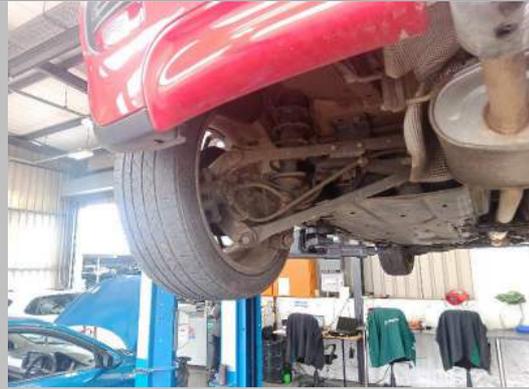
LR TYRE TREAD

| | Size | Load/Speed Index | Manufacture | Model | Type* | Production Date | Tread Depth (mm) |
|---|---|---|---|---|---|---|---|
| Rear Left | 205/45R17 | 88W | Bridgestone | Eco product | V | 0516 | 3 mm |

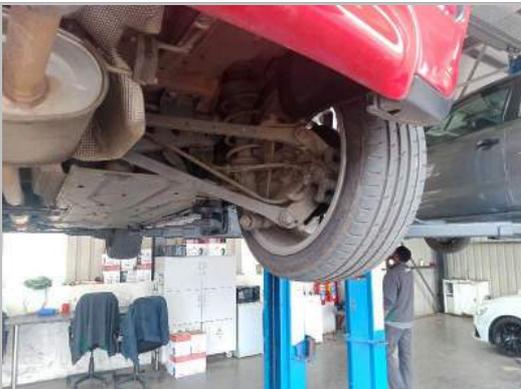
RR TYRE TREAD

| | Size | Load/Speed Index | Manufacture | Model | Type* | Production Date | Tread Depth (mm) |
|---|---|---|---|---|---|---|---|
| Rear Right | 205/45R17 | 84W | Continental | Contact | V | 2321 | 3 mm |
