CONDITION REPORT

Report No:  
2017301980  
DATE  
23/09/2026

| Manufacturer | VOLKSWAGEN | Registration Number | FVY755L |
| Model | AMAROK 3.0 TDI D-CAB 4MOTION HIGHLINE PLUS 190KW DSL PU AT [2021-2023] | Register Number | |

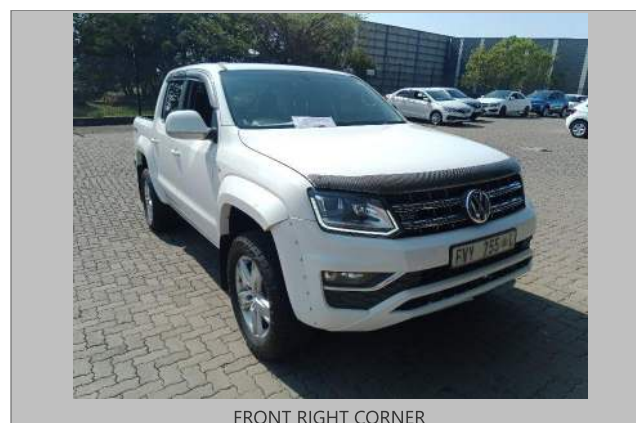
FRONT RIGHT CORNER

| Front Bumper Damaged | Repair |
| Front Fender Right Damaged | Repair |

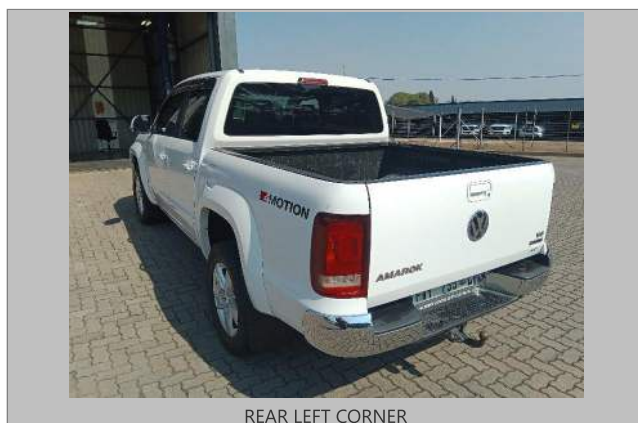
REAR LEFT CORNER

| Tail Light Left Damaged | Repair |
| Rear Fender Left Damaged | Repair |

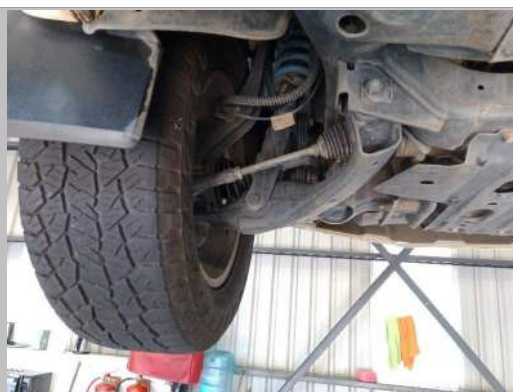
LF TYRE TREAD

| | Size | Load/Speed Index | Manufacture | Model | Type* | Production Date | Tread Depth (mm) |
|---|---|---|---|---|---|---|---|
| Front Left | 265/60R18 | 114T | Hankook | Right | V | 3325 | 3 mm |

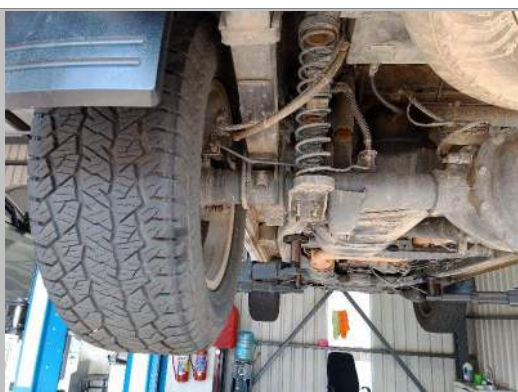
LR TYRE TREAD

| | Size | Load/Speed Index | Manufacture | Model | Type* | Production Date | Tread Depth (mm) |
|---|---|---|---|---|---|---|---|
| Rear Left | 265/60R18 | 114T | Hankook | Radial | V | 1422 | 3 mm |

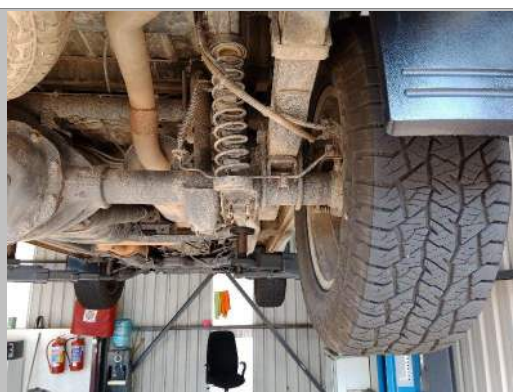
RR TYRE TREAD

| | Size | Load/Speed Index | Manufacture | Model | Type* | Production Date | Tread Depth (mm) |
|---|---|---|---|---|---|---|---|
| Rear Right | 265/60R18 | 114T | Hankook | Radial | V | 3625 | 3 mm |

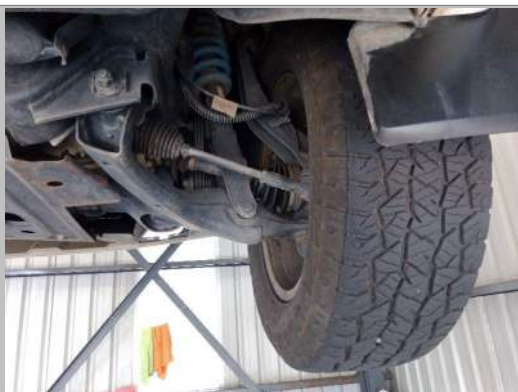
RF TYRE TREAD

| | Size | Load/Speed Index | Manufacture | Model | Type* | Production Date | Tread Depth (mm) |
|---|---|---|---|---|---|---|---|
| Front Right | 265/60R18 | 114T | Hankook | Radial | V | 3325 | 3 mm |
