## CONDITION REPORT

Report No:  
2017304779  
DATE  
29/09/2026

| Manufacturer | VOLKSWAGEN | Registration Number | MG44SYGP |
| Model | KOMBI T6 LWB 2.0 TDI COMFORTLINE MPV<br>DSL 103KW DSG [2016-2018] | Register Number | |

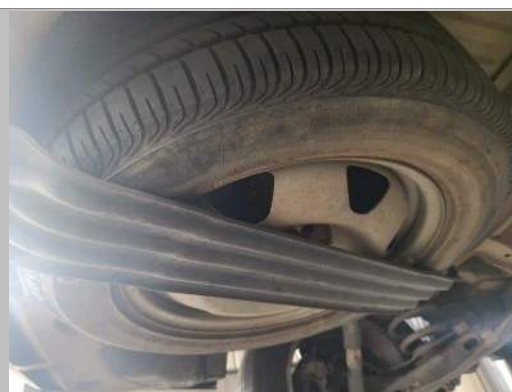
### Sparewheel

| | Size | Load/Speed Index | Manufacture | Model | Type* | Production Date | Tread Depth (mm) |
|---|---|---|---|---|---|---|---|
| Spare | 185/55R17 | 103W | Bridgestone | Turanza | V | 0000 | 7 mm |

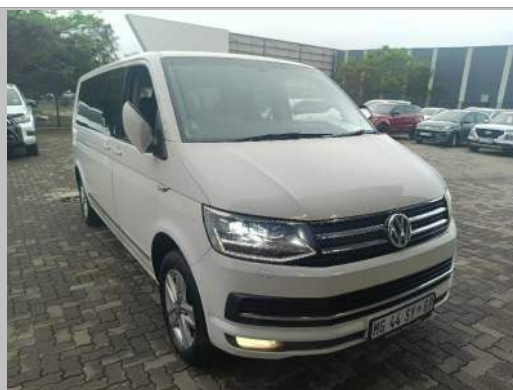
FRONT RIGHT CORNER

| Damage | Repair Way |
|---|---|
| Door Front Right Paintwork • Scratched | Repair |

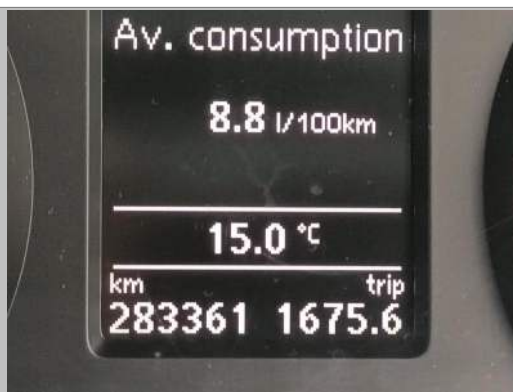
ODOMETER

| Km Reading | 283,361 KM | Fuel | DIESEL |
