## CONDITION REPORT

Report No:  
2016941265  
DATE  
10/07/2025

| Manufacturer | VOLKSWAGEN | Registration Number | JZ43KKGP |
| Model | TIGUAN ALLSPACE 1.4 TSI TRENDLINE 110KW DSG [2018-2019] | Register Number | |

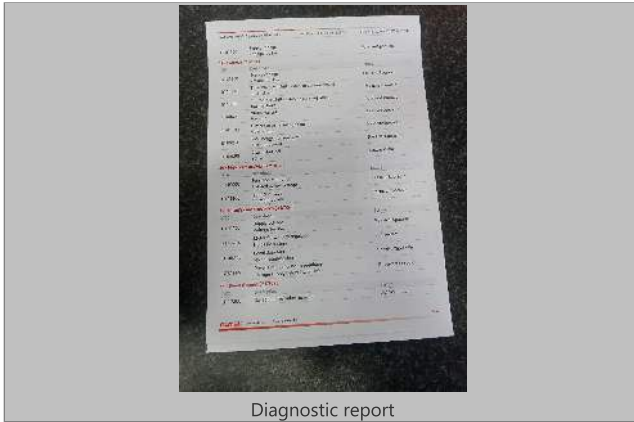
Diagnostic report

During the diagnostic the following error messages were detected: (See also attached Diagnostic Report. For more information regarding the Fault Codes (DTC) and the recommended rectifications please contact the workshops of the vehicle manufacture).

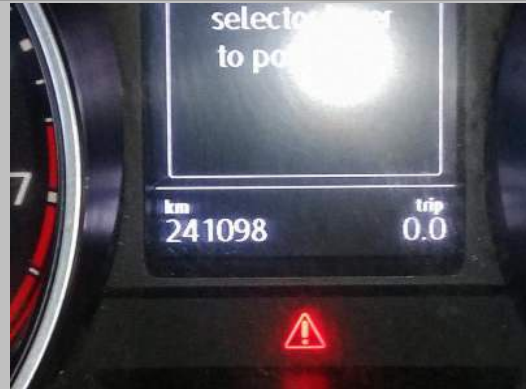
DASHBOARD (W/ ENGINE RUNNING)

| Damage | Repair Way |
|---|---|
| Engine management lights illuminated | Repair |

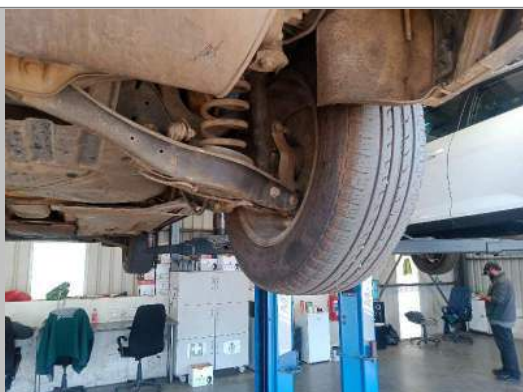
RF TYRE TREAD

| Damage | Repair Way |
|---|---|
| Tyre Front Right Smooth | Replace |
| Front tyres size differs | Replace |
