## CONDITION REPORT

Report No:  
2016924173  
DATE  
25/06/2025

| Manufacturer | VOLKSWAGEN | Registration Number | LCH503NW |
| Model | TIGUAN ALLSPACE 1.4 TSI TRENDLINE 110KW<br>DSG [2018-2019] | Register Number | |

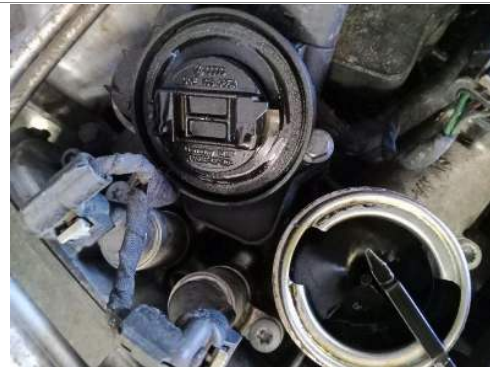
Oil cap and dipstick

| | Damage | Repair Way |
|---|---|---|
| | Engine Oil Leak<br>Radiator Damaged<br>Headlight Left Damaged<br>Side Mirror Right Damaged<br>Front Bumper Damaged<br>Bonnet Damaged<br>Front Fender Left Damaged<br>Front Fender Right Damaged<br>Rear Fender Left Residual Traces of Repair<br>Door Front Right Damaged<br>Door Rear Left Residual Traces of Repair<br>Windscreen Cracked<br>Parking Brake Performance Left / Right Difference out of legal range<br>Gearbox Oil Leak<br>Radiator Cradle Damaged<br>Gear Selections Insufficient<br>Clutch Operation Insufficient<br>No reverse gear<br>Body exterior<br>Body exterior<br>Undercarriage<br>Multiple warning lights illuminated | Repair<br>Repair<br>Replace<br>Replace<br>Replace<br>Repair<br>Repair<br>Repair<br>Repair<br>Repair<br>Repair<br>Replace<br>Repair<br>Replace<br>Replace<br>Repair<br>Replace<br>Replace<br>Repair<br>Repair<br>Repair<br>Repair<br>Signs of spray work done on some body panels<br>Minor dents scratches stone chips on some body pan<br>Undercarriage is covered<br>Repair |

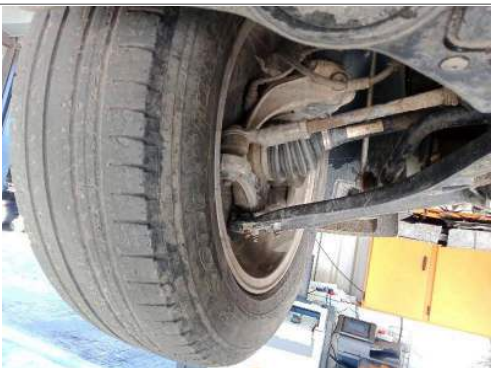
LF TYRE TREAD

| | Size | Load/Speed Index | Manufacture | Model | Type* | Production Date | Tread Depth (mm) |
|---|---|---|---|---|---|---|---|
| Front Left | 215/65R17 | 99V | Pirelli | Scorpion | V | 3719 | 3 mm |

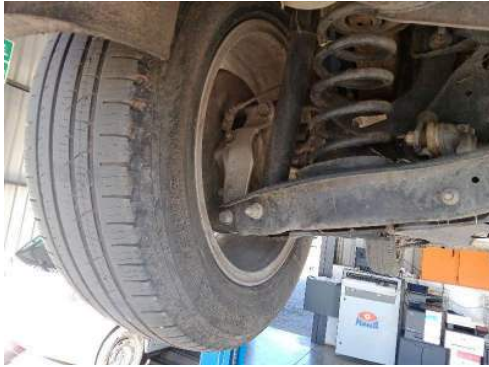
LR TYRE TREAD

| | Size | Load/Speed Index | Manufacture | Model | Type* | Production Date | Tread Depth (mm) |
|---|---|---|---|---|---|---|---|
| Rear Left | 215/65R17 | 99V | Pirelli | Scorpion | V | 3719 | 3 mm |

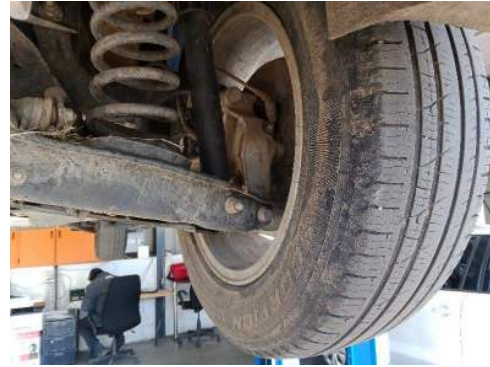
RR TYRE TREAD

| | Size | Load/Speed Index | Manufacture | Model | Type* | Production Date | Tread Depth (mm) |
|---|---|---|---|---|---|---|---|
| Rear Right | 215/65R17 | 99V | Pirelli | Scorpion | V | 3719 | 3 mm |
