CONDITION REPORT

Report No: 2016205000

MFC Auction House
M57 Pretoria Rd, Glenmarais, KEMPTON PARK
Gauteng

| Manufacturer | VOLKSWAGEN | Registration Number | JM17JYGP |

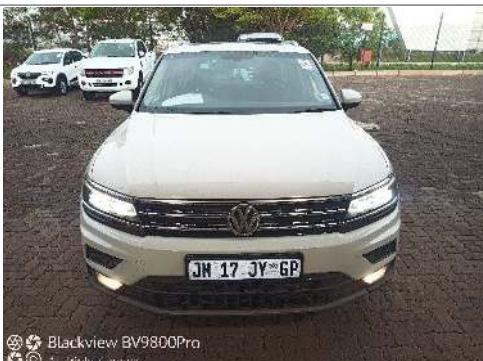
90 DEGREE FRONT

General Comments: ACCORDING TO THE AGE AND MILEAGE OF THE VEHICLE, NORMAL WEAR AND TEAR MARKS ARE VISIBLE ON THE INTERIOR, EXTERIOR, ELECTRICAL AND MECHANICAL PARTS.
 Body • Exterior: Vehicle got minor scratches, stone chips and dents on some body panels
