CONDITION REPORT

Report No: 2016842818

Vehicle Type	PASSENGER VEHICLE	Registered Owner	
Manufacturer	VOLKSWAGEN	Registration Number	DG25HHGP
Model	JETTA 6 1.6 TDI COMFORTLINE DSL DSG [2014-2015]	Register Number	
VIN	WVWZZZ16ZEM052850	Date Of First Licensing	
Engine Number		Last COR	
Doors	4	License Expiry Date	31/01/2026
Color	SILVER	Power / Displacement	
Year Model	2014	Paint Finish	TWO COAT METALLIC
Km Reading	186,902 KM	Fuel	DIESEL
Cab / Body Type	SEDAN	Transmission	AUTOMATIC

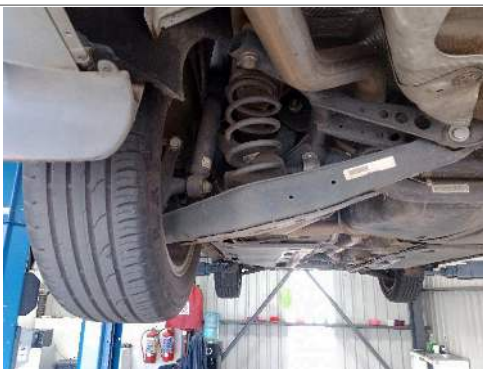
LR TYRE TREAD

Size	Load/Speed Index	Manufacture	Model	Type*	Production Date	Tread Depth (mm)
Front Left	205/55R16	91V	Continental	Contipremium	V	3420	0 mm
Front Right	205/55R16	91V	Continental	Contipremium	V	0221	2 mm
Rear Left	205/55R16	91V	Continental	Contipremium	V	0221	2 mm
Rear Right	205/55R16	91V	Continental	Contipremium	V	3420	1 mm
