MFC Auction House  
M57 Pretoria Rd, Glenmarais, KEMPTON PARK  
Gauteng

| Manufacturer | VOLKSWAGEN | Registration Number | KLR619NW |
| Model | JETTA 6 GP 1.4 TSI COMFORTLINE [2015-2017] | Register Number | |
| VIN | WVWZZZ16ZGM005020 | Date Of First Licensing | |

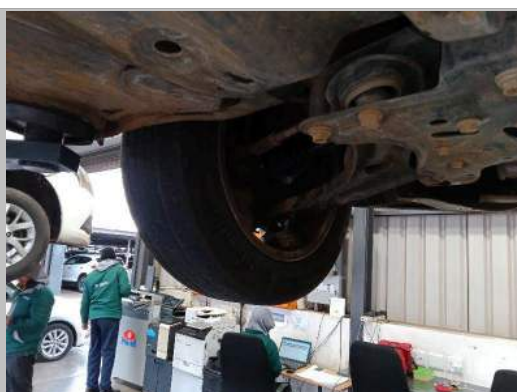
LF TYRE TREAD

| | Size | Load/Speed Index | Manufacture | Model | Type* | Production Date | Tread Depth (mm) |
|---|---|---|---|---|---|---|---|
| Front Left | 205/55R16 | 91V | Continental | Contact | V | 4523 | 2 mm |

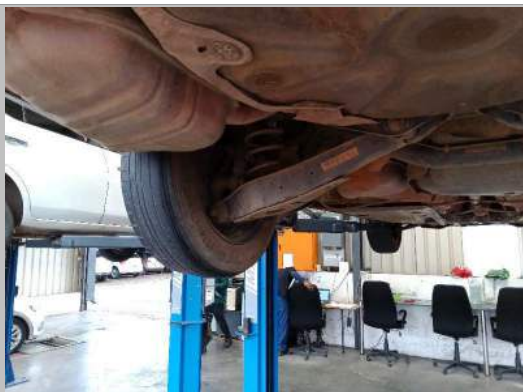
LR TYRE TREAD

| Damage | Repair Way |
|---|---|
| Tyre Rear Left Damaged | Replace |

| | Size | Load/Speed Index | Manufacture | Model | Type* | Production Date | Tread Depth (mm) |
|---|---|---|---|---|---|---|---|
| Rear Left | 205/60R16 | 96V | Kumho | Ecsta | V | 3319 | 0 mm |

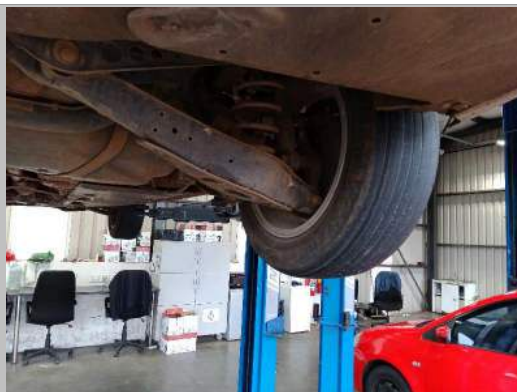
RR TYRE TREAD

| Damage | Repair Way |
|---|---|
| Tyre Rear Right Damaged | Replace |

| | Size | Load/Speed Index | Manufacture | Model | Type* | Production Date | Tread Depth (mm) |
|---|---|---|---|---|---|---|---|
| Rear Right | 205/60R16 | 92V | Lanvigator | Comfort | V | 4121 | 0 mm |

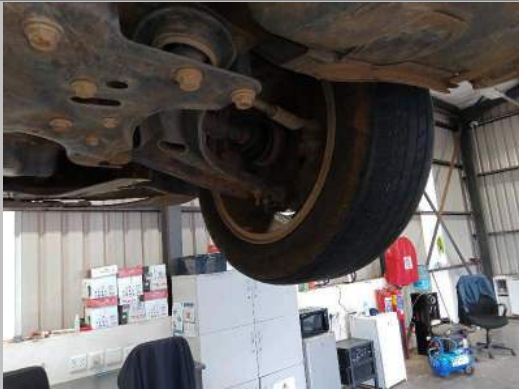
RF TYRE TREAD

| Damage | Repair Way |
|---|---|
| Tyre Front Right Excessive Wear & Tear | Replace |

| | Size | Load/Speed Index | Manufacture | Model | Type* | Production Date | Tread Depth (mm) |
|---|---|---|---|---|---|---|---|
| Front Right | 205/55R16 | 91V | Firestone | Touring | V | 2122 | 0 mm |

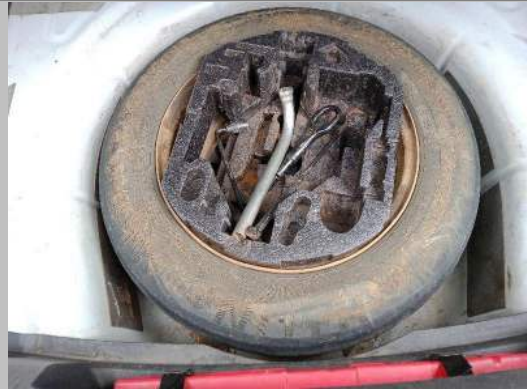
Spare wheel

| Damage | Repair Way |
|---|---|
| Spare Tyre Smooth | Replace |

| | Size | Load/Speed Index | Manufacture | Model | Type* | Production Date | Tread Depth (mm) |
|---|---|---|---|---|---|---|---|
| Spare | 195/65R15 | 91V | Apollo | Manchester u | V | 0000 | 0 mm |
