MFC Auction House  
M57 Pretoria Rd, Glenmarais, KEMPTON PARK  
Gauteng

Vehicle Type	PASSENGER VEHICLE	Registered Owner	MFC
Manufacturer	VOLKSWAGEN	Registration Number	FMP001L
Model	GOLF	Register Number	
VIN	WVWZZZ1KZDK008612	Date Of First Licensing	
Engine Number		Last COR	
Doors	2	License Expiry Date	31/07/2023
Color	SILVER	Power / Displacement	
Year Model		Paint Finish	M - METALLIC
Km Reading	171,289 KM	Fuel	PETROL
Cab / Body Type	COUPE	Transmission	AUTOMATIC

## CONDITION REPORT

Report No: 2016213124

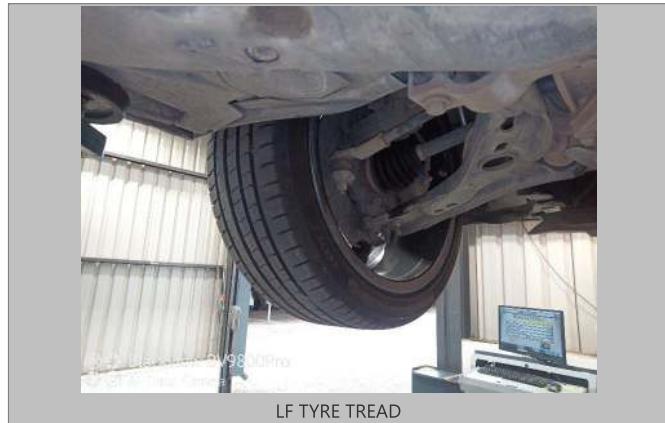
LF TYRE TREAD

Size	Load/Speed Index	Manufacture	Model	Type*	Production Date	Tread Depth (mm)
Front Left	225/40R18	92Y	Zeetex	Hp5000 max	V	1323	4 mm
Front Right	225/40R18	92Y	Zeetex	Hp5000 max	V	1323	4 mm
Rear Left	235/40R18	95W	Winrun	R330	V	3820	0 mm
Rear Right	225/40R18	92W	Habillead	Sport max	V	1018	2 mm

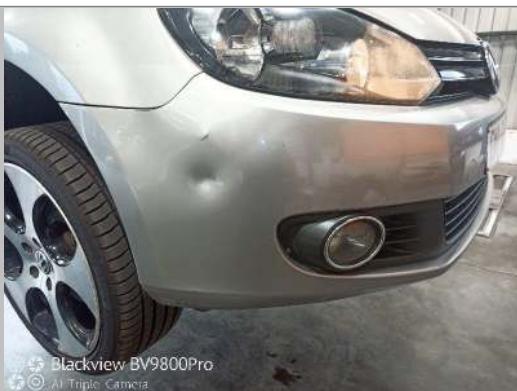
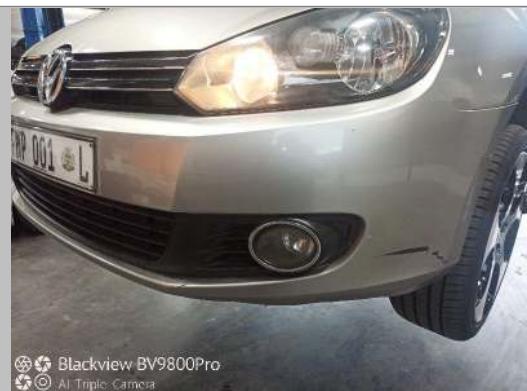
Front Bumper

Body • Exterior: Vehicle got minor scratches, stone chips and dents on some body panels

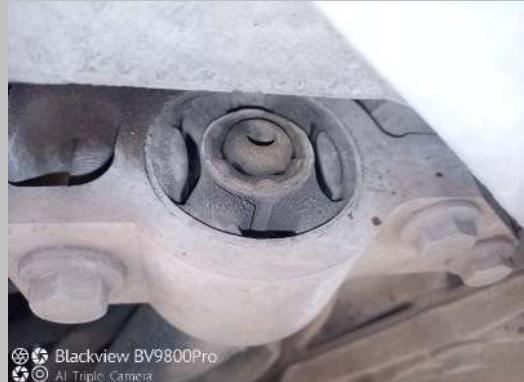
Damage	Repair Way
Engine Oil Sweat	Repair
Under bonnet insulation cover Defective	Repair
Center Console / Cubbyhole + Lid Damaged	Repair
Switch Electrical Window Winder front left Missing	Repair
Switch Electrical Window Winder front right Missing	Repair
Seat Front Right Torn / Cut	Repair
Mirror Adjusters Damaged	Repair
Front Bumper Dented	Repair
Front Fender Left Paintwork • Scratched	Repair
Front Fender Right Dented	Repair
Rear Fender Left Paintwork • Scratched	Repair
Door Front Left Paintwork • Scratched	Repair
Rear bumper Paintwork • Scratched	Repair
Control Arm Bush(es) Front Axle Left Cracked	Replace
Control Arm Bush(es) Front Axle Right Cracked	Replace
Tyre Rear Left Damaged	Replace
Belly plates Loose / Excessive Play	Repair
