CONDITION REPORT

Report No: 2016489888

MFC Auction House
M57 Pretoria Rd, Glenmarais, KEMPTON PARK
Gauteng

Vehicle Type	PASSENGER VEHICLE	Registered Owner	
Manufacturer	VOLKSWAGEN	Registration Number	HC50ZLGP
Model	POLO	Register Number	
VIN	WVWZZZ60ZJT063252	Date Of First Licensing	
Engine Number		Last COR	
Doors	4	License Expiry Date	13/08/2024
Color	SILVER	Power / Displacement	
Year Model		Paint Finish	M - METALLIC
Km Reading	201,985 KM	Fuel	PETROL
Cab / Body Type	SEDAN	Transmission	MANUAL

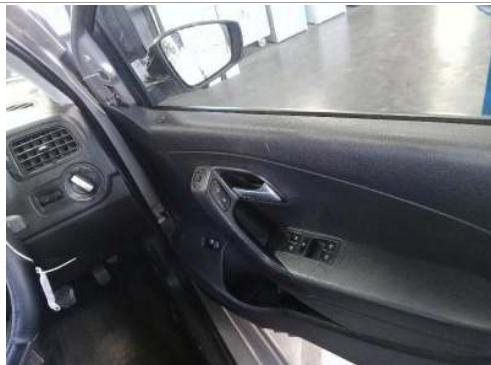
Door Panel Front Right

Door Front Right Dented	Repair
Door Rear Left Cracked	Repair
Door Rear Right Paintwork • Scratched	Repair
Boot Lid / Hatch door Paintwork • Discoloured	Repair
