## CONDITION REPORT

Report No:  
2016961407  
DATE  
29/07/2025

| Manufacturer | VOLKSWAGEN | Registration Number | JZ71XJGP |
| Model | POLO SEDAN 1.6 COMFORTLINE [2019-2021] | Register Number | |

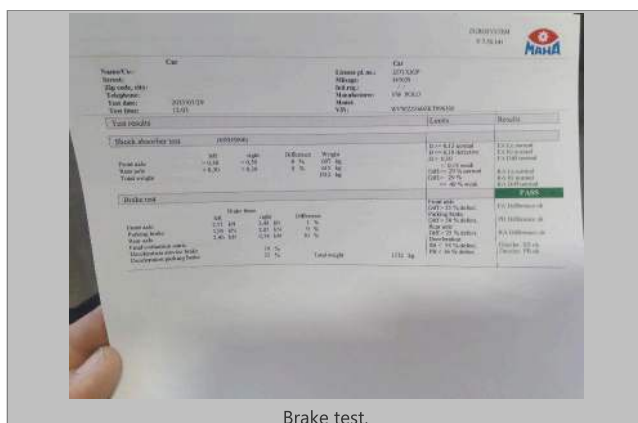
Brake test.

| | Left | Right | | |
|---|---|---|---|---|
| Front | 2.51 | 2.48 | - | |
| Rear | 2.46 | 2.74 | - | |
| Emergency / Parking | 1.88 | 2.05 | - | |

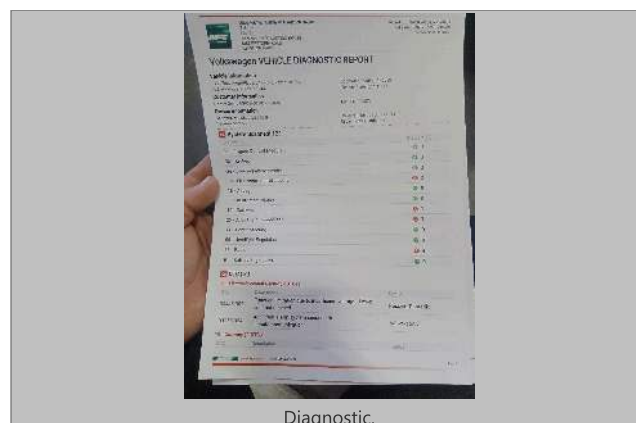
Diagnostic.

| No | System | Code | Description | Status |
|---|---|---|---|---|
| 1 | ELECTRONIC CENTRAL<br>ELECTRIC | 03156:004 | ANTI- THEFT ALARM SYSTEM SENSOR-NO SIGNAL<br>/COMMUNICATION | |

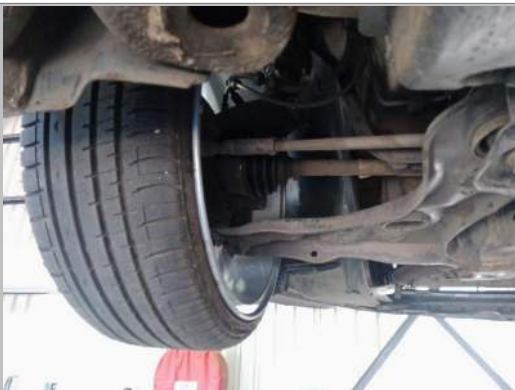
LF TYRE TREAD

| | Size | Load/Speed Index | Manufacture | Model | Type* | Production Date | Tread Depth (mm) |
|---|---|---|---|---|---|---|---|
| Front Left | 185/35R17 | 82V | Acceiera | Radial | V | 3024 | 4 mm |

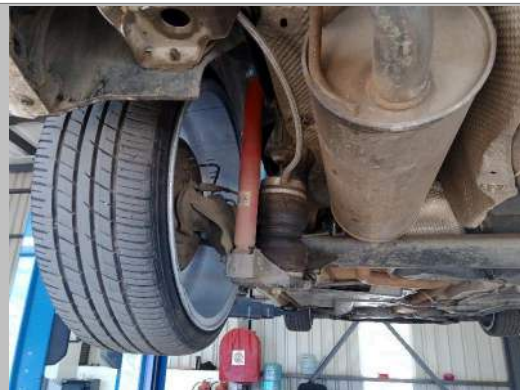
LR TYRE TREAD

| | Size | Load/Speed Index | Manufacture | Model | Type* | Production Date | Tread Depth (mm) |
|---|---|---|---|---|---|---|---|
| Rear Left | 185/35R17 | 74V | Hockenheim | Radial | V | 1624 | 4 mm |

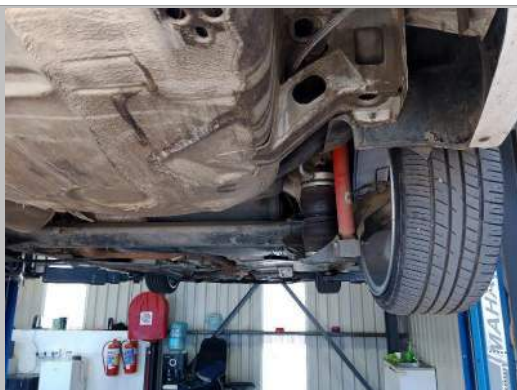
RR TYRE TREAD

| | Size | Load/Speed Index | Manufacture | Model | Type* | Production Date | Tread Depth (mm) |
|---|---|---|---|---|---|---|---|
| Rear Right | 185/35R17 | 74W | Hockenheim | Radial | V | 1624 | 4 mm |

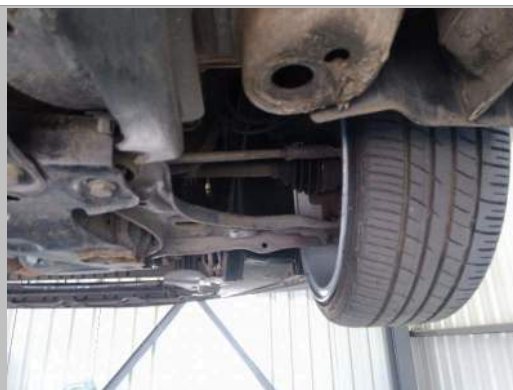
RF TYRE TREAD

| | Size | Load/Speed Index | Manufacture | Model | Type* | Production Date | Tread Depth (mm) |
|---|---|---|---|---|---|---|---|
| Front Right | 185/35R17 | 74V | Hockenheim | Radial | V | 1524 | 4 mm |

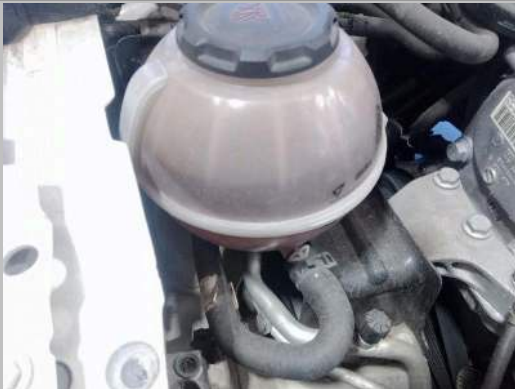
Water level

| Damage | Repair Way |
|---|---|
| Radiator Water Leak | Repair |
