## CONDITION REPORT

Report No:  
2017302493  
DATE  
23/09/2026

| Manufacturer | VOLKSWAGEN | Registration Number | MT44KPGP |
| Model | POLO SEDAN 1.6 COMFORTLINE [2019-2021] | Register Number | |

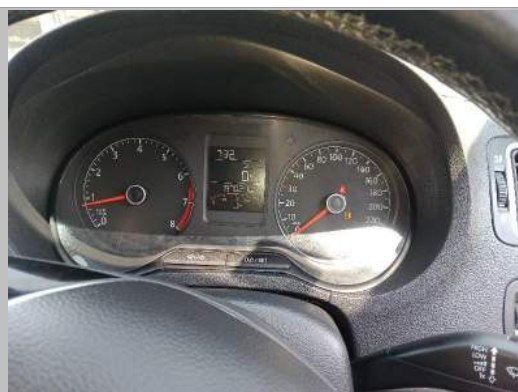
DASHBOARD (W/ ENGINE RUNNING)

| No | System | Code | Description | Status |
|---|---|---|---|---|
| 1 | PASSIVE SPORADIC | 28823:000 | LOST COMMUNICATION WITH RESTRAINTS CONTROL MODULE | |

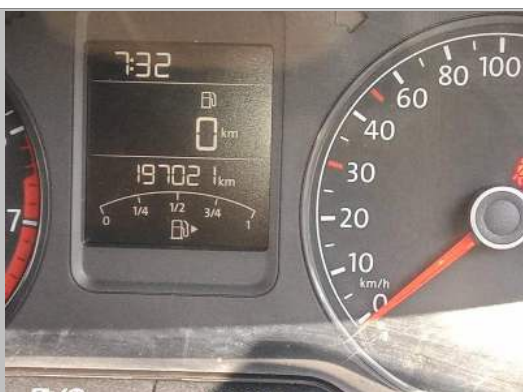
ODOMETER

| Km Reading | 197,021 KM | Fuel | PETROL |

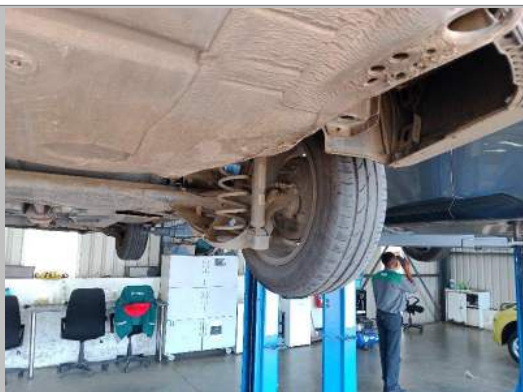
RR TYRE TREAD

| | Size | Load/Speed Index | Manufacture | Model | Type* | Production Date | Tread Depth (mm) |
|---|---|---|---|---|---|---|---|
| Rear Right | 185/60R15 | 84H | Continental | Contact | V | 4024 | 3 mm |

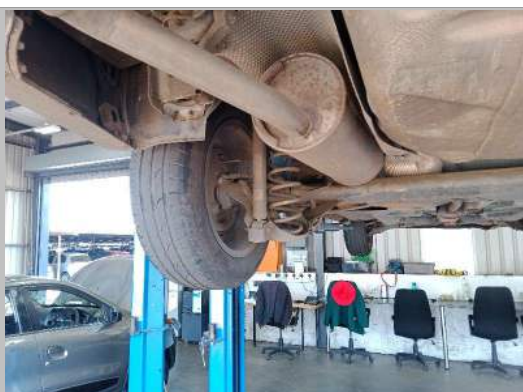
LR TYRE TREAD

| | Size | Load/Speed Index | Manufacture | Model | Type* | Production Date | Tread Depth (mm) |
|---|---|---|---|---|---|---|---|
| Rear Left | 185/60R15 | 84H | Continental | Contact | V | 2723 | 3 mm |

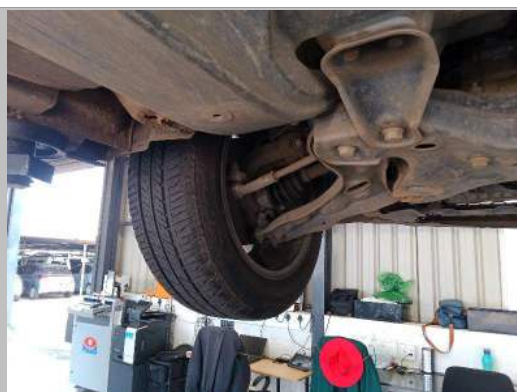
LF TYRE TREAD

| Front tires deferred name brand | Repair |

| | Size | Load/Speed Index | Manufacture | Model | Type* | Production Date | Tread Depth (mm) |
|---|---|---|---|---|---|---|---|
| Front Left | 185/60R15 | 88H | Firestone | Touring | V | 3422 | 3 mm |

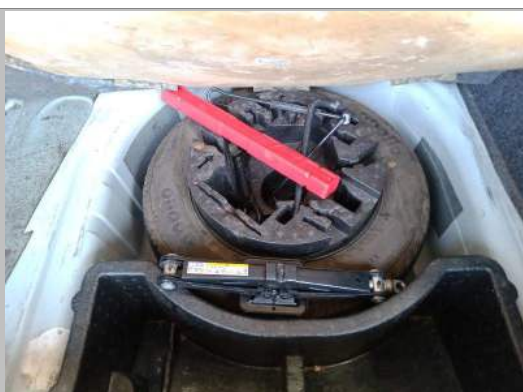
Spare wheel

| | Size | Load/Speed Index | Manufacture | Model | Type* | Production Date | Tread Depth (mm) |
|---|---|---|---|---|---|---|---|
| Spare | 175/70R14 | 84T | Apollo | Alnac | V | 0000 | 4 mm |
