MFC Auction House
M57 Pretoria Rd, Glenmarais, KEMPTON PARK
Gauteng

DEKRA MFC
M57 Pretoria Rd - 1619
KEMPTON PARK - GT
08610 33572

Vehicle Type	PASSENGER VEHICLE	Registered Owner	
Manufacturer	VOLKSWAGEN	Registration Number	JR20CZGP
Model	GOLF 7 2.0 TSI GTI PERFORMANCE PACK 5-DR DSG [2015-2017]	Register Number	
VIN	WVWZZZAUZGW054867	Date Of First Licensing	
Engine Number		Last COR	
Doors	5	License Expiry Date	30/11/2022
Color	WHITE	Power / Displacement	
Year Model	2016	Paint Finish	C - COMMON
Km Reading	299,129 KM	Fuel	PETROL
Cab / Body Type	HATCHBACK	Transmission	AUTOMATIC

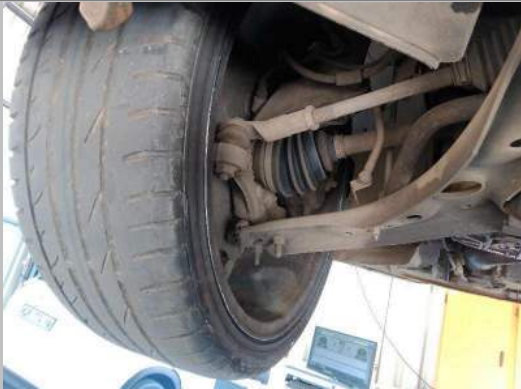
LF TYRE TREAD

Size	Load/Speed Index	Manufacture	Model	Type*	Production Date	Tread Depth (mm)
Front Left	235/35R19	91Y	Sailun	Atrezzo	V	2821	1 mm
Front Right	235/35R19	91W	Davanti	DX640	V	1924	5 mm
Rear Left	235/35R19	91Y	Pirelli	Pzero	V	2221	2 mm
Rear Right	235/35R19	91W	Rapid	P609	V	3422	0 mm

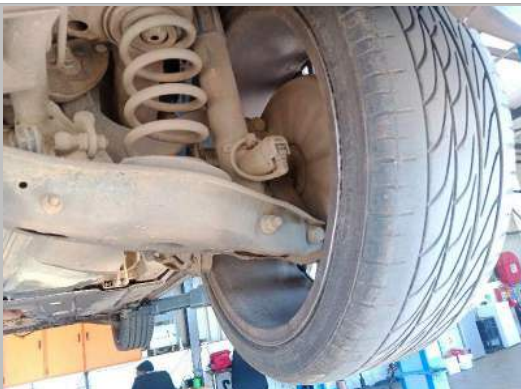
RR TYRE TREAD

Damage	Repair Way
Stabilizer Mounting Rear Right Damaged	Replace
Tyre Front Right Damaged	Replace
Tyre Rear Right Smooth	Replace
Rim Rear Left Damaged	Repair
Rim Rear Right Welded	Replace
Bolt(s) / Nut(s) Rear Wheel Left Missing	Replace
Bolt(s) / Nut(s) Rear Wheel Right Missing	Replace
Belly plates Damaged	Replace
Gearbox Oil Leak	Repair
Alternator belt missing	Replace
Vehicle electronics malfunction	Repair
Boot does not open, electric malfunction	Repair
Vehicle push into Dekra parking	Repair

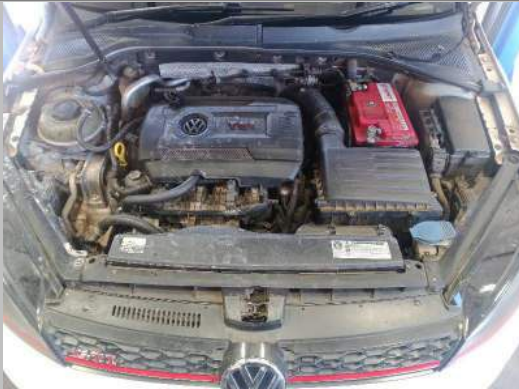
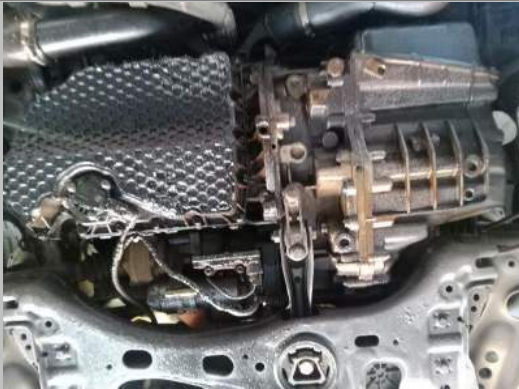
Damage	Repair Way
Engine Oil Leak	Repair
Hoses Oil Leak	Repair
Water level Insufficient	Repair
Air conditioner pump Damaged	Replace
Bonnet stay and shocks Insufficient	Replace
Switch Electrical Window Winder rear left Defective	Repair
Seat Front Left Torn / Cut	Repair
Seat Front Right Torn / Cut	Repair
Door Sealing Rubber Front Right Torn / Cut	Replace
Carpet Front Torn / Cut	Repair
Side Mirror Left Damaged	Repair
Side Mirror Right Paintwork • Scratched	Repair
Front Bumper Paintwork • Scratched	Repair
Bonnet Paintwork • Chipmarks	Repair
Rear Fender Left Damaged	Repair
Door Front Left Paintwork • Scratched	Repair
Door Rear Left Damaged	Repair
Fuel Flap Damaged	Repair
Windscreen Cracked	Replace

ENGINE 1

ENGINE 2

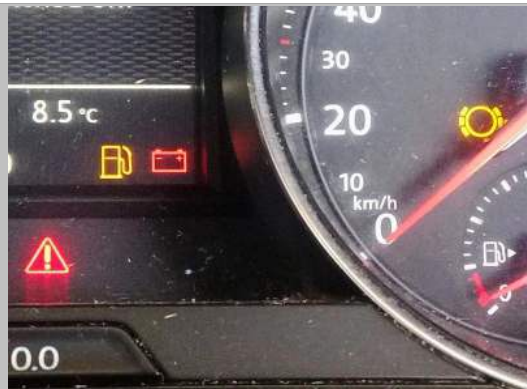
No	System	Code	Description	Status
1	ENGINE CONTROL MODULE	P029900	TURBOCHARGER SUPERCHARGER UNDERBOOST	
2	ELECTRONIC CENTRAL ELECTRIC	U101100	SUPPLY VOLTAGE VOLTAGE TOO LOW

Warning lights illuminated

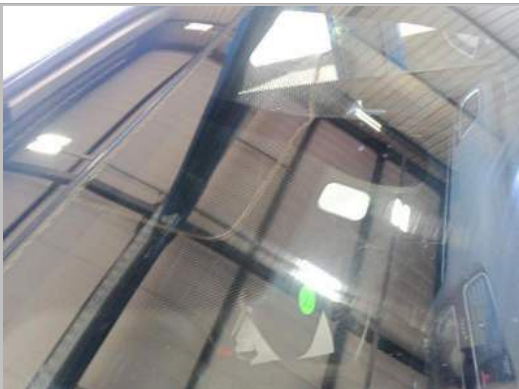
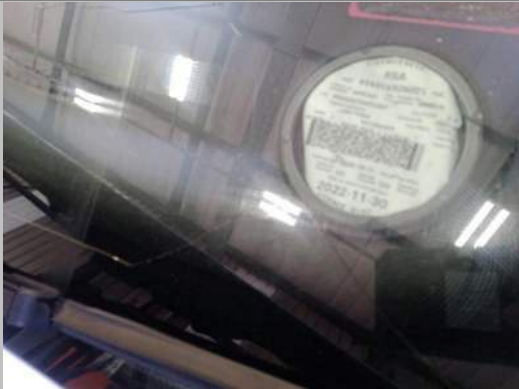
Windscreen
