DEKRA MFC  
M57 Pretoria Rd - 1619  
KEMPTON PARK - GT  
08610 33572

| Model | GOLF 7 2.0 TSI GTI 5-DR DSG [2016-2017] | Register Number | |

## CONDITION REPORT

Report No: 2016800274

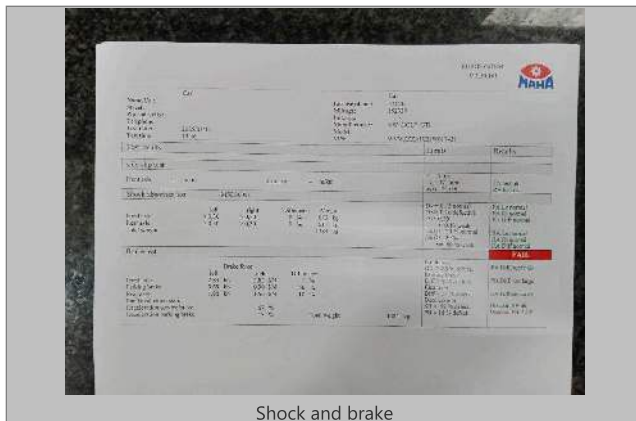
Shock and brake

| Damage | Repair Way |
|---|---|
| Parking Brake Performance Left / Right Difference out of legal range | Repair |

| | Left | Right | | |
|---|---|---|---|---|
| Emergency / Parking | 0.6 | 0.3 | - | |

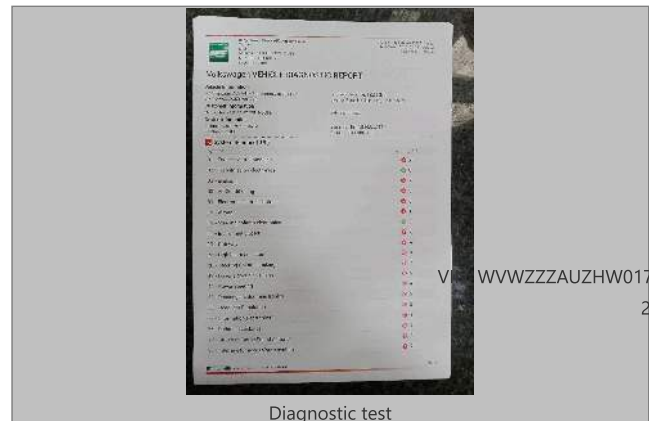
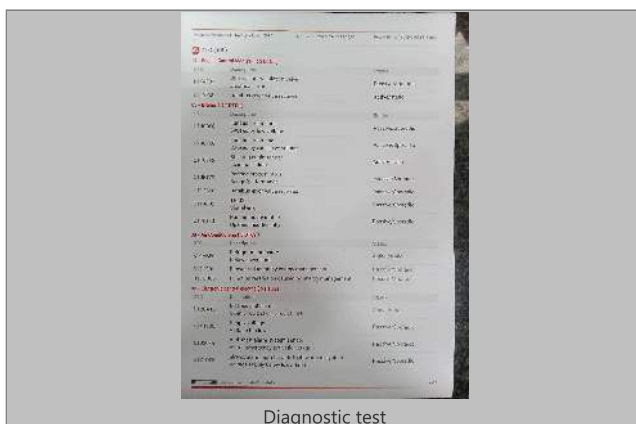
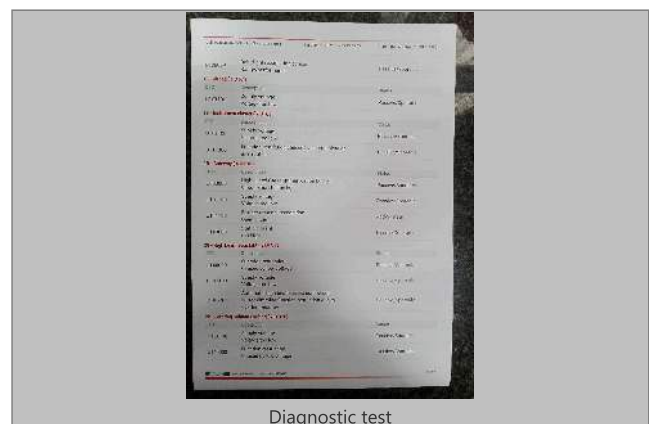
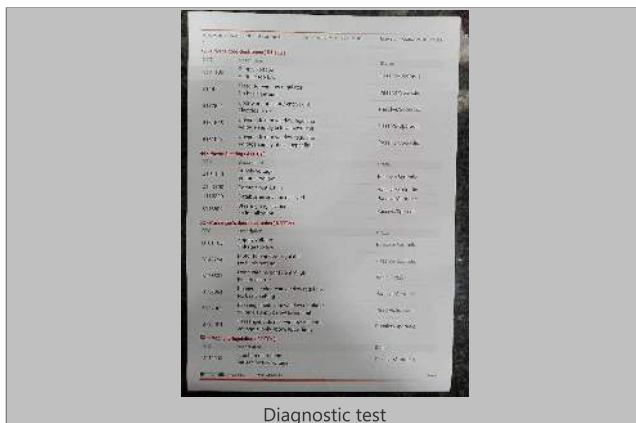
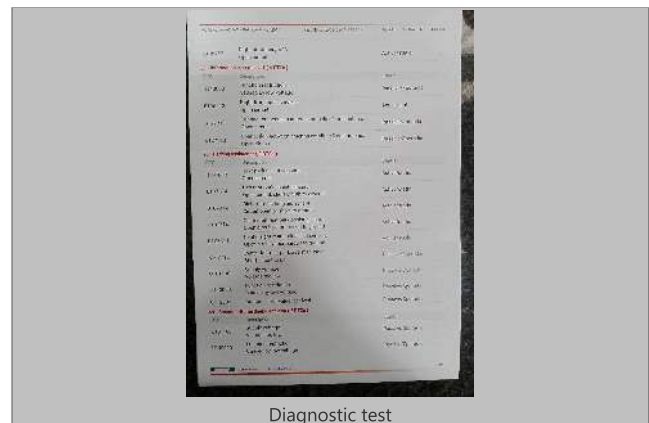
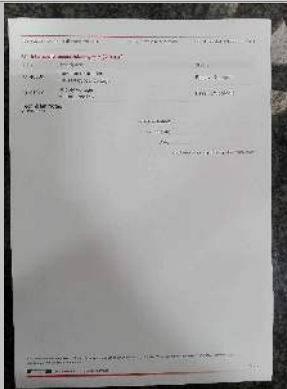
Diagnostic test

| No | System | Code | Description | Status |
|---|---|---|---|---|
| 1 | ENGINE CONTROL MODULE | P164E00 | OIL PRESSURE REGULATION VALVE ELECTRICAL ERROR | |

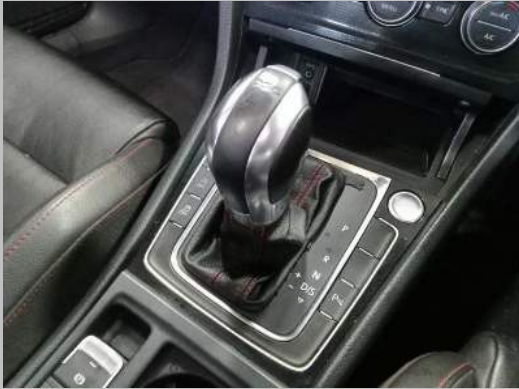
Automatic

| Damage | Repair Way |
|---|---|
| Gear Selections Insufficient | Repair |

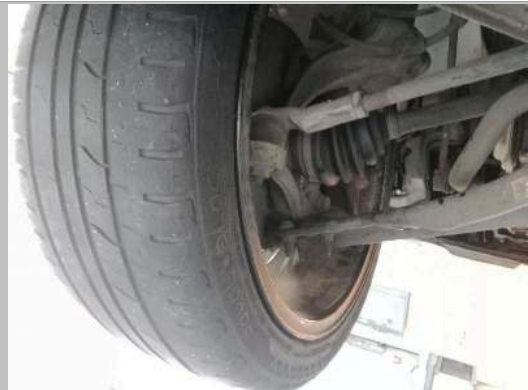
LF TYRE TREAD

| | Size | Load/Speed Index | Manufacture | Model | Type* | Production Date | Tread Depth (mm) |
|---|---|---|---|---|---|---|---|
| Front Left | 225/40R18 | 92W | Royal black | Royal | V | 4021 | 2 mm |

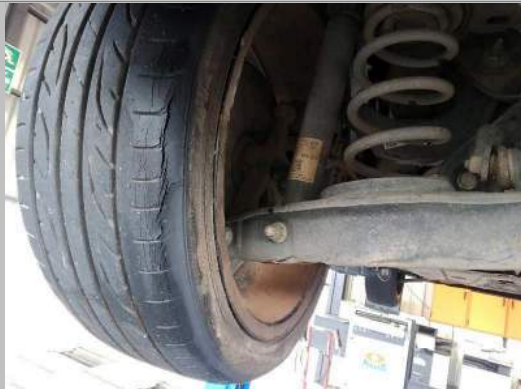
LR TYRE TREAD

| Damage | Repair Way |
|---|---|
| Tyre Rear Left Excessive Wear & Tear | Replace |

| | Size | Load/Speed Index | Manufacture | Model | Type* | Production Date | Tread Depth (mm) |
|---|---|---|---|---|---|---|---|
| Rear Left | 225/40R18 | 92W | Dunlop | Sport | V | 2617 | 1 mm |

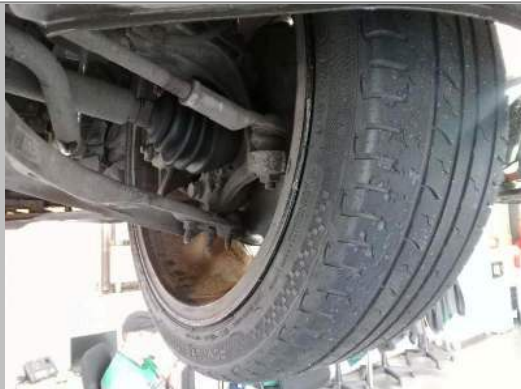
RF TYRE TREAD

| | Size | Load/Speed Index | Manufacture | Model | Type* | Production Date | Tread Depth (mm) |
|---|---|---|---|---|---|---|---|
| Front Right | 225/40R18 | 92W | Royal black | Royal | V | 1822 | 1 mm |
