## CONDITION REPORT

Report No:  
2016957348  
DATE  
24/07/2025

| Manufacturer | VOLKSWAGEN | Registration Number | KZM034NW |
| Model | GOLF 7 1.0 TSI TRENDLINE BLUEMOTION<br>81KW 5-DR [2017-2019] | Register Number | |

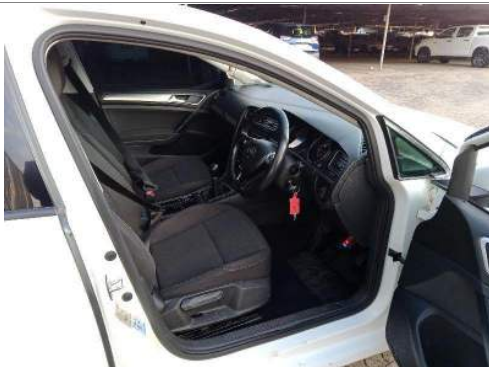
INTERIOR (FRONT DRIVER DOOR)

| Damage | Repair Way |
|---|---|
| Interior | Vehicle interior dirty and some panels scratched |

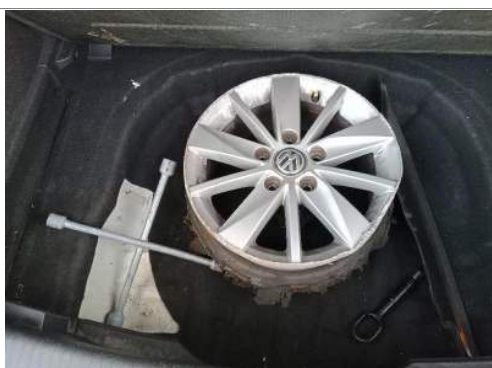
Spare rim and Accessories

| Damage | Repair Way |
|---|---|
| Spare Tyre Damaged | Replace |
| Rim Spare Wheel Damaged | Replace |

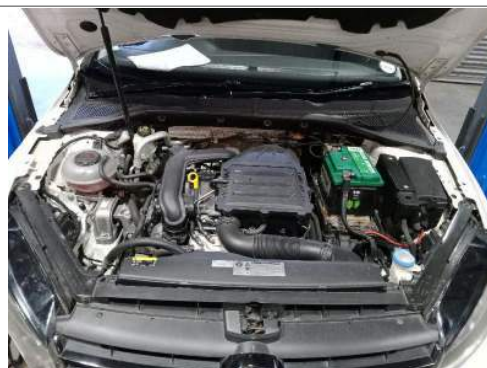
ENGINE 1

| Damage | Repair Way |
|---|---|
| Engine Oil Leak | Repair |
| Undercarriage | Excessive oil leak on engine splash plate |
| Undercarriage | Bottom of engine and gearbox fully covered |
| Undercarriage | Cannot pin direction of oil leak |

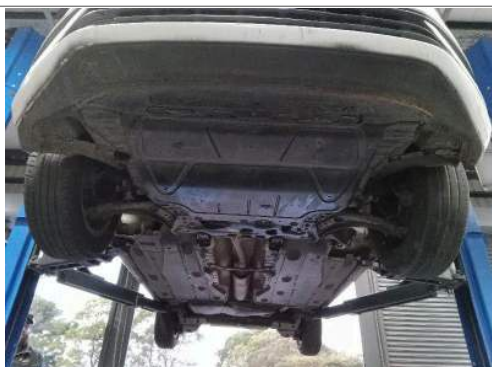
Front chassis

| Damage | Repair Way |
|---|---|
| Chassis Dented | Repair |
