CONDITION REPORT

Report No:
2016943873
DATE
11/07/2025

Vehicle Type	PASSENGER VEHICLE	Registered Owner	
Manufacturer	VOLVO	Registration Number	KW08TYGP
Model	S60 T4 2.0 MOMENTUM GEARTRONIC [2015-2016]	Register Number	
		Date Of First Licensing	
VIN	YV1FS41C0G2400123	Last COR	
Engine Number		License Expiry Date	31/03/2026
Doors	4	Power / Displacement	
Color	SILVER	Paint Finish	TWO COAT UNI
Year Model	2015	Fuel	PETROL
Km Reading	167,700 KM	Transmission	AUTOMATIC
Cab / Body Type	SEDAN

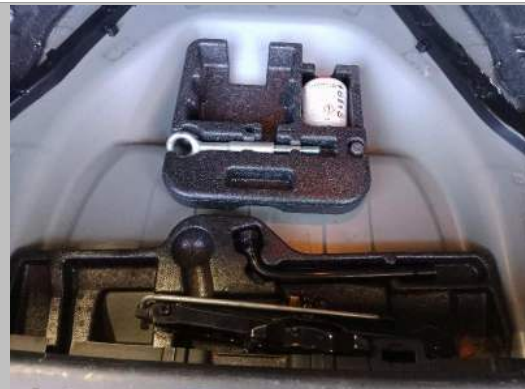
Spare wheel Accessories

Tyre Front Right Damaged	Replace
Tyre Rear Left Damaged	Replace
Rim Front Left Scratched	Repair
Rim Front Right Scratched	Repair
Rim Rear Left Scratched	Repair
Rim Rear Right Scratched	Repair
Sub Frame Dented	Repair
Engine Noise Excessive	Repair
Warning lights illuminated on dashboard	Repair
Engine	Signs rodent in engine bay
Body and Exterior	Residual traces of repair on some body panels
Body and Exterior	Stone chips and spray work on some body panels
Body and Exterior	Dents and scratches on some body panels
Interior/ Gear knob cracked	Replace
Engine bay dirty.	Clean
Engine splash plate missing	Replace
Parking brake switch faulty	Repair
Oil level could not be checked	Repair
Spare wheel missing.	Replace

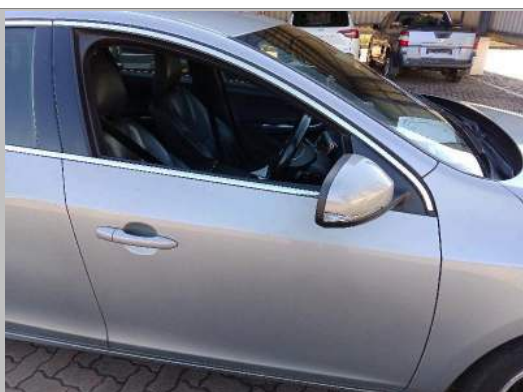
Damage	Repair Way
Hoses Oil Sweat	Repair
Air Conditioner Insufficient	Replace
Indicator Light Front Left Damaged	Replace
Headlight Left Damaged	Replace
Door Panel Front Right Defective	Repair
Door Panel Rear Right Damaged	Repair
Side Mirror Left Damaged	Replace
Side Mirror Right Paintwork • Scratched	Repair
Front Bumper Damaged	Repair
Bonnet Paintwork • Scratched	Repair
Front Fender Left Paintwork • Scratched	Repair
Front Fender Right Residual Traces of Repair	Repair
Rear Fender Left Damaged	Repair
Rear Fender Right Damaged	Repair
Door Front Left Damaged	Repair
Door Front Right Paintwork • Scratched	Repair
Door Rear Left Paintwork • Scratched	Repair
Door Rear Right Paintwork • Scratched	Repair
Boot Lid / Hatch door Paintwork • Scratched	Repair
Rear bumper Paintwork • Scratched	Repair
Sill Panel Left Dented	Repair
Parking Brake Performance Left / Right Difference out of legal range	Repair
Tyre Front Left Damaged	Replace
