## CONDITION REPORT

Report No:  
2017303120  
DATE  
25/09/2026

| Manufacturer | VOLVO | Registration Number | KW53KXGP |
| Model | S60 T5 2.0 R-DESIGN [2012-2013] | Register Number | |

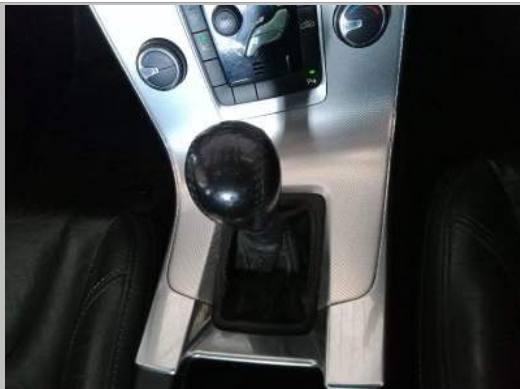
Manual Transmission

| Damage | Repair Way |
|---|---|
| Gearbox Oil Sweat | Repair |

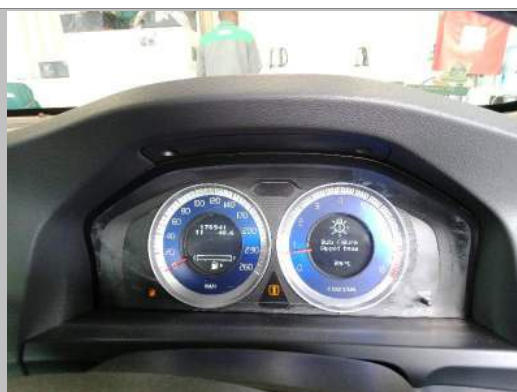
DASHBOARD (W/ ENGINE RUNNING)

| Damage | Repair Way |
|---|---|
| Warning light illuminated on dashboard | Repair |

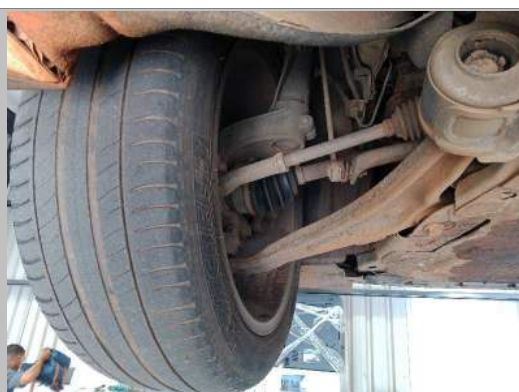
LF TYRE TREAD

| | Size | Load/Speed Index | Manufacture | Model | Type* | Production Date | Tread Depth (mm) |
|---|---|---|---|---|---|---|---|
| Front Left | 215/50 R18 | 92W | Michelin | Primacy 3 | V | 1722 | 1 mm |

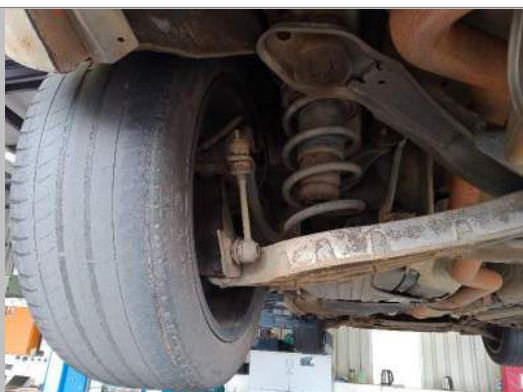
LR TYRE TREAD

| Damage | Repair Way |
|---|---|
| Tyre Rear Left Damaged | Replace |

| | Size | Load/Speed Index | Manufacture | Model | Type* | Production Date | Tread Depth (mm) |
|---|---|---|---|---|---|---|---|
| Rear Left | 215/50 R18 | 92W | Michelin | Primacy 3 | V | 3916 | 0 mm |

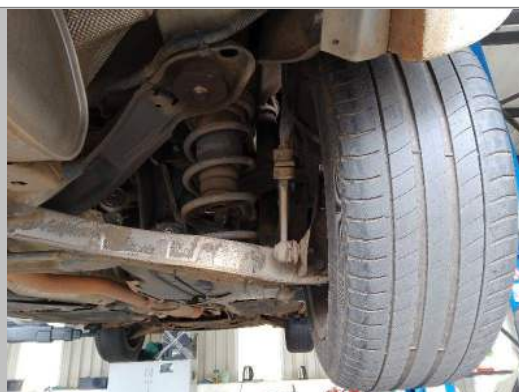
RR TYRE TREAD

| Damage | Repair Way |
|---|---|
| Tyre Rear Right Torn / Cut | Replace |

| | Size | Load/Speed Index | Manufacture | Model | Type* | Production Date | Tread Depth (mm) |
|---|---|---|---|---|---|---|---|
| Rear Right | 215/50 R18 | 92W | Michelin | Primacy 3 | V | 1722 | 2 mm |

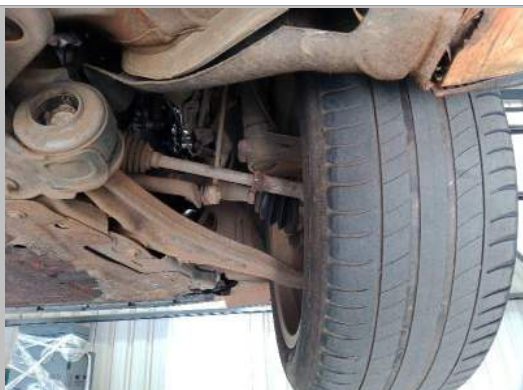
RF TYRE TREAD

| | Size | Load/Speed Index | Manufacture | Model | Type* | Production Date | Tread Depth (mm) |
|---|---|---|---|---|---|---|---|
| Front Right | 215/50 R18 | 92W | Michelin | Primacy 3 | V | 1722 | 2 mm |
