CONDITION REPORT

Report No:  
2017297770  
DATE  
11/09/2026

MFC Auction House  
M57 Pretoria Rd, Glenmarais, KEMPTON PARK  
Gauteng

| Model | URBAN CRUISER 1.5 XR AT [2023-2024] | Register Number | |

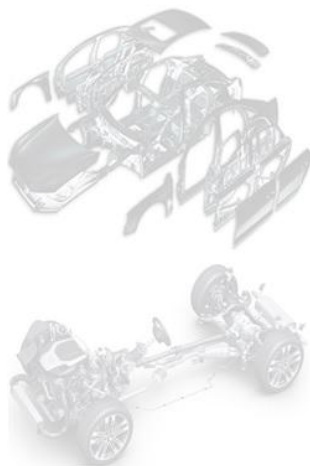
Front Bumper Paintwork • Scratched  
 Bonnet Dented  
 Front Fender Right Dented  
 Door Front Right Paintwork • Scratched  
 Rear bumper Paintwork • Scratched

Repair  
 Repair  
 Repair  
 Repair  
 Repair

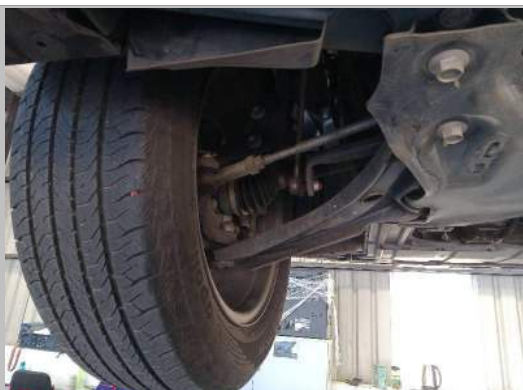
LF TYRE TREAD

| | Size | Load/Speed Index | Manufacture | Model | Type* | Production Date | Tread Depth (mm) |
|---|---|---|---|---|---|---|---|
| Front Left | 215/60 R17 | 96H | Apollo | Apterra | V | 3223 | 4 mm |

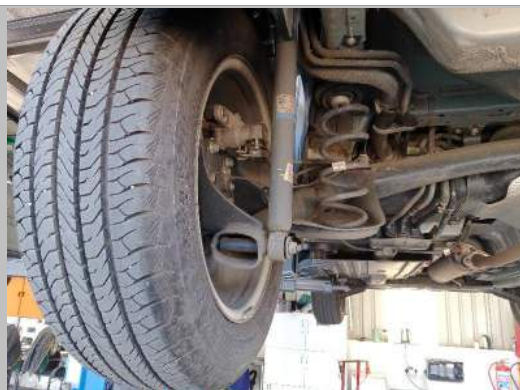
LR TYRE TREAD

| | Size | Load/Speed Index | Manufacture | Model | Type* | Production Date | Tread Depth (mm) |
|---|---|---|---|---|---|---|---|
| Rear Left | 215/60 R17 | 96H | Apollo | Apterra | V | 3323 | 5 mm |

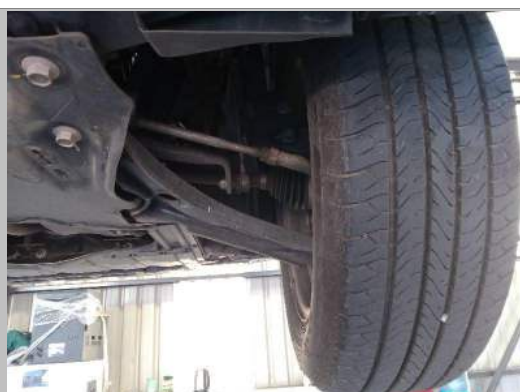
RF TYRE TREAD

| | Size | Load/Speed Index | Manufacture | Model | Type* | Production Date | Tread Depth (mm) |
|---|---|---|---|---|---|---|---|
| Front Right | 215/60 R17 | 96H | Apollo | Apterra | V | 3323 | 4 mm |

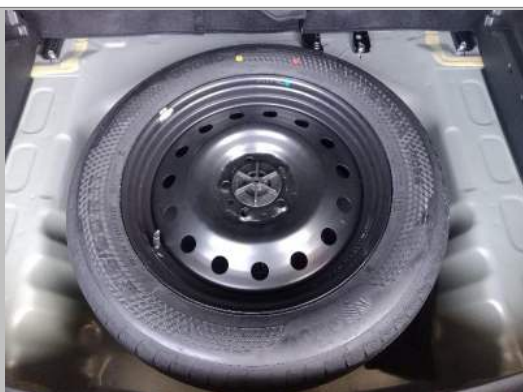
Spare Wheel

| | Size | Load/Speed Index | Manufacture | Model | Type* | Production Date | Tread Depth (mm) |
|---|---|---|---|---|---|---|---|
| Spare | 215/60 R17 | 96H | Apollo | Apterra | V | 3223 | 6 mm |

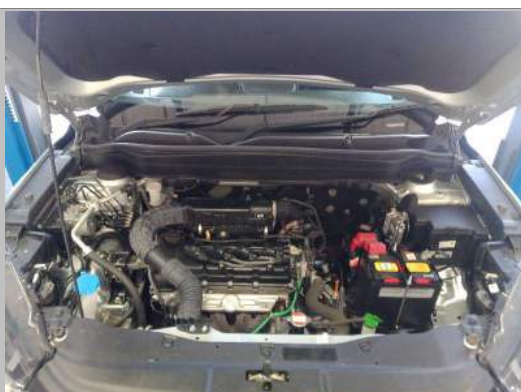
ENGINE 1

No Test Drive  
Battery Flat  
Engine number – not possible to verify engine number (not visible without dismantling)  
Inspection conditions for the vehicle inspection were sufficient
