CONDITION REPORT

Report No:  
2017298331  
DATE  
14/09/2026

| Manufacturer | GWM | Registration Number | LBH295MP |
| Model | P-SERIES 2.0TD PV LUXURY SPECIAL 4X4 8-SP<br>DSL D-CAB PU AT [2020-2025] | Register Number | |

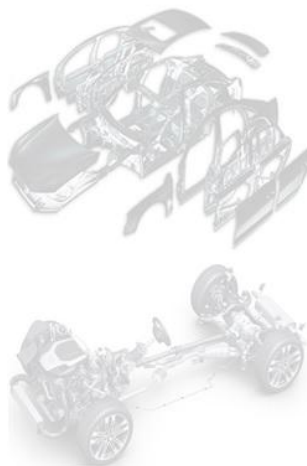
| Front Bumper Paintwork • Scratched | Repair |
| Door Front Right Paintwork • Scratched | Repair |
| Tailgate Paintwork • Scratched | Repair |
| Rear bumper Paintwork • Scratched | Repair |
| Load Body Paintwork • Scratched | Repair |

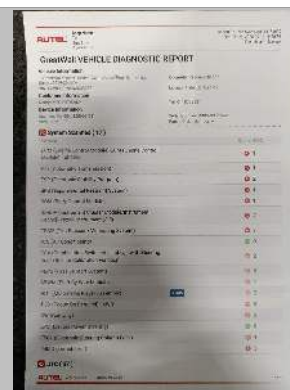
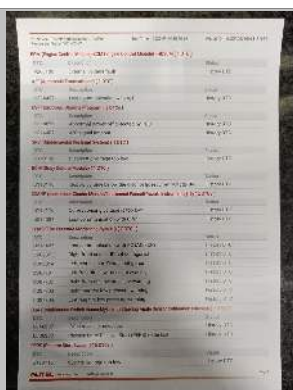
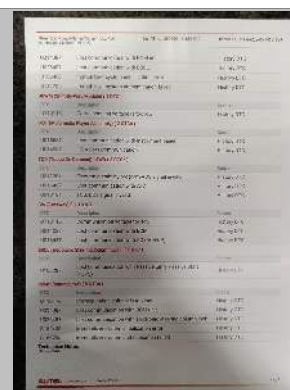
Diagnostics report

| No | System | Code | Description | Status |
|---|---|---|---|---|
| 1 | ENGINE CONTROL MODULE | P26E100 | EXTERNAL VOLTAGE FAULT | |

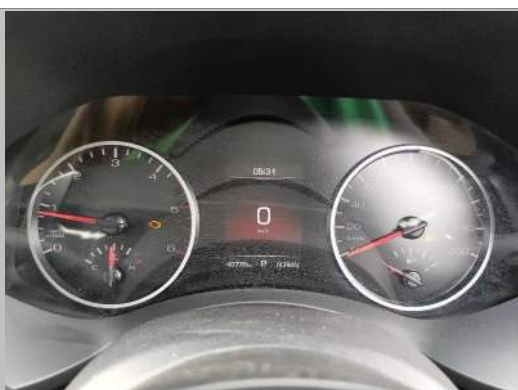
DASHBOARD (W/ ENGINE RUNNING)

| Engine warning lights illuminated | Repair |

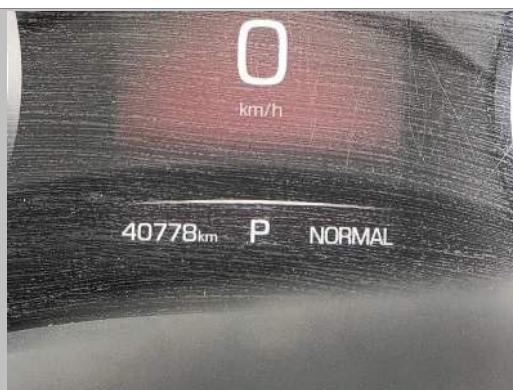
ODOMETER

| Km Reading | 40,778 KM | Transmission | AUTOMATIC |

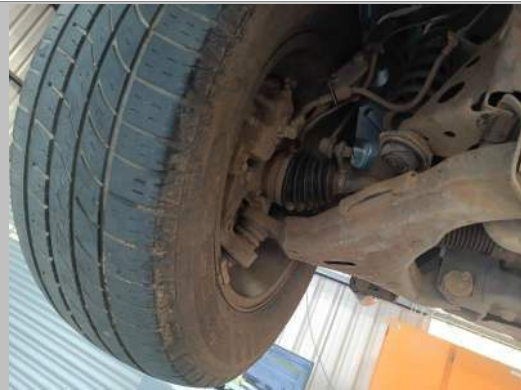
LF TYRE TREAD

| | Size | Load/Speed Index | Manufacture | Model | Type* | Production Date | Tread Depth (mm) |
|---|---|---|---|---|---|---|---|
| Front Left | 265/60R18 | 110H | Cooper | Discoverer | V | 3422 | 2 mm |

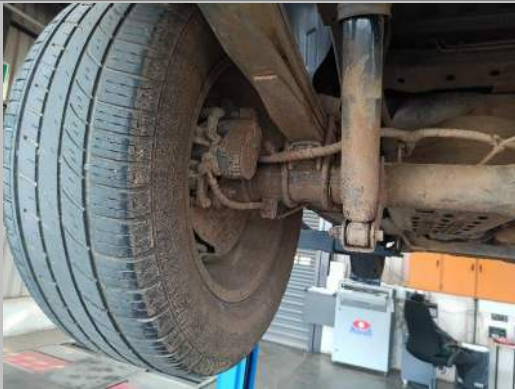
LR TYRE TREAD

| | Size | Load/Speed Index | Manufacture | Model | Type* | Production Date | Tread Depth (mm) |
|---|---|---|---|---|---|---|---|
| Rear Left | 265/60R18 | 110H | Cooper | Discoverer | V | 3422 | 3 mm |

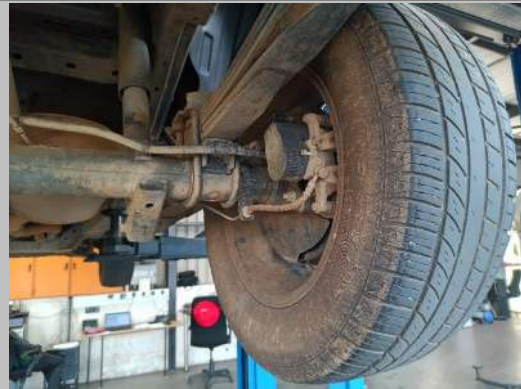
RR TYRE TREAD

| | Size | Load/Speed Index | Manufacture | Model | Type* | Production Date | Tread Depth (mm) |
|---|---|---|---|---|---|---|---|
| Rear Right | 265/60R18 | 110H | Cooper | Discoverer | V | 3422 | 3 mm |

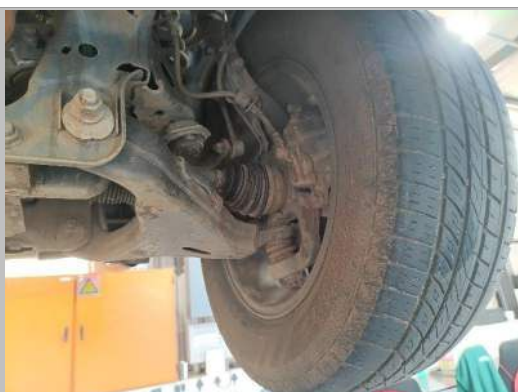
RF TYRE TREAD

| | Size | Load/Speed Index | Manufacture | Model | Type* | Production Date | Tread Depth (mm) |
|---|---|---|---|---|---|---|---|
| Front Right | 265/60R18 | 110H | Cooper | Discoverer | V | 3422 | 2 mm |

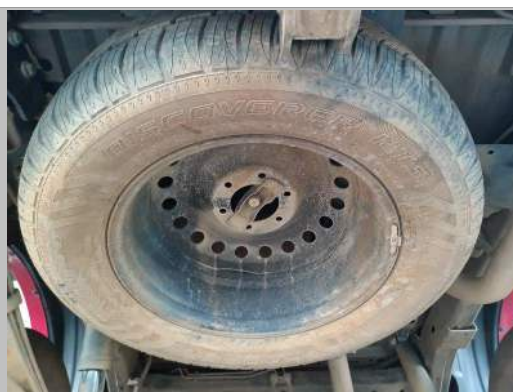
Sparewheel

| | Size | Load/Speed Index | Manufacture | Model | Type* | Production Date | Tread Depth (mm) |
|---|---|---|---|---|---|---|---|
| Spare | 265/60R18 | 110H | Cooper | Discoverer | V | 0000 | 9 mm |

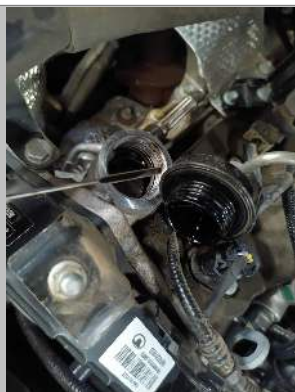
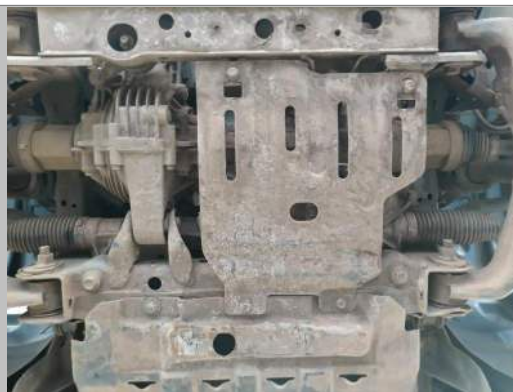
ENGINE 1

| Engine Performance Idling / Hunting | Repair |
| Bottom of engine is dirty | Repair |

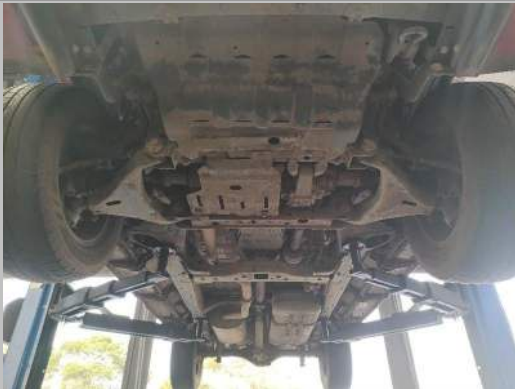
CHASSIS

General Comments: ACCORDING TO THE AGE AND MILEAGE OF THE VEHICLE, NORMAL WEAR AND TEAR MARKS ARE VISIBLE ON THE INTERIOR, EXTERIOR, ELECTRICAL AND MECHANICAL PARTS. Engine Compartment: Bottom of engine is fully covered.
