CONDITION REPORT

Report No:  
2017296814  
DATE  
10/09/2026

| Manufacturer | JAC | Registration Number | HGY189L |
| Model | T9 | Register Number | |

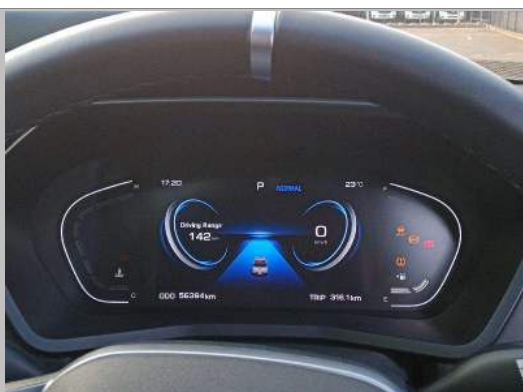
DASHBOARD (W/ ENGINE RUNNING)

| Warning light illuminated on dashboard | Repair |

| No | System | Code | Description | Status |
|---|---|---|---|---|
| 1 | EMS(ENGINE SYSTEM)-<br>EMS(ENGINE MANAGEMENT<br>SYSTEM) | P229964 | ACCELERATOR PEDAL AND BRAKE PEDAL SIGNAL IMPLAUSIB | |

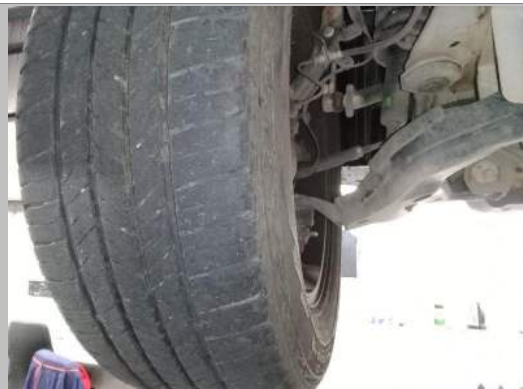
LF TYRE TREAD

| Tyre Front Left Worn | Replace |

| | Size | Load/Speed Index | Manufacture | Model | Type* | Production Date | Tread Depth (mm) |
|---|---|---|---|---|---|---|---|
| Front Left | 265/60 R18 | 110H | Citi | Citi4x4 | V | 4123 | 0 mm |

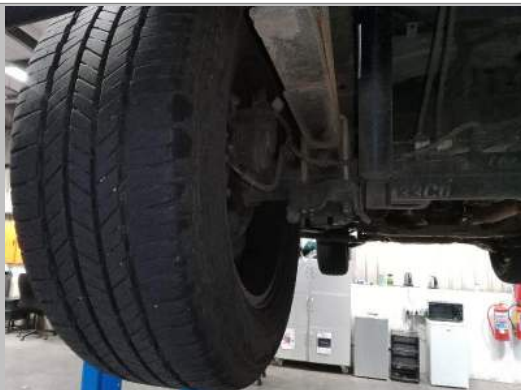
LR TYRE TREAD

| | Size | Load/Speed Index | Manufacture | Model | Type* | Production Date | Tread Depth (mm) |
|---|---|---|---|---|---|---|---|
| Rear Left | 265/60 R18 | 110H | Citi | Citi4x4 | V | 4223 | 3 mm |

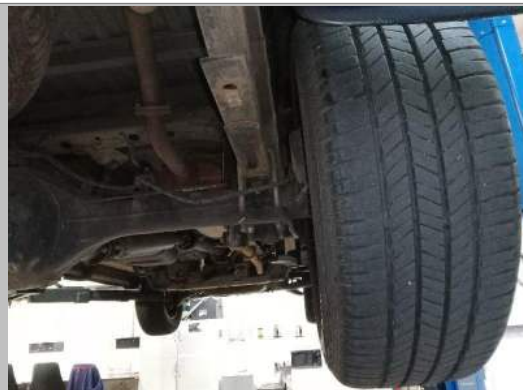
RR TYRE TREAD

| | Size | Load/Speed Index | Manufacture | Model | Type* | Production Date | Tread Depth (mm) |
|---|---|---|---|---|---|---|---|
| Rear Right | 265/60 R18 | 110H | Citi | Citi4x4 | V | 4223 | 2 mm |

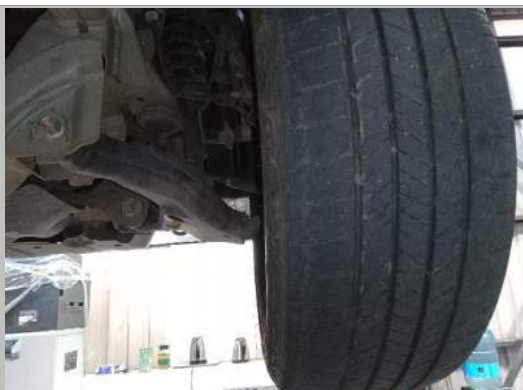
RF TYRE TREAD

| Tyre Front Right Worn | Replace |

| | Size | Load/Speed Index | Manufacture | Model | Type* | Production Date | Tread Depth (mm) |
|---|---|---|---|---|---|---|---|
| Front Right | 265/60 R18 | 110H | Citi | Citi4x4 | V | 4123 | 0 mm |

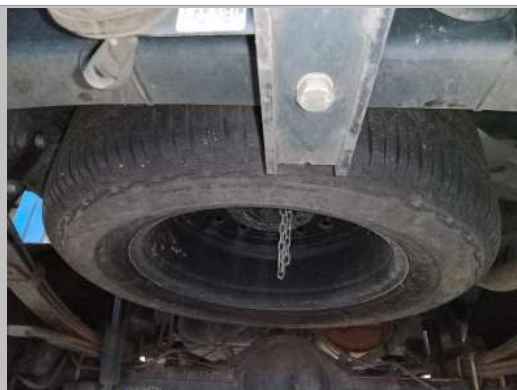
Spare Wheel

| | Size | Load/Speed Index | Manufacture | Model | Type* | Production Date | Tread Depth (mm) |
|---|---|---|---|---|---|---|---|
| Spare | 265/60 R18 | 110H | Citi | Citi4x4 | V | 4223 | 7 mm |

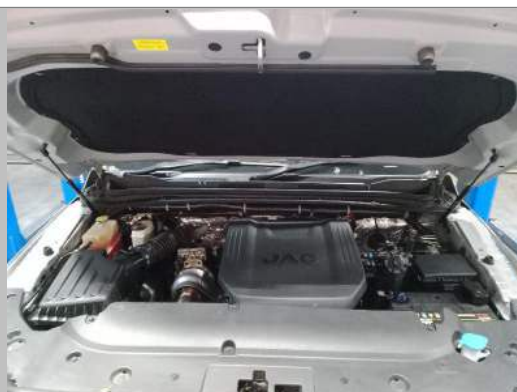
ENGINE 1

| Engine Oil Leak | Repair |

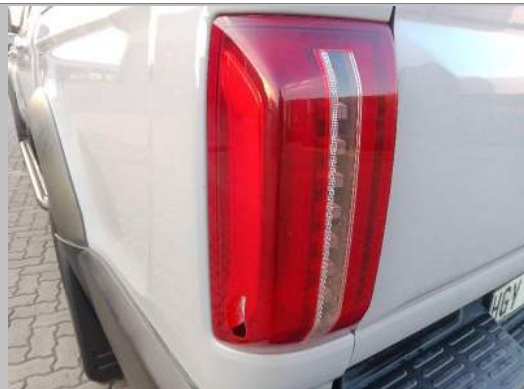
| Tail Light Left Damaged | Replace |

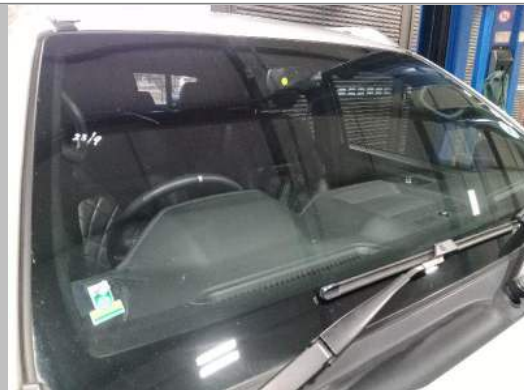
| Windscreen Chipped | Repair |

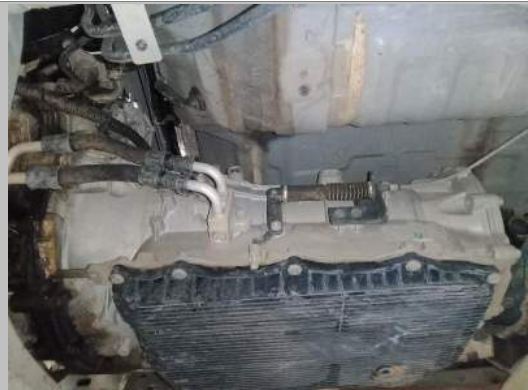
| Gearbox Oil Leak | Repair |

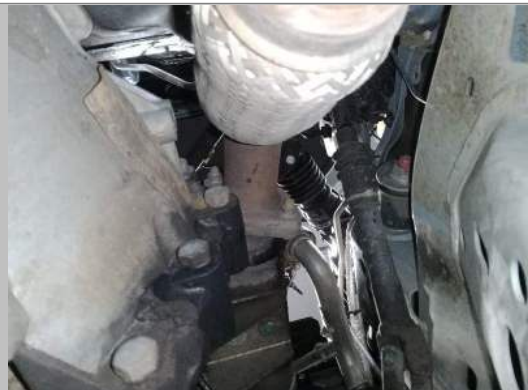
| Catalytic converter Missing | Replace |
