## CONDITION REPORT

2017298441

| Manufacturer | RENAULT | Registration Number | MJ34ZRGF |
| Model | KIGER | Register Number | |

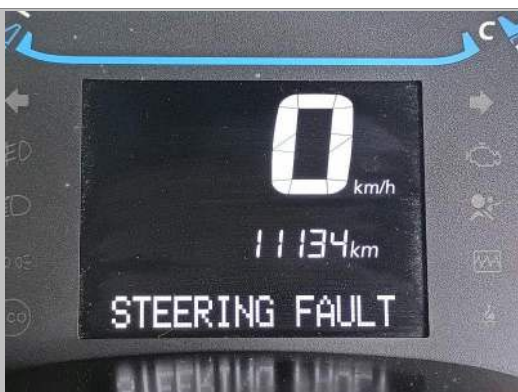
ODOMETER

| Km Reading | 11,134 KM | Fuel | PETROL |

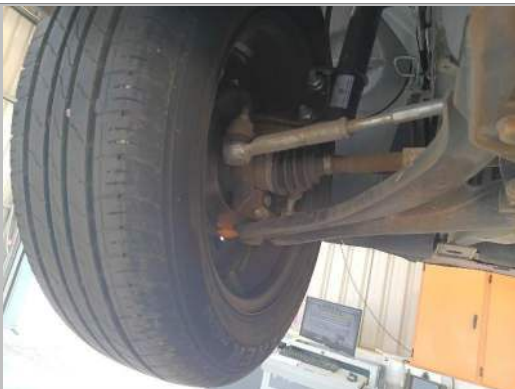
LF TYRE TREAD

| | Size | Load/Speed Index | Manufacture | Model | Type* | Production Date | Tread Depth (mm) |
|---|---|---|---|---|---|---|---|
| Front Left | 195/60R16 | 89H | MRF | Wanderer | V | 0125 | 6 mm |

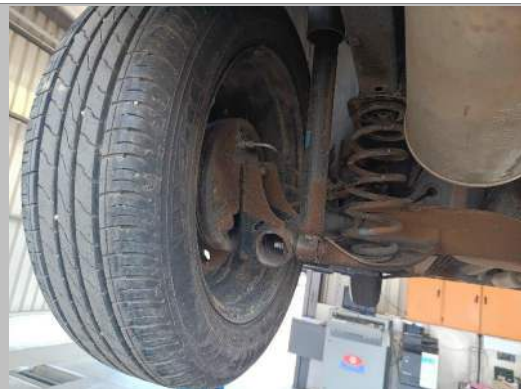
LR TYRE TREAD

| | Size | Load/Speed Index | Manufacture | Model | Type* | Production Date | Tread Depth (mm) |
|---|---|---|---|---|---|---|---|
| Rear Left | 195/60R16 | 89H | MRF | Wanderer | V | 0125 | 6 mm |

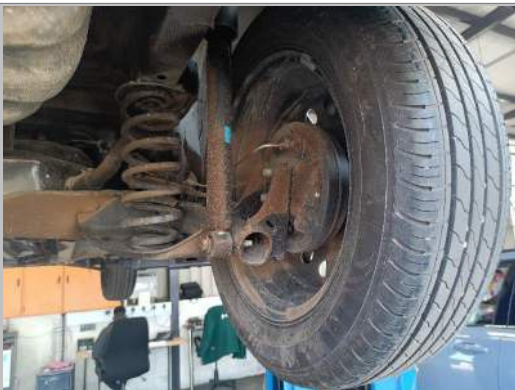
RR TYRE TREAD

| | Size | Load/Speed Index | Manufacture | Model | Type* | Production Date | Tread Depth (mm) |
|---|---|---|---|---|---|---|---|
| Rear Right | 195/60R16 | 89H | MRF | Wanderer | V | 0125 | 6 mm |

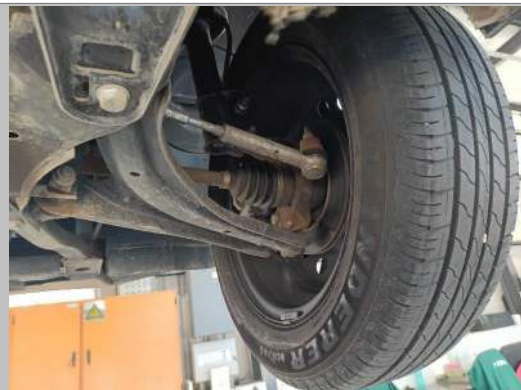
RF TYRE TREAD

| | Size | Load/Speed Index | Manufacture | Model | Type* | Production Date | Tread Depth (mm) |
|---|---|---|---|---|---|---|---|
| Front Right | 195/60R16 | 89H | MRF | Wanderer | V | 0125 | 6 mm |

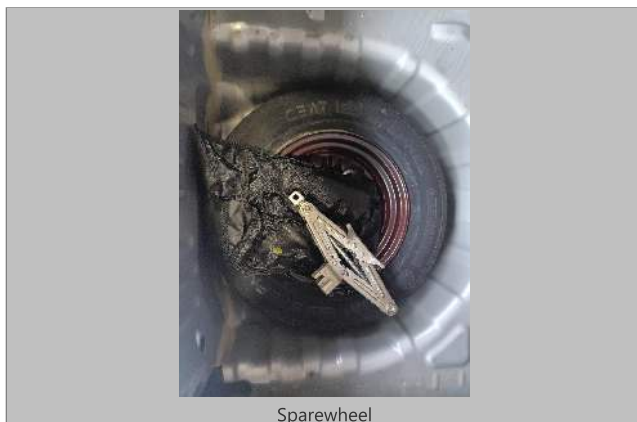
Sparewheel

| | Size | Load/Speed Index | Manufacture | Model | Type* | Production Date | Tread Depth (mm) |
|---|---|---|---|---|---|---|---|
| Spare | 165/80R14 | 85R | Ceat | Temporary | V | 0000 | 5 mm |

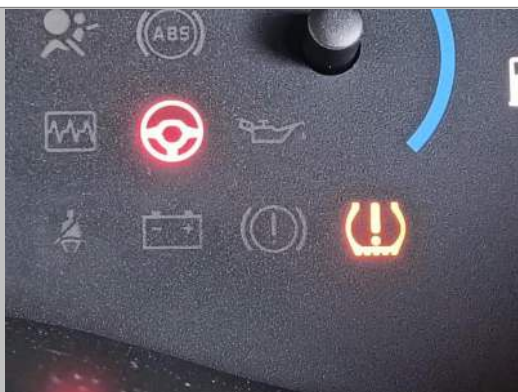
Seat Front Right Dirty  
 Front Bumper Paintwork • Scratched  
 Boot Lid / Hatch door Paintwork • Scratched  
 Steering Insufficient  
 Warning lights illuminated

Warning lights illuminated

Repair  
 Repair  
 Repair  
 Repair  
 Repair

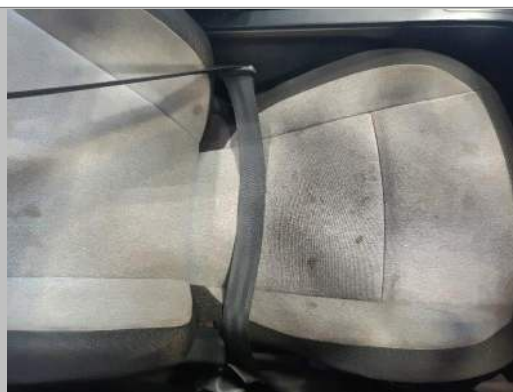
Seat Front Right

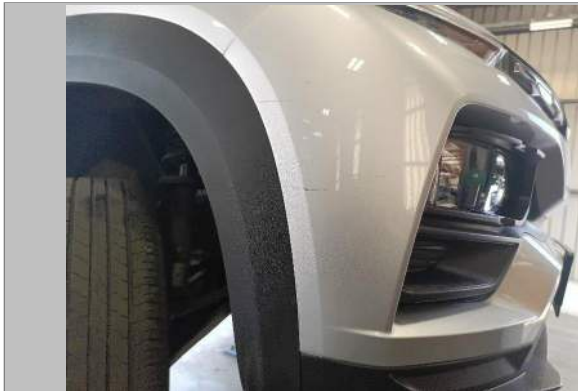
Front Bumper

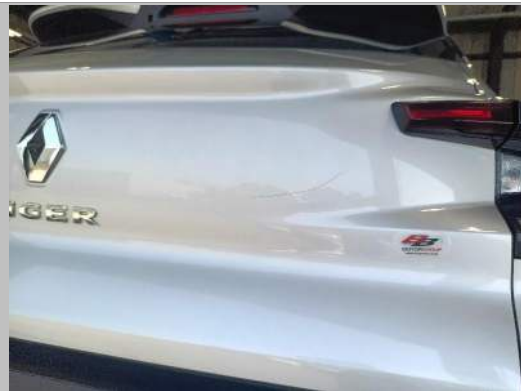
Boot Lid / Hatch door
