CONDITION REPORT

Report No:  
2017297402  
DATE  
11/09/2026

| Manufacturer | BMW | Registration Number | LY94PTGP |
| Model | X1 XLINE SDRIVE18I SAV STEPTRONIC [2022-ON] | Register Number | |

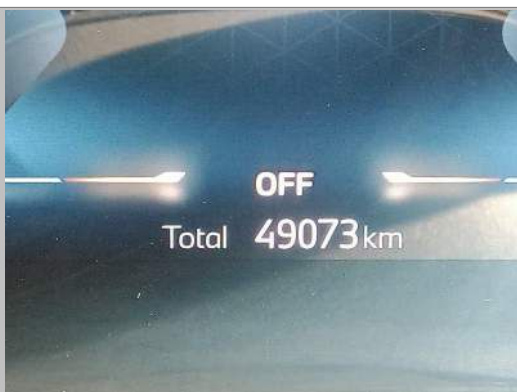
ODOMETER

| Km Reading | 49,073 KM | Transmission | AUTOMATIC |

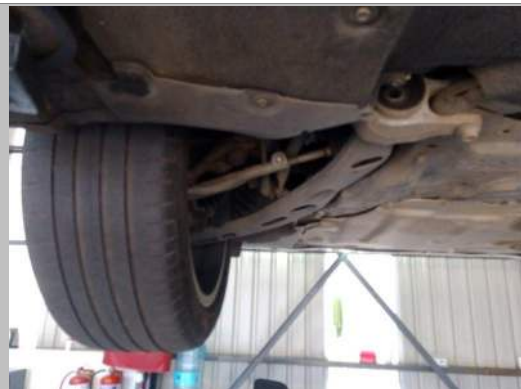
LF TYRE TREAD

| | Size | Load/Speed Index | Manufacture | Model | Type* | Production Date | Tread Depth (mm) |
|---|---|---|---|---|---|---|---|
| Front Left | 245/45R19 | 102Y | Pirelli | Radial | V | 1724 | 2 mm |

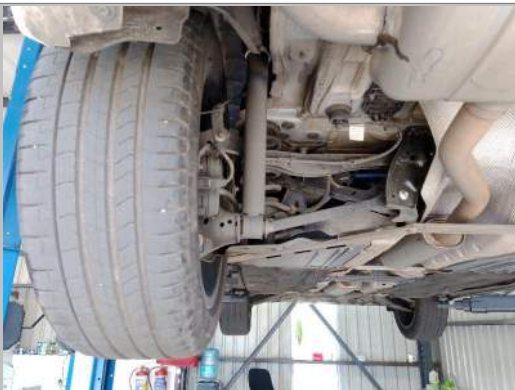
LR TYRE TREAD

| | Size | Load/Speed Index | Manufacture | Model | Type* | Production Date | Tread Depth (mm) |
|---|---|---|---|---|---|---|---|
| Rear Left | 245/45R19 | 102Y | Pirelli | Radial | V | 1724 | 3 mm |

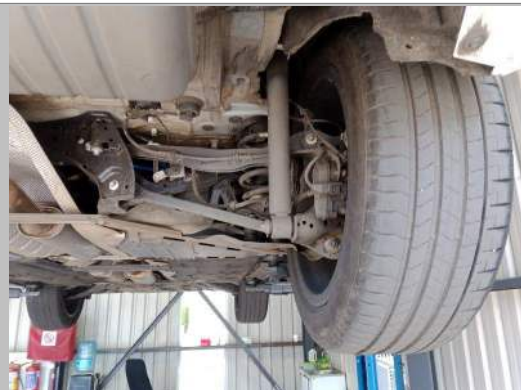
RR TYRE TREAD

| | Size | Load/Speed Index | Manufacture | Model | Type* | Production Date | Tread Depth (mm) |
|---|---|---|---|---|---|---|---|
| Rear Right | 245/45R19 | 102Y | Pirelli | Radial | V | 1724 | 3 mm |

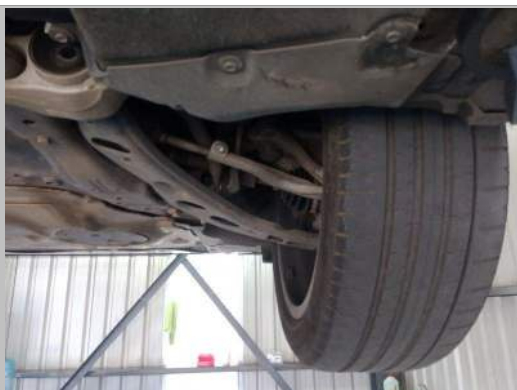
RF TYRE TREAD

| | Size | Load/Speed Index | Manufacture | Model | Type* | Production Date | Tread Depth (mm) |
|---|---|---|---|---|---|---|---|
| Front Right | 245/45R19 | 102Y | Pirelli | Radial | V | 1724 | 2 mm |
