MFC Auction House  
M57 Pretoria Rd, Glenmarais, KEMPTON PARK  
Gauteng

| Model | AMAROK 3.0 TDI D-CAB 4MOTION HIGHLINE<br>DSL PU AT [2017-2019] | Register Number | |

## CONDITION REPORT

Report No: 2016812441

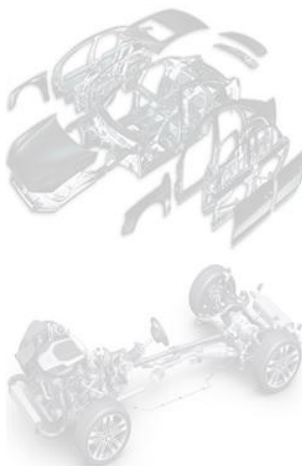
| Damage | Repair Way |
|---|---|
| Engine Oil Leak | Repair |
| Windscreen Wiper Malfunction | Repair |
| Differential Oil Leak | Repair |
| Electronics malfunction | Signs of spray work done on some body panels |
| Electronics malfunction | secure lid faulty |
| Engine | Bottom of engine is fully covered |
| wiper blades not working electrical malfunction | Repair |

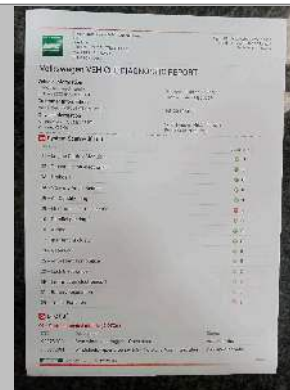
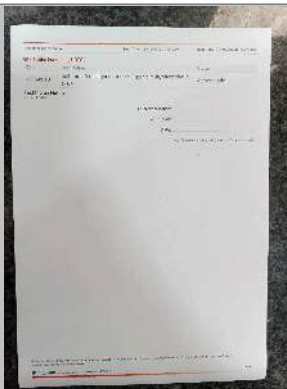
Diagnostic test

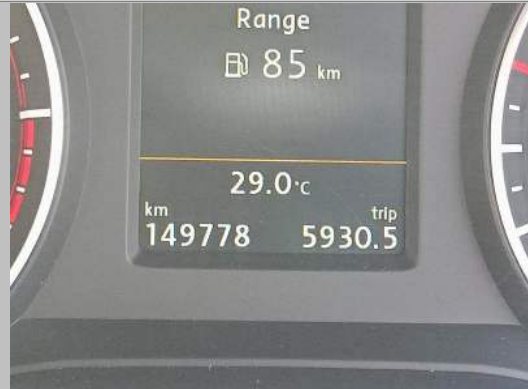
ODOMETER

| Km Reading | 149,778 KM | Fuel | DIESEL |

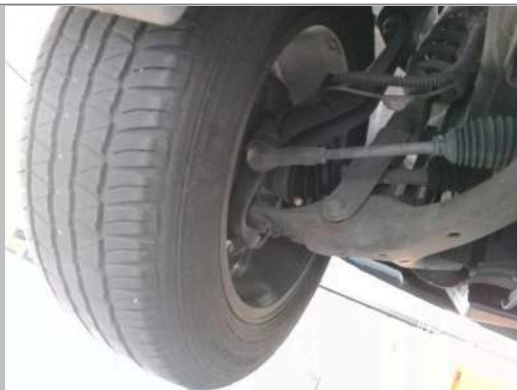
LF TYRE TREAD

| | Size | Load/Speed Index | Manufacture | Model | Type* | Production Date | Tread Depth (mm) |
|---|---|---|---|---|---|---|---|
| Front Left | 265/55R20 | 113V | Dunlop | Grandtrek | V | 1723 | 3 mm |

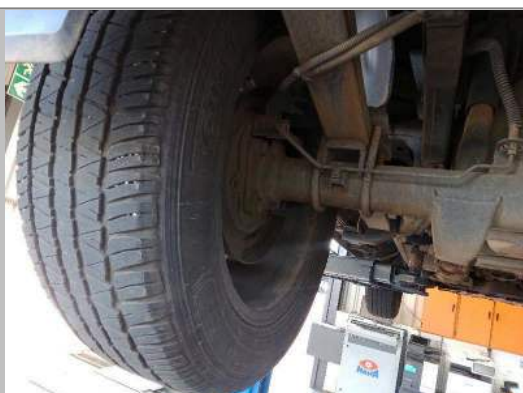
RF TYRE TREAD

| | Size | Load/Speed Index | Manufacture | Model | Type* | Production Date | Tread Depth (mm) |
|---|---|---|---|---|---|---|---|
| Front Right | 265/55R20 | 113V | Dunlop | Grandtrek | V | 1423 | 5 mm |

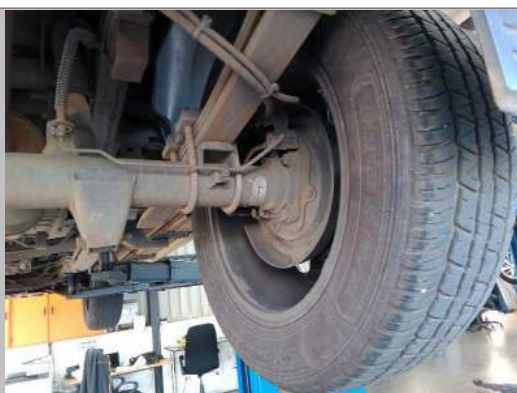
RR TYRE TREAD

| | Size | Load/Speed Index | Manufacture | Model | Type* | Production Date | Tread Depth (mm) |
|---|---|---|---|---|---|---|---|
| Rear Right | 265/55R20 | 113V | Dunlop | Grandtrek | V | 1723 | 5 mm |

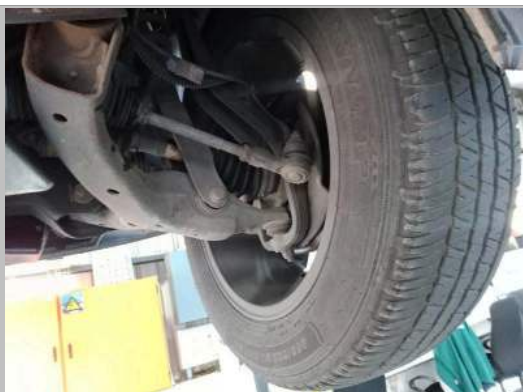
LR TYRE TREAD

| | Size | Load/Speed Index | Manufacture | Model | Type* | Production Date | Tread Depth (mm) |
|---|---|---|---|---|---|---|---|
| Rear Left | 265/55R20 | 113V | Dunlop | Grandtrek | V | 1723 | 5 mm |

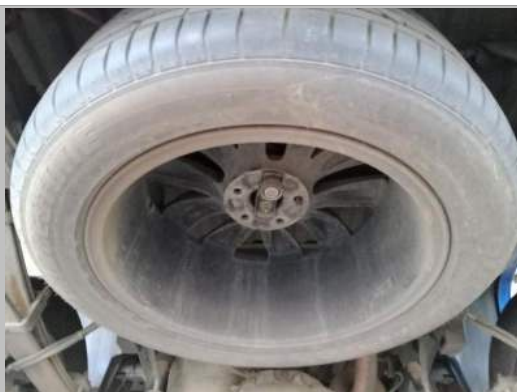
Sparewheel

| | Size | Load/Speed Index | Manufacture | Model | Type* | Production Date | Tread Depth (mm) |
|---|---|---|---|---|---|---|---|
| Spare | 255/50R20 | 109H | Bridgestone | Dueler | V | 0000 | 5 mm |
