## CONDITION REPORT

2017271385

| Manufacturer | VOLKSWAGEN | Registration Number | CJ10NMGP |
| Model | POLO 1.6 TDI COMFORTLINE DSL 5-DR [2009-2015] | Register Number | |

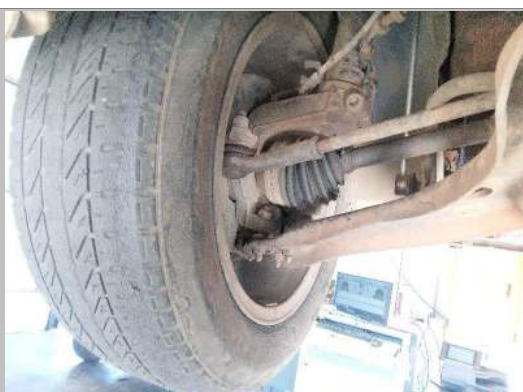
LF TYRE TREAD

| Tyre Front Left Smooth | Replace |

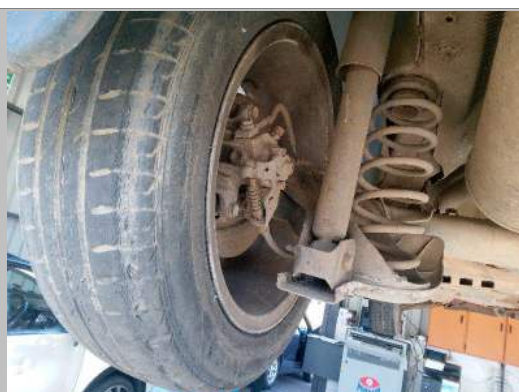
LR TYRE TREAD

| Tyre Rear Left Smooth | Replace |

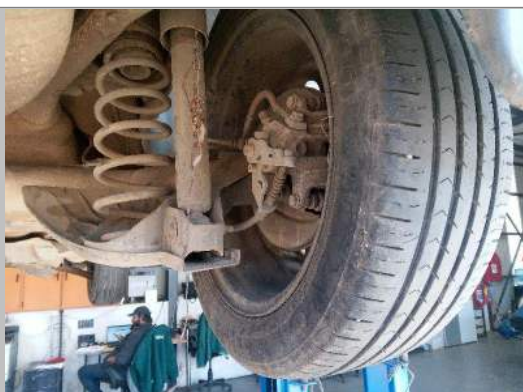
RR TYRE TREAD

| Tyre Rear Right Torn / Cut | Replace |

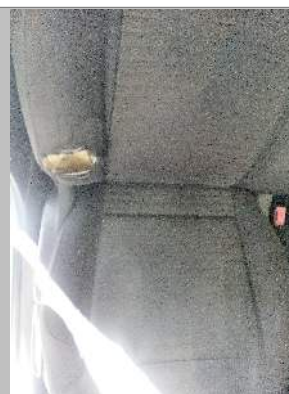
| Seat Front Right Torn / Cut | Repair |

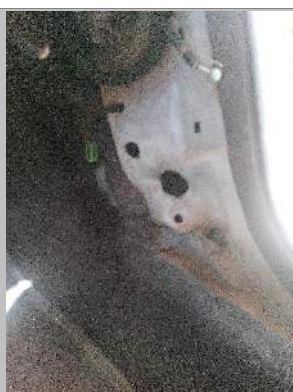
| Carpet Front Torn / Cut | Repair |

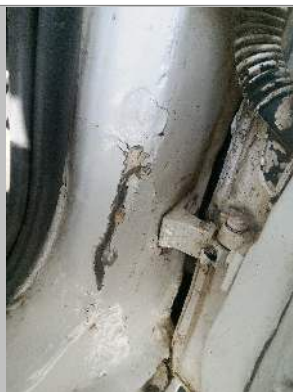
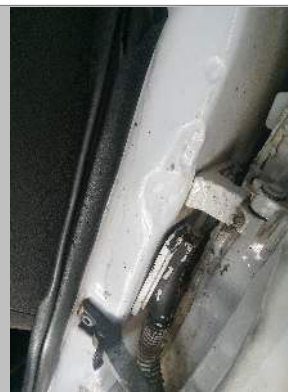
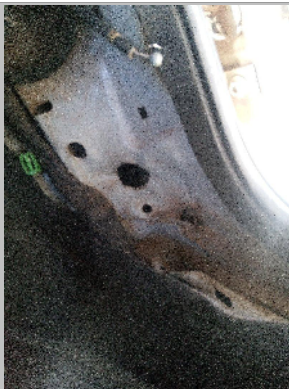
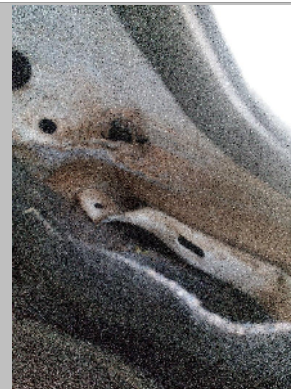
| A • Pillar Right Damaged | Repair |

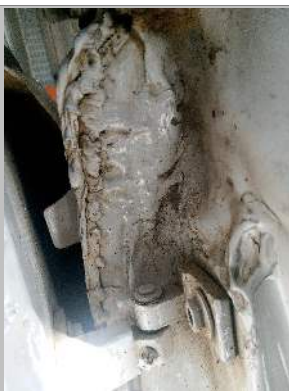
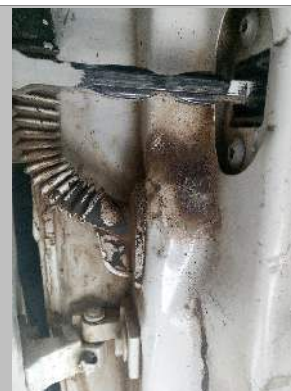
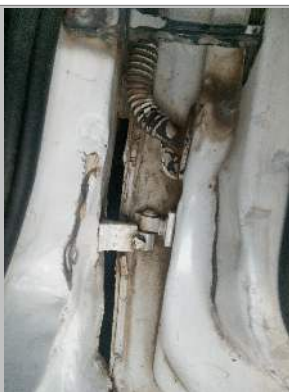
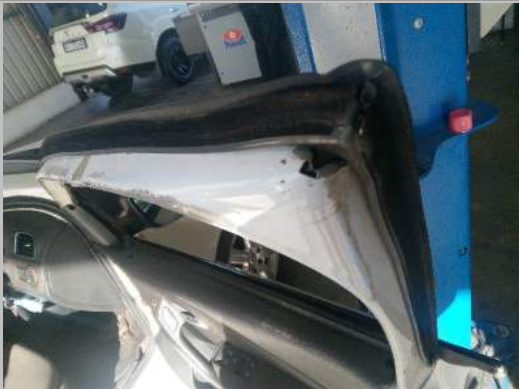
| Door Front Right Welded | Repair |

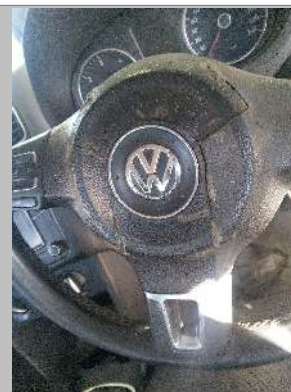
| Steering Wheel Trim Damaged | Replace |

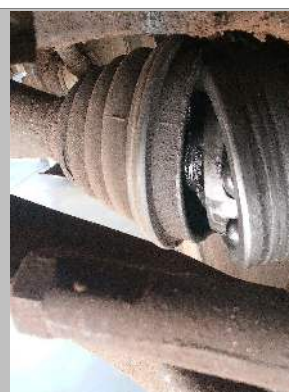
| CV Joint(s) Boot(s) Front Right (inner/outer) Damaged | Replace |

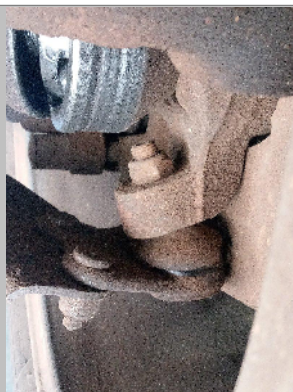
| Ball Joint(s) Front Axle Right Cracked | Replace |

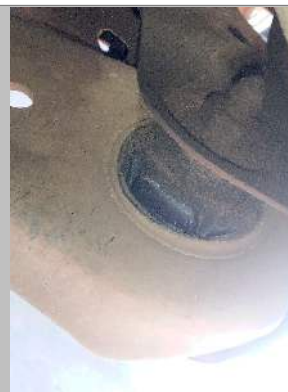
| Control Arm Bush(es) Front Axle Left Cracked | Replace |

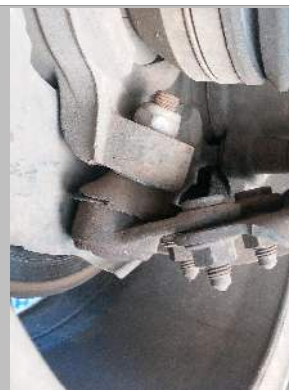
| Ball Joint(s) Front Axle Left Damaged | Replace |

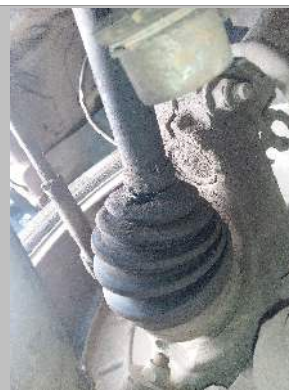
| CV Joint(s) Boot(s) Front Left (inner/outer) Damaged | Replace |

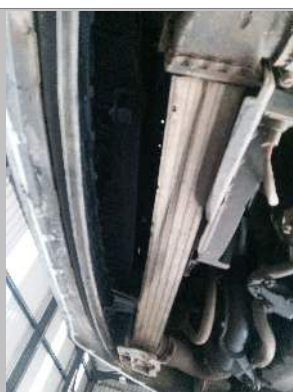
| Radiator Cross Member Missing | Replace |

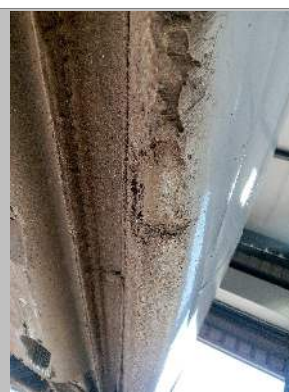
| Sill Panel Left Residual Traces of Repair | Repair |

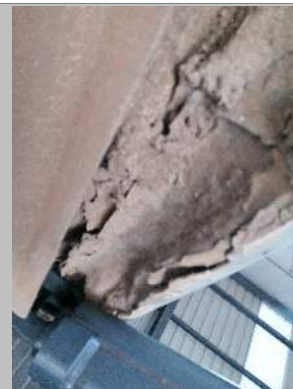
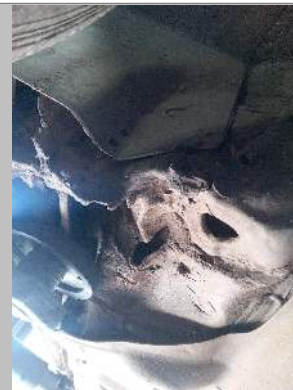
| Sill Panel Right Damaged | Repair |
