## CONDITION REPORT

Report No:  
2017287377  
DATE  
20/08/2026

| Manufacturer | VOLKSWAGEN | Registration Number | JX57BDGP |
| Model | POLO VIVO 1.4 55KW TRENDLINE 5-DR [2020-2022] | Register Number | |

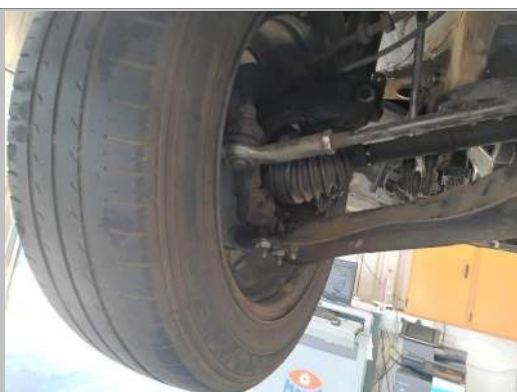
LF TYRE TREAD

| | Size | Load/Speed Index | Manufacture | Model | Type* | Production Date | Tread Depth (mm) |
|---|---|---|---|---|---|---|---|
| Front Left | 175/65R15 | 84H | Kumho | Solus | V | 2314 | 1 mm |

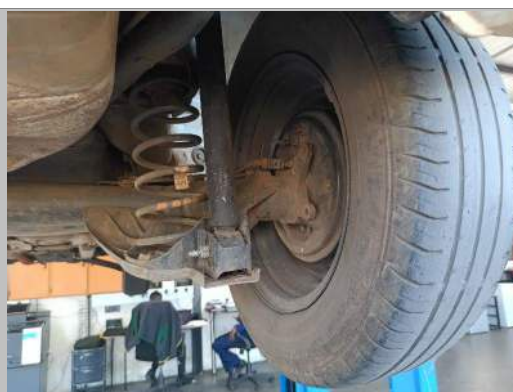
RR TYRE TREAD

| | Size | Load/Speed Index | Manufacture | Model | Type* | Production Date | Tread Depth (mm) |
|---|---|---|---|---|---|---|---|
| Rear Right | 175/70R14 | 84T | Continental | Contact | V | 4618 | 1 mm |

| Damage | Repair Way |
|---|---|
| Rear tyre size differs | Replace |

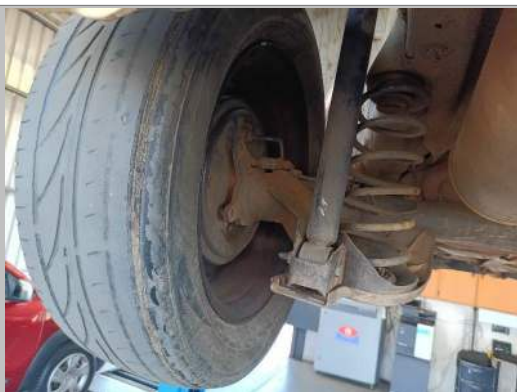
LR TYRE TREAD

| Damage | Repair Way |
|---|---|
| Tyre Rear Left Worn | Replace |

| | Size | Load/Speed Index | Manufacture | Model | Type* | Production Date | Tread Depth (mm) |
|---|---|---|---|---|---|---|---|
| Rear Left | 185/60R14 | 86H | Radar | RPX | V | 1420 | 0 mm |

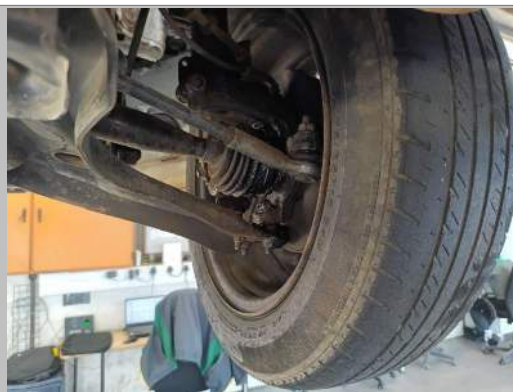
RF TYRE TREAD

| | Size | Load/Speed Index | Manufacture | Model | Type* | Production Date | Tread Depth (mm) |
|---|---|---|---|---|---|---|---|
| Front Right | 175/65R15 | 84H | Wanli | S1023 | V | 3813 | 1 mm |

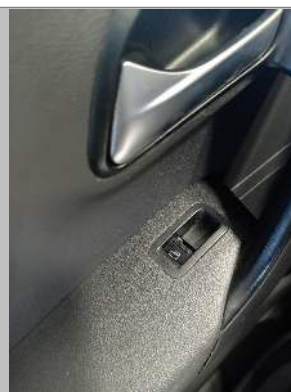
| Damage | Repair Way |
|---|---|
| Switch Electrical Window Winder front left Defective | Repair |

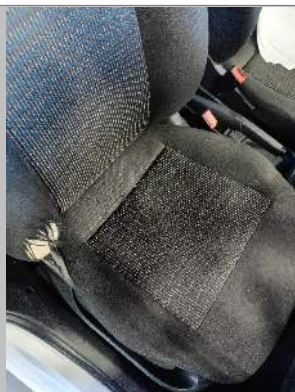
| Damage | Repair Way |
|---|---|
| Seat Front Right Torn / Cut | Repair |

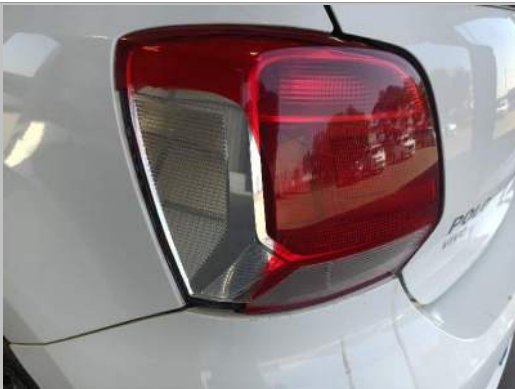
| Damage | Repair Way |
|---|---|
| Tail Light Left Damaged | Replace |

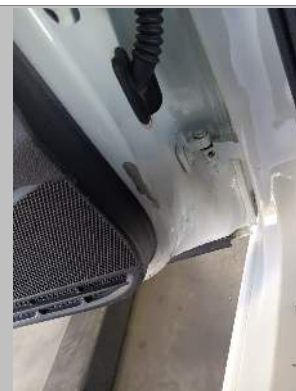
| Damage | Repair Way |
|---|---|
| Door Rear Left Paintwork • Scratched | Repair |

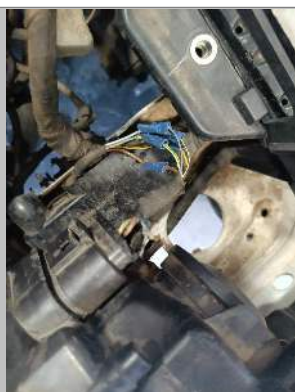
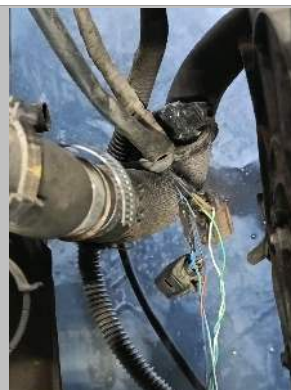
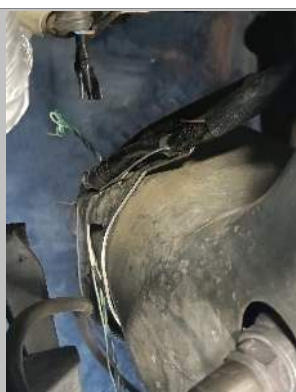
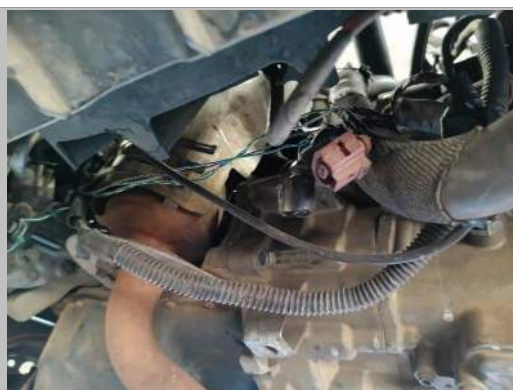
| Damage | Repair Way |
|---|---|
| Engine Wiring Defective | Repair |

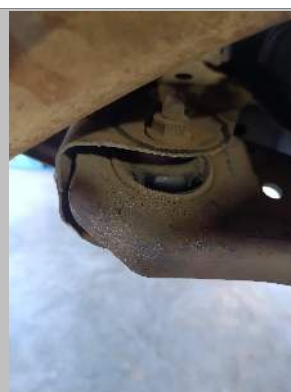
| Damage | Repair Way |
|---|---|
| Control Arm Bush(es) Front Axle Right Cracked | Replace |

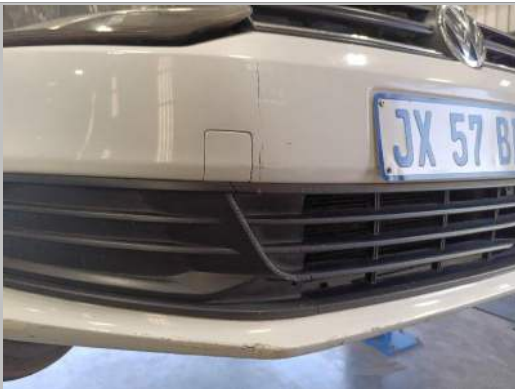
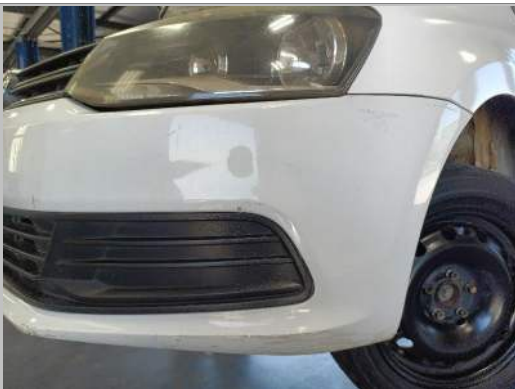
| Damage | Repair Way |
|---|---|
| Front Bumper Paintwork • Scratched | Repair |

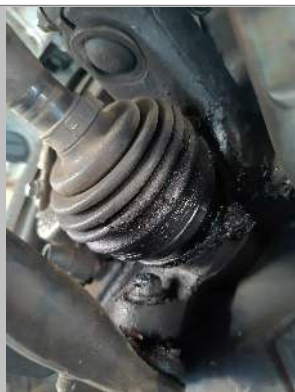
| Damage | Repair Way |
|---|---|
| CV Joint(s) Boot(s) Front Right (inner/outer) Damaged | Replace |
| both front CV joints excessive noise | Replace |

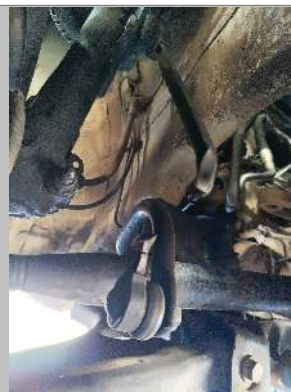
| Damage | Repair Way |
|---|---|
| Stabilizer Mounting Front Right Damaged | Replace |

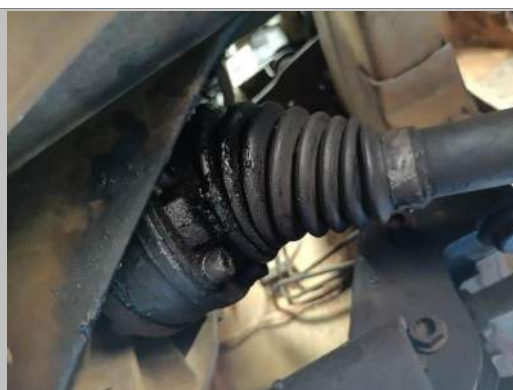
| Damage | Repair Way |
|---|---|
| CV Joint(s) Boot(s) Front Left (inner/outer) Damaged | Replace |

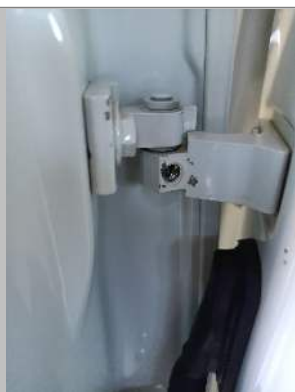
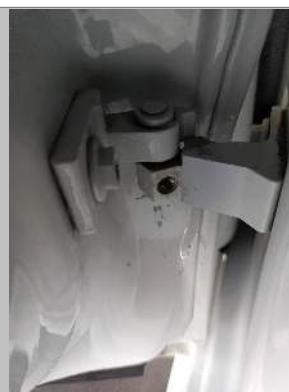
| Damage | Repair Way |
|---|---|
| Door Hinges Rear Left Defective | Replace |
