CONDITION REPORT

Report No:  
2017303131  
DATE  
25/09/2026

| Manufacturer | VOLKSWAGEN | Registration Number | KTZ298NW |
| Model | POLO VIVO 1.4 63KW COMFORTLINE 5-DR [2022-2024] | Register Number | |

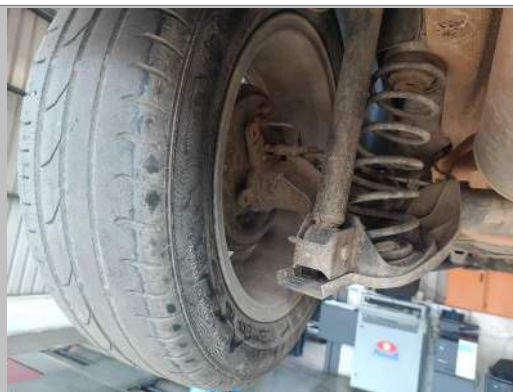
LR TYRE TREAD

| | Size | Load/Speed Index | Manufacture | Model | Type* | Production Date | Tread Depth (mm) |
|---|---|---|---|---|---|---|---|
| Rear Left | 185/60R15 | 84H | Continental | Contact | V | 4629 | 1 mm |

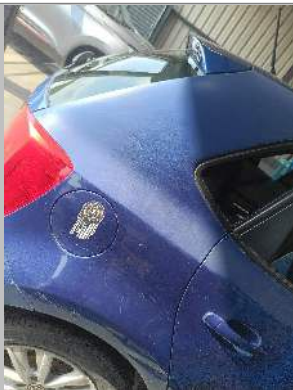
| Damage | Repair Way |
|---|---|
| Rear Fender Right Residual Traces of Repair | Repair |

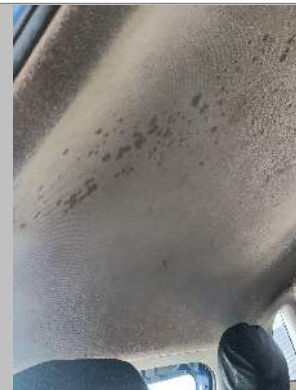
| Damage | Repair Way |
|---|---|
| Hood Lining Dirty | Repair |

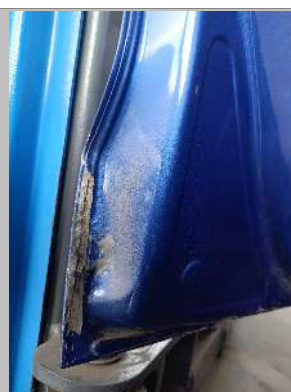
| Damage | Repair Way |
|---|---|
| Door Front Left Residual Traces of Repair | Repair |

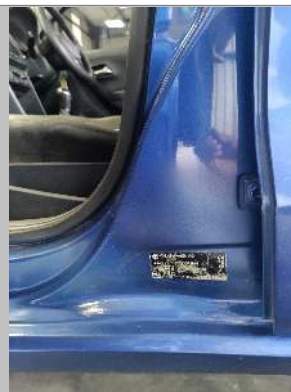
| Damage | Repair Way |
|---|---|
| B • Pillar Left Residual Traces of Repair | Repair |

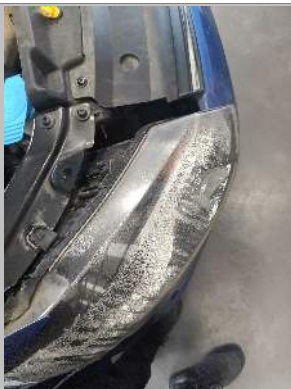
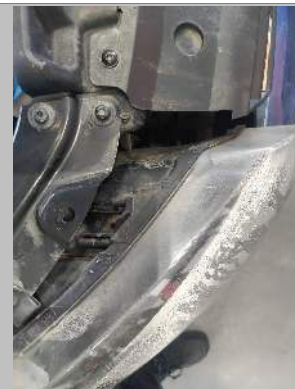
| Damage | Repair Way |
|---|---|
| Headlight Right Damaged | Replace |

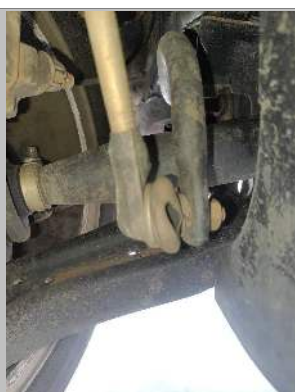
| Damage | Repair Way |
|---|---|
| Stabilizer Mounting Front Right Damaged | Replace |

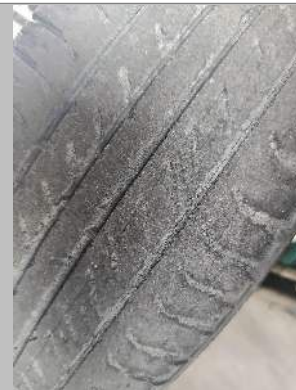
| Damage | Repair Way |
|---|---|
| Tyre Front Left Smooth | Replace |

| | Size | Load/Speed Index | Manufacture | Model | Type* | Production Date | Tread Depth (mm) |
|---|---|---|---|---|---|---|---|
| Front Left | 185/60R15 | 84H | Michelin | Energy | V | 0617 | 0 mm |

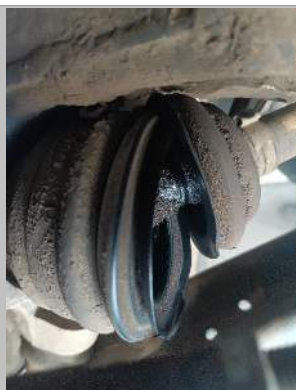
| Damage | Repair Way |
|---|---|
| CV Joint(s) Boot(s) Front Left (inner/outer) Damaged | Replace |

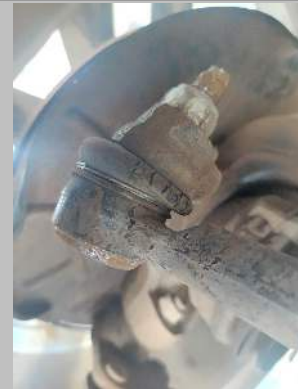
| Damage | Repair Way |
|---|---|
| Tie Rod End left Cracked | Replace |

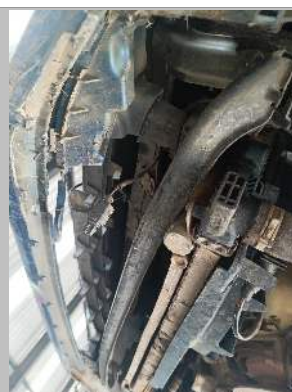
| Damage | Repair Way |
|---|---|
| Radiator Cross Member Damaged | Repair |

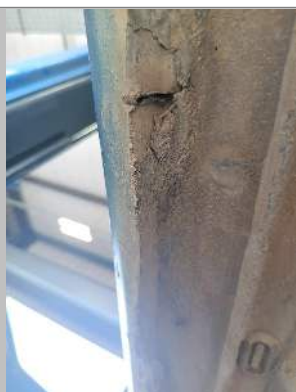
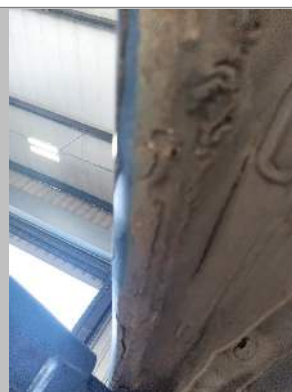
| Damage | Repair Way |
|---|---|
| Sill Panel Left Residual Traces of Repair | Repair |
