MFC Auction House  
M57 Pretoria Rd, Glenmarais, KEMPTON PARK  
Gauteng

## Assignment

| Manufacturer | VOLKSWAGEN | Registration Number | FN55CLGP |
| Model | POLO VIVO 1.4 TRENDLINE 5-DR TIPTRONIC [2011-2015] | Register Number | |

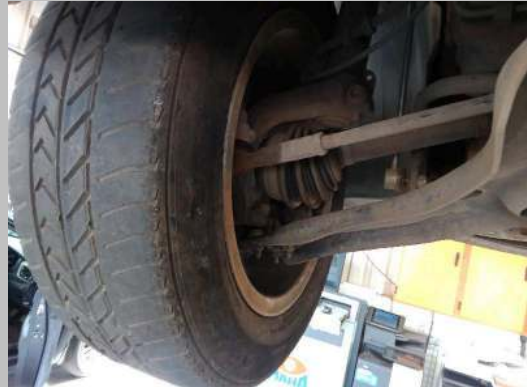
LF TYRE TREAD

| | Damage | Repair Way |
|---|---|---|
| | Tyre Front Left Excessive Wear & Tear | Replace |

| | Size | Load/Speed Index | Manufacture | Model | Type* | Production Date | Tread Depth (mm) |
|---|---|---|---|---|---|---|---|
| Front Left | 185/65R14 | 86T | General | Altimax | V | 5020 | 1 mm |

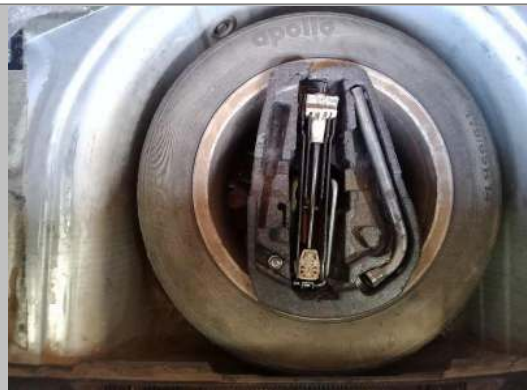
Sparewheel

| | Damage | Repair Way |
|---|---|---|
| | Spare Tyre Excessive Wear & Tear | Replace |

| | Size | Load/Speed Index | Manufacture | Model | Type* | Production Date | Tread Depth (mm) |
|---|---|---|---|---|---|---|---|
| Spare | 175/65R14 | 82H | Apollo | Alnac | V | 0000 | 0 mm |

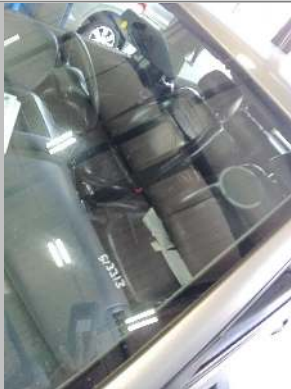
No license disc

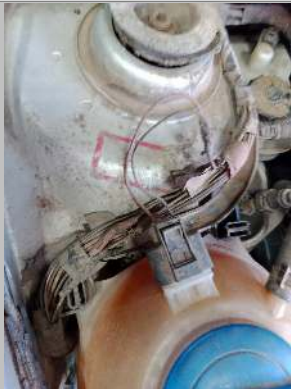
| | Damage | Repair Way |
|---|---|---|
| | Engine Wiring Defective | Repair |

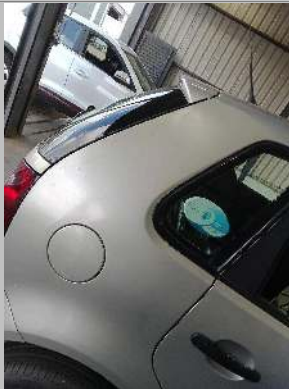
| | Damage | Repair Way |
|---|---|---|
| | Rear Fender Right Paintwork • Dull | Repair |

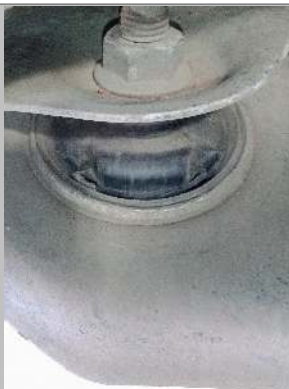
| | Damage | Repair Way |
|---|---|---|
| | Control Arm Bush(es) Front Axle Right Cracked | Replace |

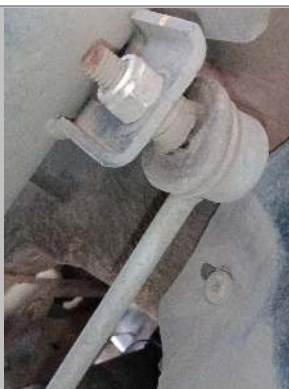
| | Damage | Repair Way |
|---|---|---|
| | Stabilizer Mounting Front Right Damaged | Replace |

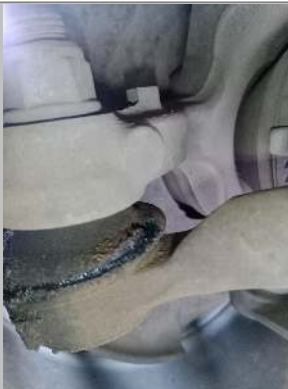
| | Damage | Repair Way |
|---|---|---|
| | Tie Rod left Damaged | Replace |
