## CONDITION REPORT

Report No: 2016866298

| Manufacturer | VOLKSWAGEN | Registration Number | DP39DMGP |
| Model | POLO VIVO GP 1.6 GT 5-DR [2014-2016] | Register Number | |

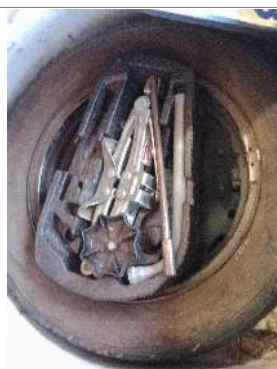
Sparewheel

| Damage | Repair Way |
|---|---|
| Spare Tyre Excessive Wear & Tear | Replace |

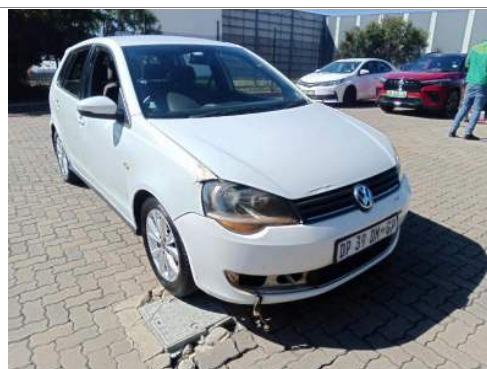
FRONT RIGHT CORNER

| Damage | Repair Way |
|---|---|
| Fog Light Front Right Missing | Replace |
| Headlight Right Damaged | Replace |
| Front Bumper Damaged | Repair |
| Grill Damaged | Replace |

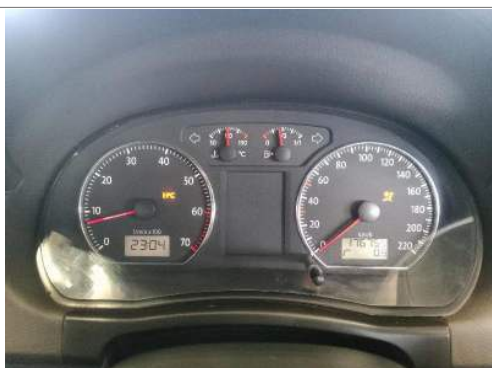
DASHBOARD (W/ ENGINE RUNNING)

| Damage | Repair Way |
|---|---|
| Warning lights illuminated on cluster | Repair |

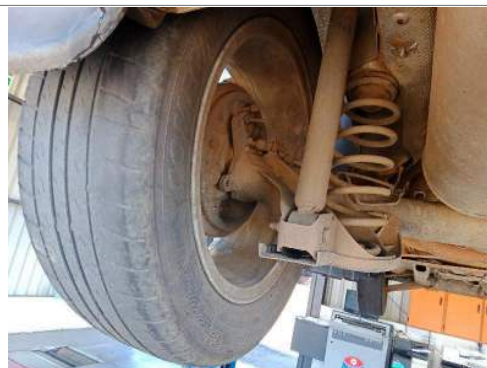
LR TYRE TREAD

| Damage | Repair Way |
|---|---|
| Tyre Rear Left Excessive Wear & Tear | Replace |

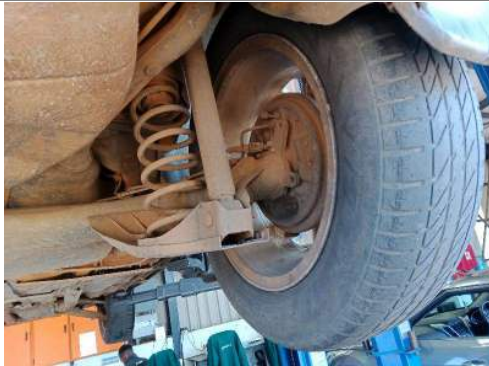
RR TYRE TREAD

| Damage | Repair Way |
|---|---|
| Tyre Rear Right Excessive Wear & Tear | Replace |

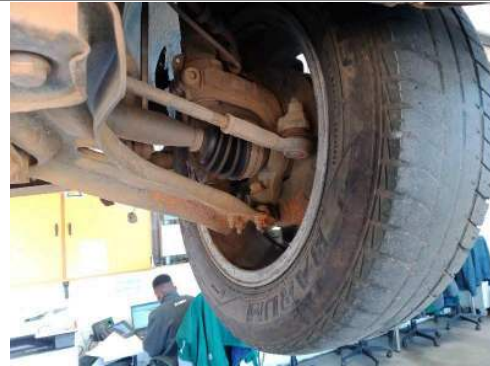
RF TYRE TREAD

| Damage | Repair Way |
|---|---|
| Tyre Front Right Smooth | Replace |

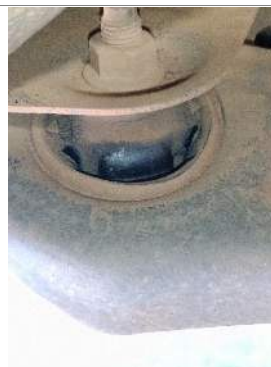
| Damage | Repair Way |
|---|---|
| Control Arm Bush(es) Front Axle Right Cracked | Replace |
