## CONDITION REPORT

Report No: 2016843982

MFC Auction House  
M57 Pretoria Rd, Glenmarais, KEMPTON PARK  
Gauteng

| Manufacturer | VOLKSWAGEN | Registration Number | FVZ841L |

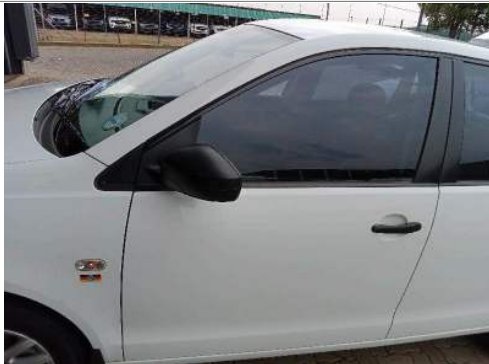
| Damage | Repair Way |
|---|---|
| Door Front Left Paintwork • Scratched | Repair |

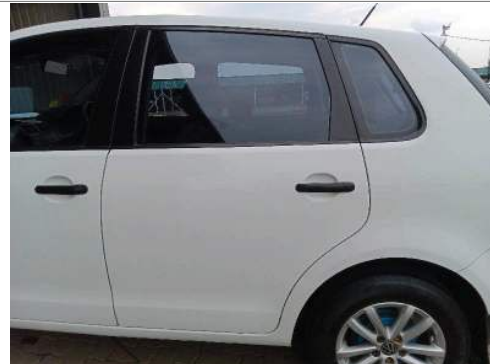
| Damage | Repair Way |
|---|---|
| Door Rear Left Paintwork • Scratched | Repair |

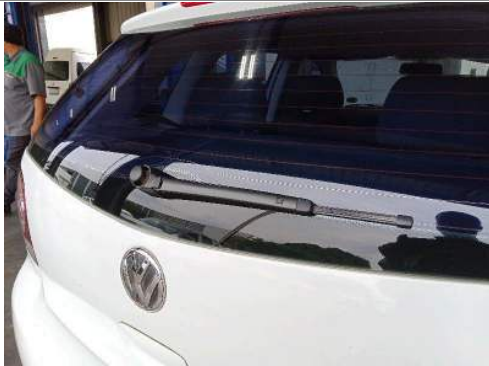
| Damage | Repair Way |
|---|---|
| Windscreen Wiper Damaged | Replace |

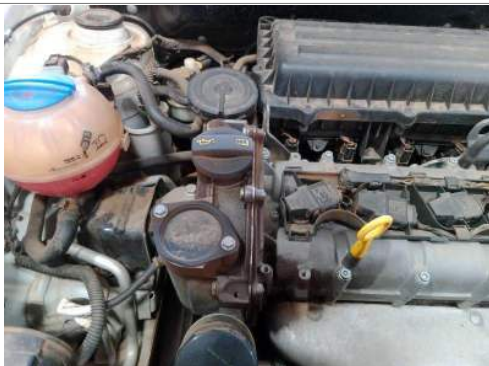
| Damage | Repair Way |
|---|---|
| Engine Oil Sweat | Repair |

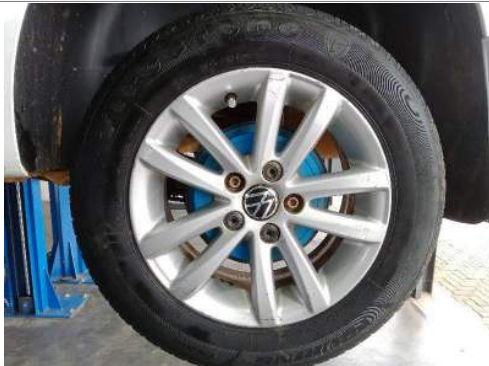
| Damage | Repair Way |
|---|---|
| Rim Rear Left Scratched | Repair |

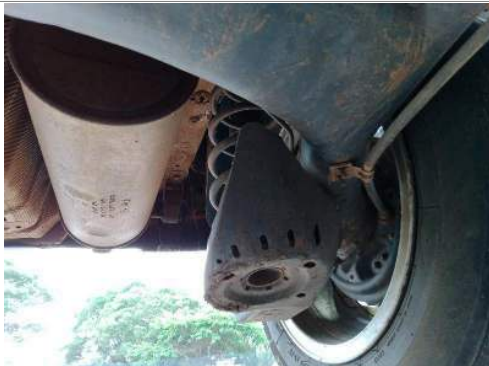
| Damage | Repair Way |
|---|---|
| Belly plates Damaged | Repair |
