## CONDITION REPORT

Report No: 2016379379

DATE  
15/05/2024

| Manufacturer | VOLKSWAGEN | Registration Number | JF35SXGP |

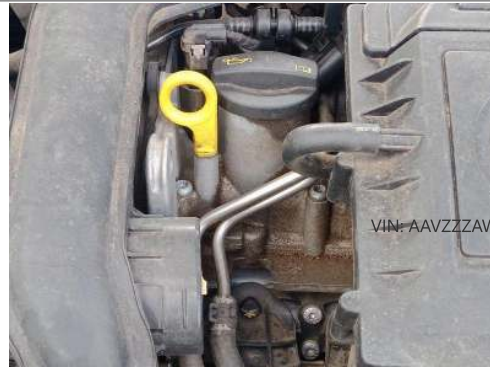
| Damage | Repair Way |
|---|---|
| Engine Oil Sweat | Repair |

| Damage | Repair Way |
|---|---|
| Engine Noise Excessive | Repair |

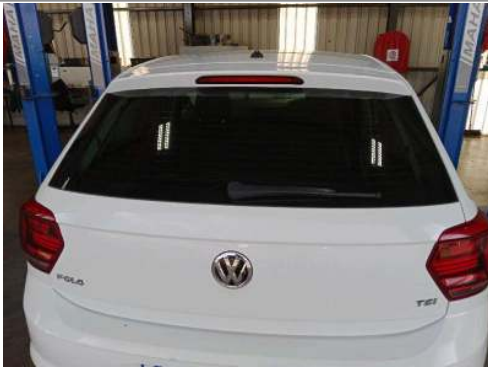
| Damage | Repair Way |
|---|---|
| Boot Lid / Hatch door Paintwork • Scratched | Repair |

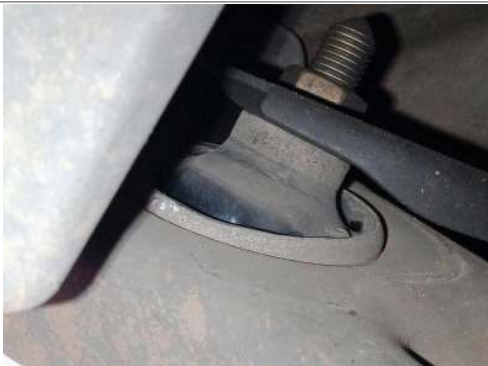
| Damage | Repair Way |
|---|---|
| Control Arm Bush(es) Front Axle Right Cracked | Replace |

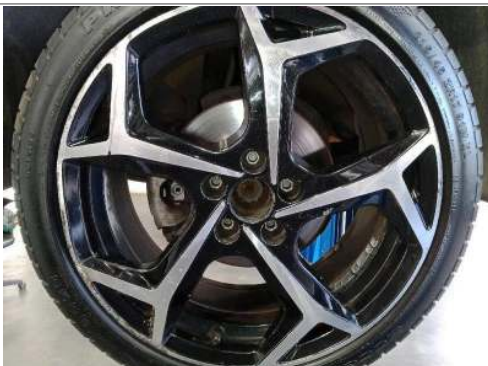
| Damage | Repair Way |
|---|---|
| Rim Front Left Dented | Repair |

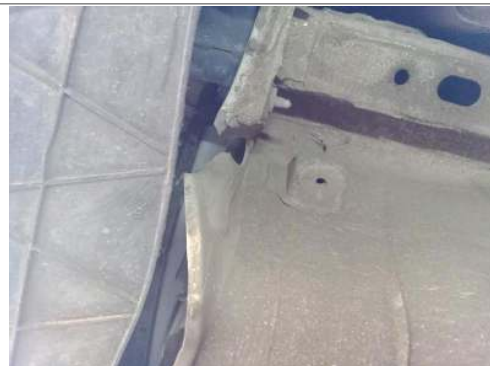
| Damage | Repair Way |
|---|---|
| Inner Boot Floor Pan and Spare Wheel Well Damaged | Repair |

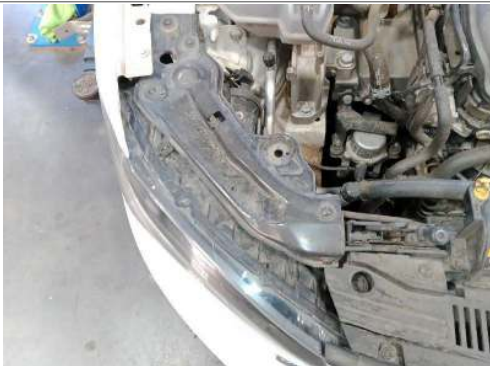
| Damage | Repair Way |
|---|---|
| Headlight Right Defective | Repair |

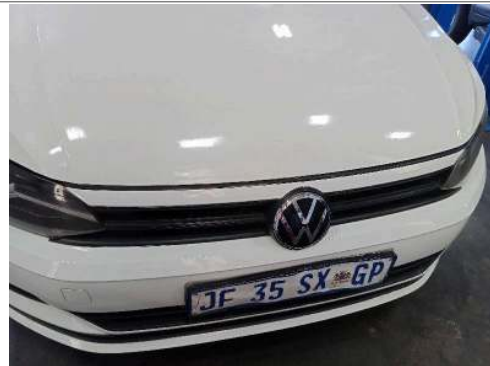
| Damage | Repair Way |
|---|---|
| Grill Cracked | Repair |

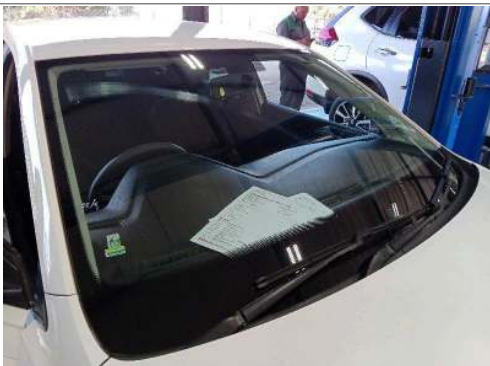
| Damage | Repair Way |
|---|---|
| Windscreen Chipped | Replace |
