## CONDITION REPORT

Report No:  
2016959196  
DATE  
26/07/2025

| Manufacturer | ISUZU | Registration Number | DXX836L |
| Model | KB250 HO HR D-CAB DSL PU [2016-2018] | Register Number | |

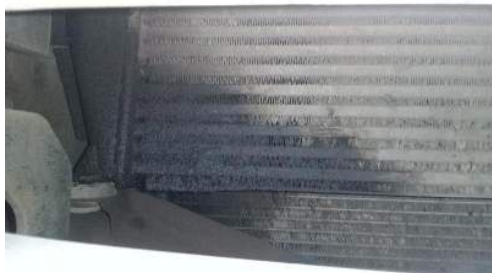
Intercooler

| Damage | Repair Way |
|---|---|
| Engine | Oil leak on intercooler |

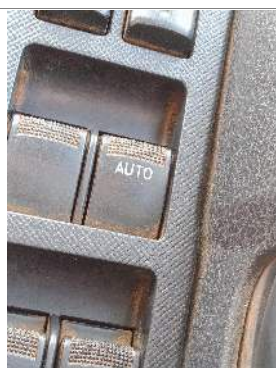
| Damage | Repair Way |
|---|---|
| Switch Electrical Window Winder front right Damaged | Replace |

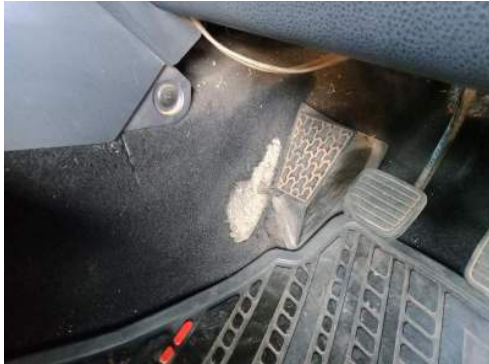
| Damage | Repair Way |
|---|---|
| Carpet Front Damaged | Repair |

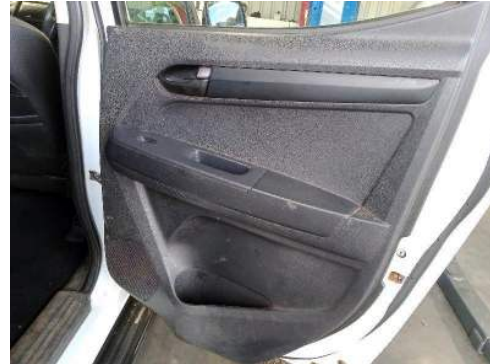
| Damage | Repair Way |
|---|---|
| Door Panel Rear Right Defective | Repair |

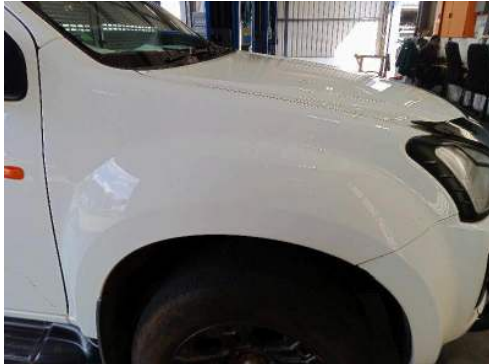
| Damage | Repair Way |
|---|---|
| Front Fender Right Dented | Repair |

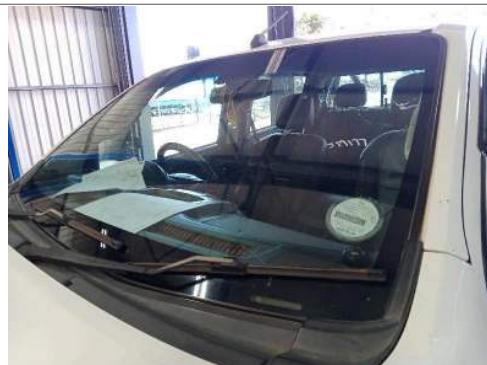
| Damage | Repair Way |
|---|---|
| Windscreen Cracked | Replace |

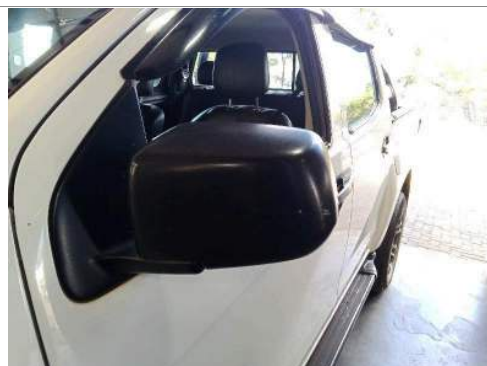
| Damage | Repair Way |
|---|---|
| Side Mirror Left Paintwork • Scratched | Repair |

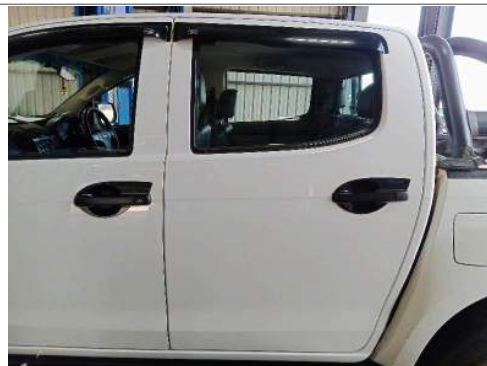
| Damage | Repair Way |
|---|---|
| Door Rear Left Paintwork • Scratched | Repair |

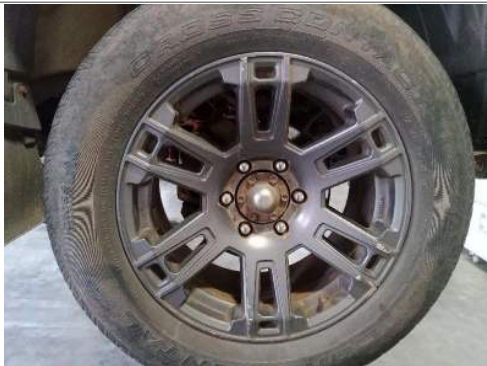
| Damage | Repair Way |
|---|---|
| Rim Front Right Scratched | Repair |
