## CONDITION REPORT

Report No:  
2016927175  
DATE  
27/06/2025

| Manufacturer | CHEVROLET | Registration Number | NO REG |
| Model | UTILITY 1.8 SPORT PU [2011-2017] | Register Number | |

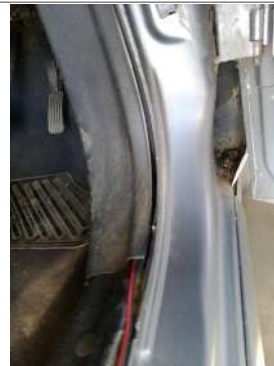
| Damage | Repair Way |
|---|---|
| Door Sealing Rubber Front Right Missing | Replace |

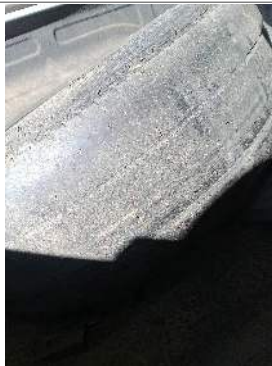
| Damage | Repair Way |
|---|---|
| Spare Tyre Smooth | Replace |

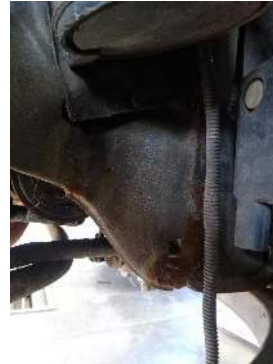
| Damage | Repair Way |
|---|---|
| Main Beam Right Welded | Repair |

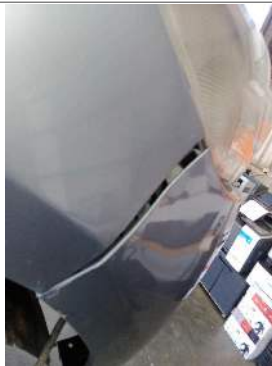
| Damage | Repair Way |
|---|---|
| Front Bumper Damaged | Repair |

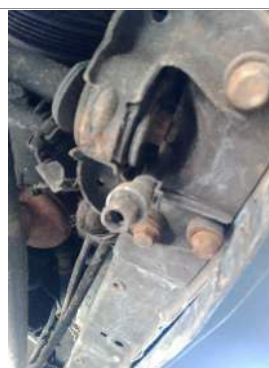
| Damage | Repair Way |
|---|---|
| Engine Wiring Damaged | Repair |

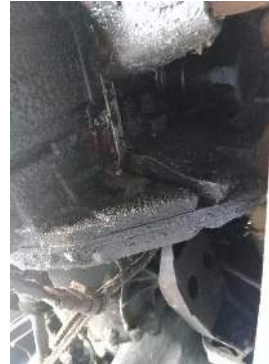
| Damage | Repair Way |
|---|---|
| Gearbox Grease Leak | Repair |

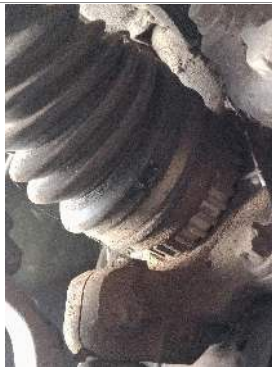
| Damage | Repair Way |
|---|---|
| CV Joint(s) Boot(s) Front Left (inner/outer) Damaged | Replace |

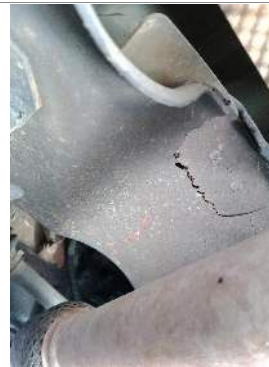
| Damage | Repair Way |
|---|---|
| Cross Member Front Right Damaged | Replace |

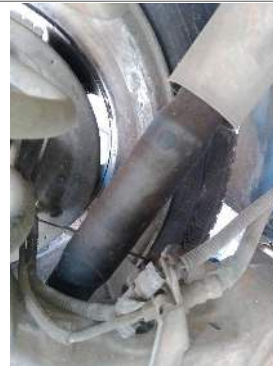
| Damage | Repair Way |
|---|---|
| Shock Absorber Rear Left Leak | Replace |

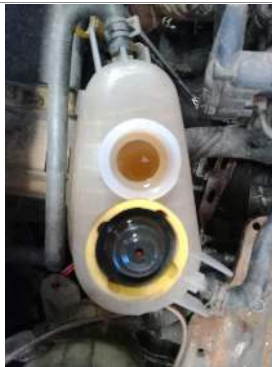
Water level

| Damage | Repair Way |
|---|---|
| engine water leak. | Repair |
