## CONDITION REPORT

Report No:  
2016963494  
DATE  
31/07/2025

| Manufacturer | ISUZU | Registration Number | JDY681NW |
| Model | KB300 LX 4X4 DSL PU [2013-2014] | Register Number | |

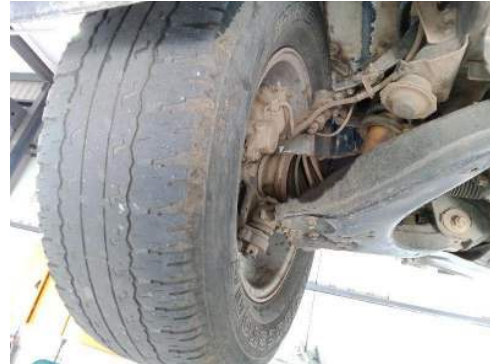
LF TYRE TREAD

| Damage | Repair Way |
|---|---|
| Tyre Front Left Excessive Wear & Tear | Replace |

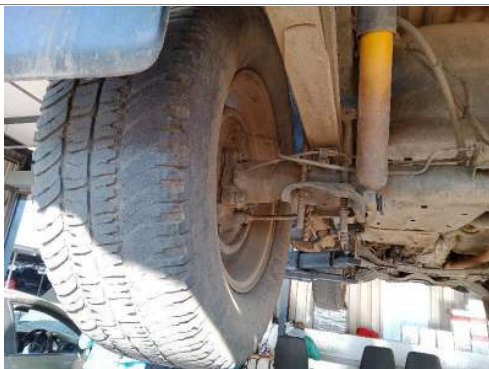
LR TYRE TREAD

| Damage | Repair Way |
|---|---|
| Tyre Rear Left Worn | Replace |

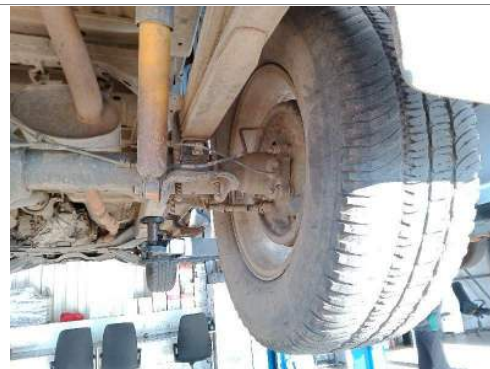
RR TYRE TREAD

| Damage | Repair Way |
|---|---|
| Tyre Rear Right Worn | Replace |

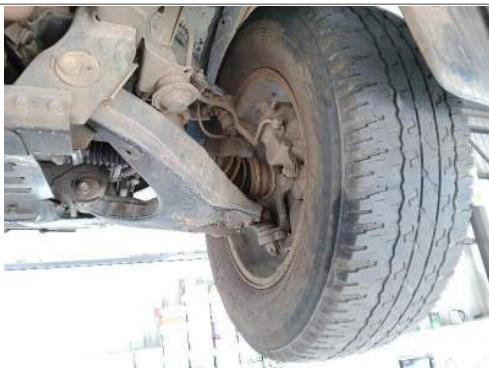
RF TYRE TREAD

| Damage | Repair Way |
|---|---|
| Tyre Front Right Excessive Wear & Tear | Replace |

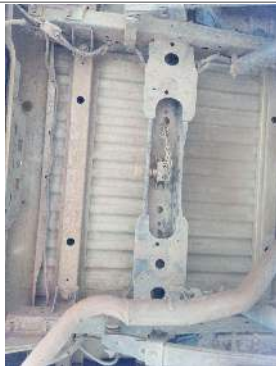
| Damage | Repair Way |
|---|---|
| Spare Tyre Incorrect | Replace |

No spare wheel fitted.

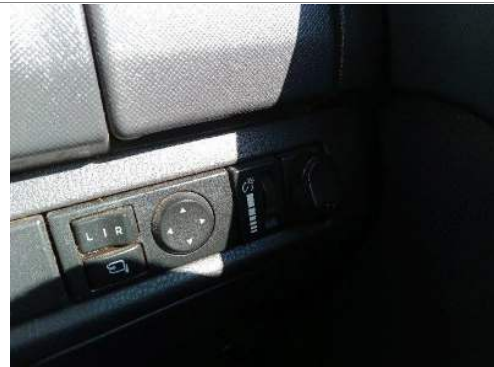
Fold away mirrors.

| Damage | Repair Way |
|---|---|
| Fold away mirrors incorrect operation | Repair |

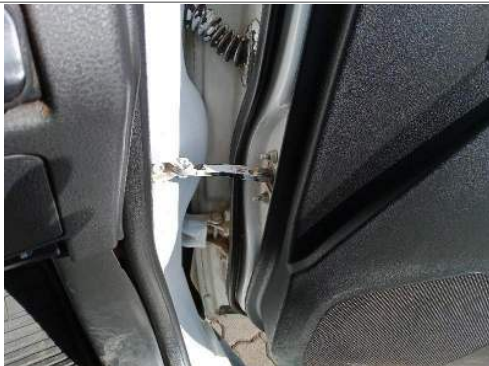
Door retainer

| Damage | Repair Way |
|---|---|
| Right Door retaining hinge defective | Repair |

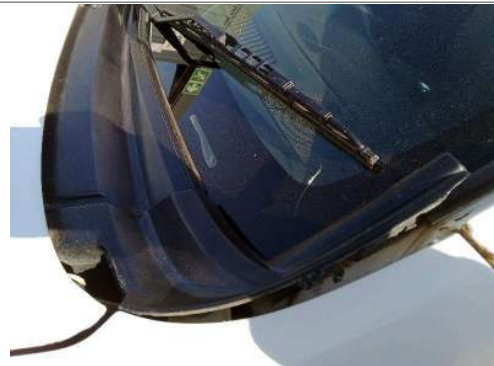
| Damage | Repair Way |
|---|---|
| Wiper valance grille defective | Repair |

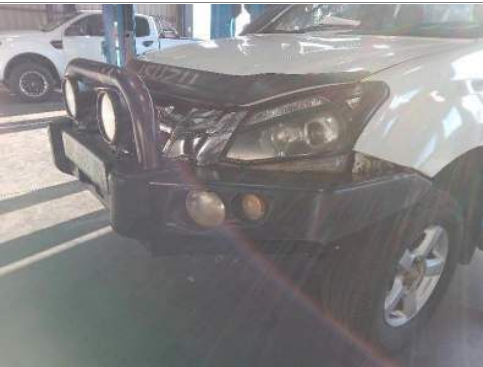
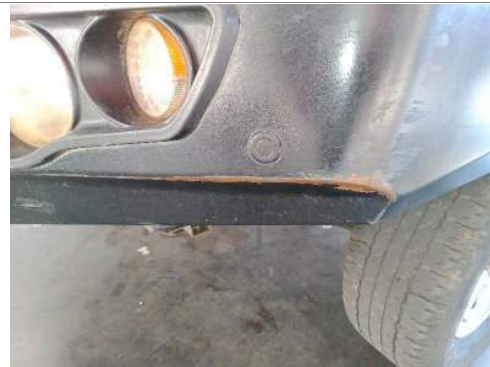
| Damage | Repair Way |
|---|---|
| Front Bumper Corrosion | Repair |

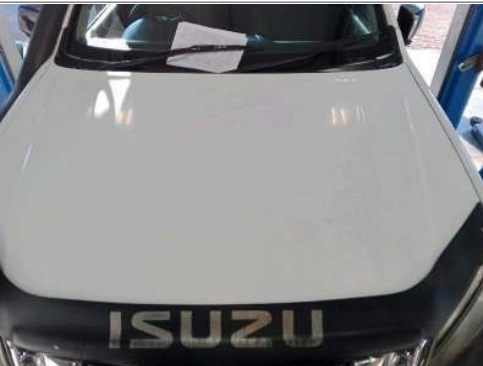
| Damage | Repair Way |
|---|---|
| Bonnet Residual Traces of Repair | Repair |

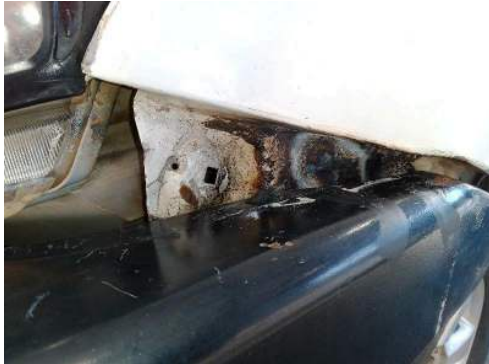
| Damage | Repair Way |
|---|---|
| Front Fender Left / Inner Tray Welded | Repair |

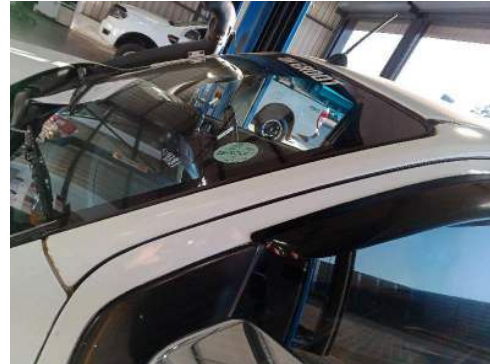
| Damage | Repair Way |
|---|---|
| A • Pillar Left Residual Traces of Repair | Repair |

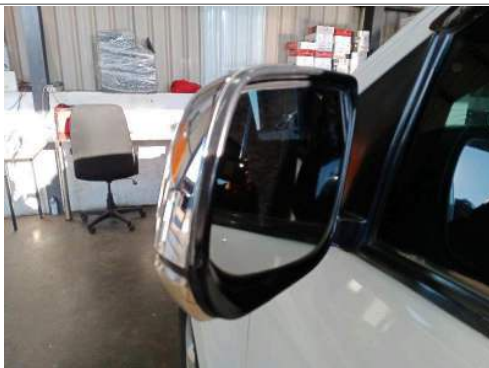
| Damage | Repair Way |
|---|---|
| Side Mirror Left Damaged | Replace |

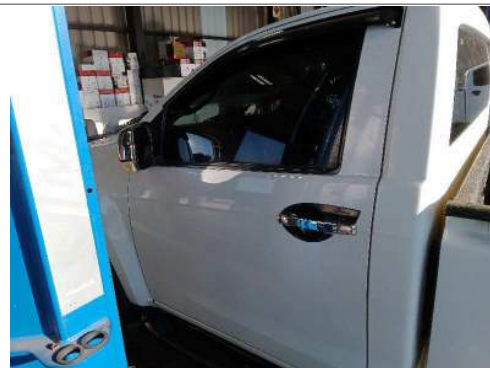
| Damage | Repair Way |
|---|---|
| Door Front Left Residual Traces of Repair | Repair |

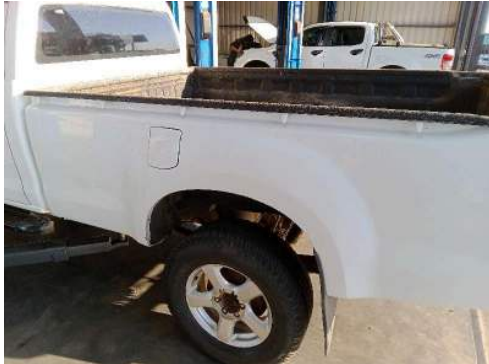
| Damage | Repair Way |
|---|---|
| Rear Fender Left Residual Traces of Repair | Repair |

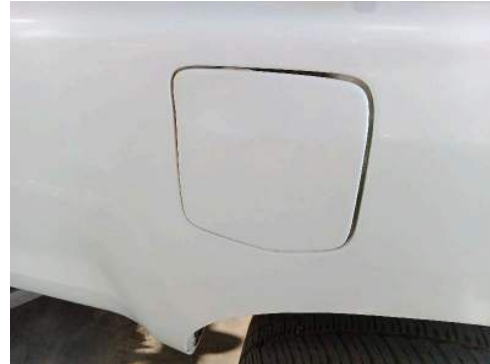
| Damage | Repair Way |
|---|---|
| Fuel Flap Residual Traces of Repair | Repair |

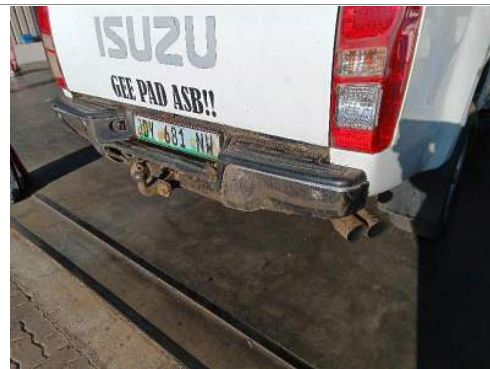
| Damage | Repair Way |
|---|---|
| Rear bumper Damaged | Repair |

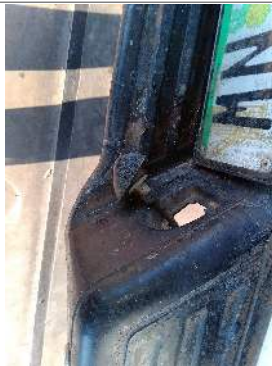
| Damage | Repair Way |
|---|---|
| Number Plate Light Right Damaged | Repair |

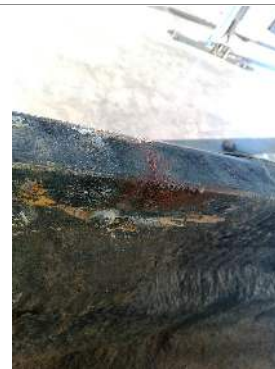
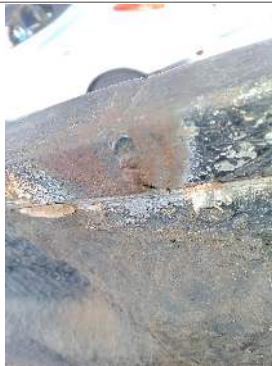
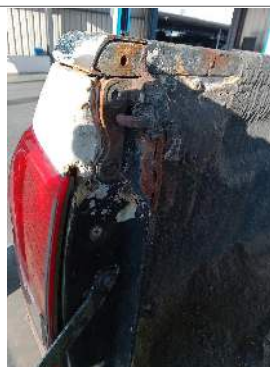
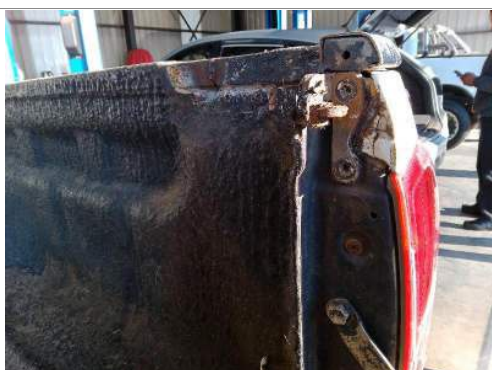
| Damage | Repair Way |
|---|---|
| Load Body Welded | Replace |

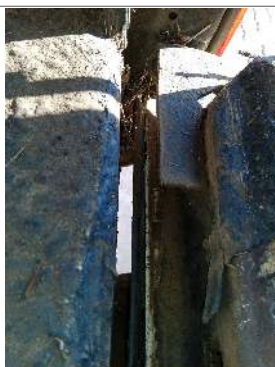
| Damage | Repair Way |
|---|---|
| Tailgate Hinge Right Damaged | Replace |

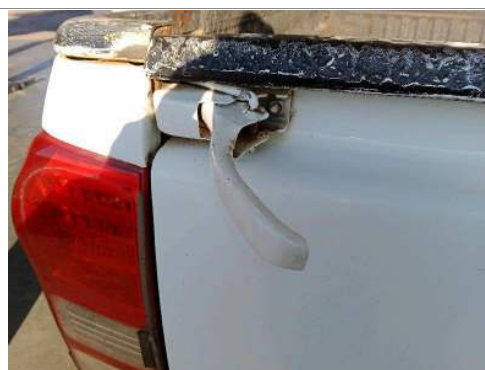
| Damage | Repair Way |
|---|---|
| Tailgate Defective | Replace |

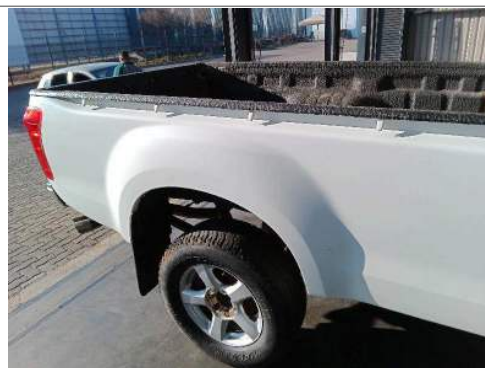
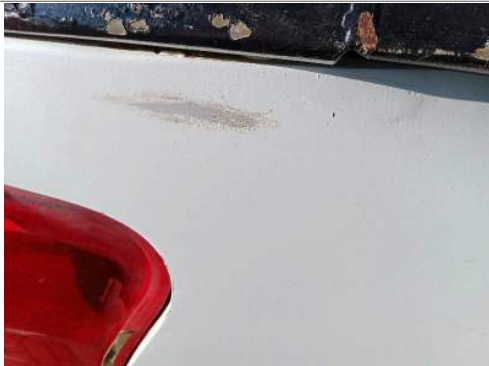
| Damage | Repair Way |
|---|---|
| Rear Fender Right Residual Traces of Repair | Repair |

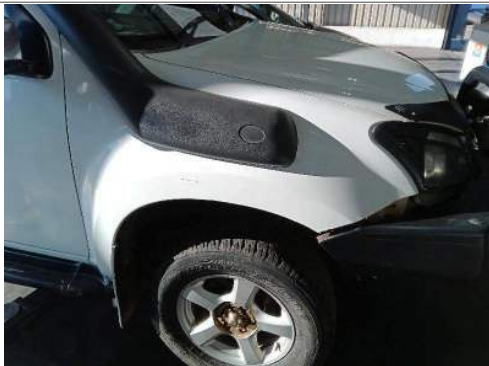
| Damage | Repair Way |
|---|---|
| Front Fender Right Residual Traces of Repair | Repair |

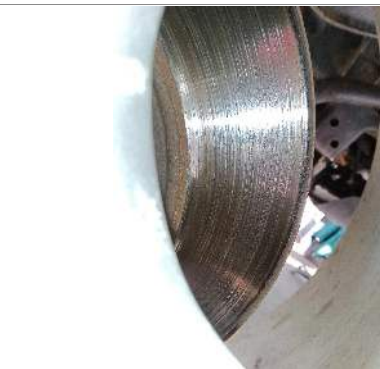
| Damage | Repair Way |
|---|---|
| Brake disc 1. Axle right Excessive Wear & Tear | Replace |

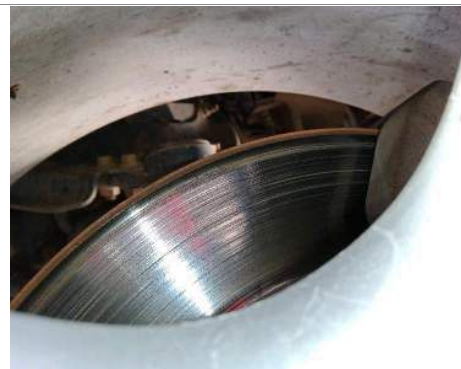
| Damage | Repair Way |
|---|---|
| Brake disc 1. Axle left Excessive Wear & Tear | Replace |

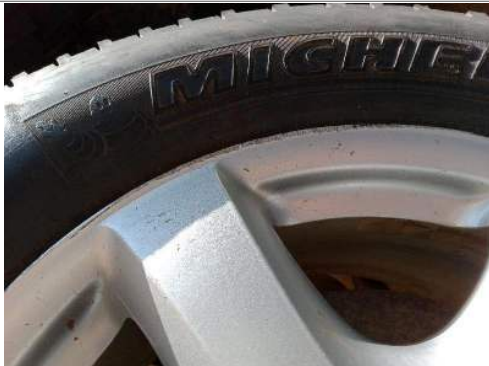
| Damage | Repair Way |
|---|---|
| Rim Rear Right Scratched | Repair |

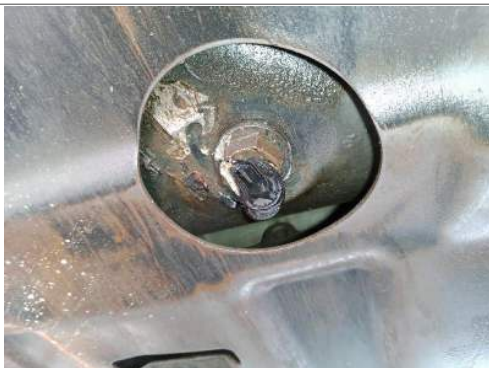
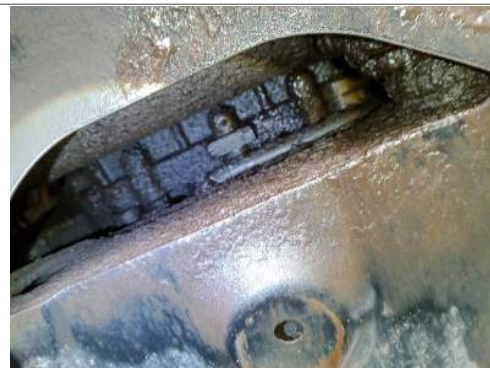
| Damage | Repair Way |
|---|---|
| Engine Performance Insufficient | Repair |
| Engine Noise Excessive | Repair |

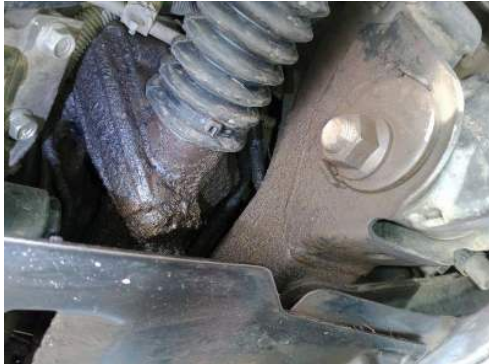
| Damage | Repair Way |
|---|---|
| Steering Rack Defective | Repair |

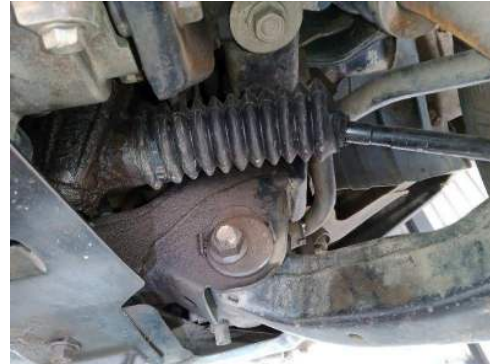
| Damage | Repair Way |
|---|---|
| Steering Rack Boot Right Defective | Replace |

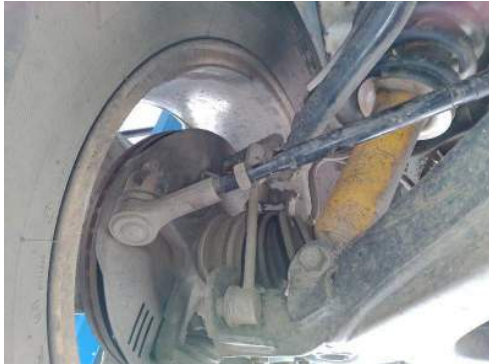
| Damage | Repair Way |
|---|---|
| Tie Rod End right Defective | Replace |

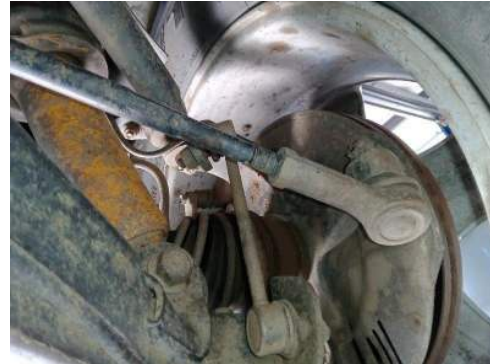
| Damage | Repair Way |
|---|---|
| Tie Rod End left Loose / Excessive Play | Replace |

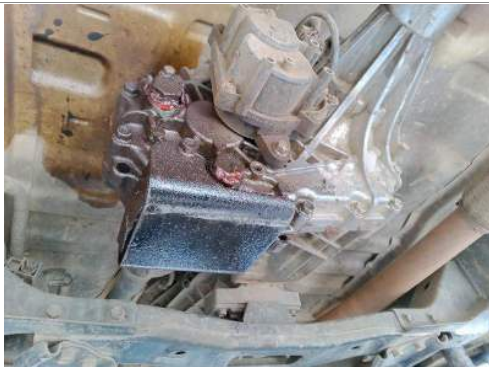
| Damage | Repair Way |
|---|---|
| Gearbox Oil Leak | Repair |

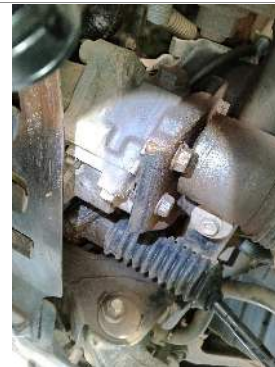
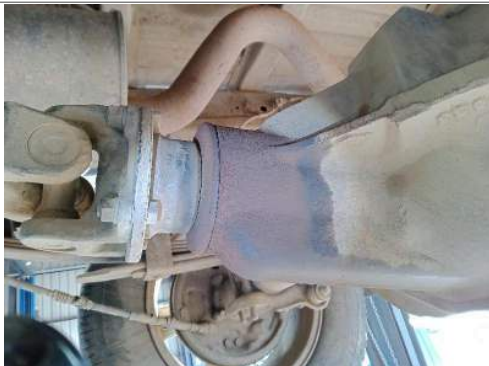
| Damage | Repair Way |
|---|---|
| Differential Oil Leak | Repair |

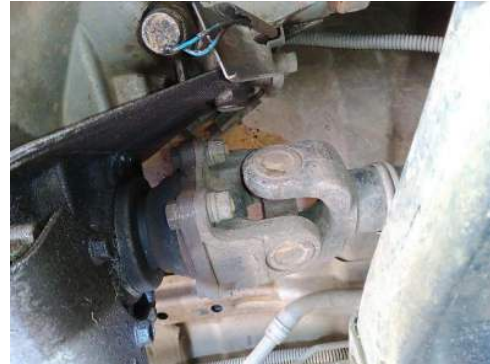
| Damage | Repair Way |
|---|---|
| Universal Joint Loose / Excessive Play | Replace |

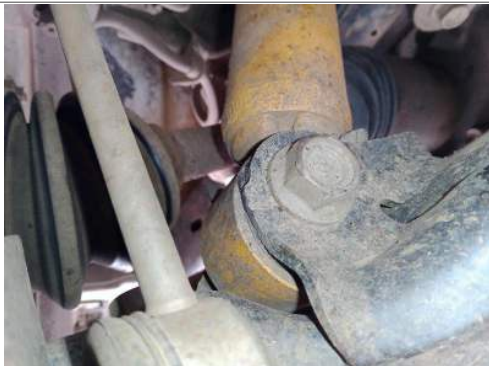
| Damage | Repair Way |
|---|---|
| Shock Absorber Mounting Front Right Excessive Wear & Tear | Replace |

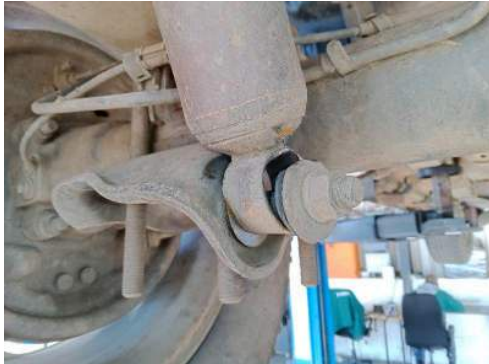
| Damage | Repair Way |
|---|---|
| Shock Absorber Mounting Rear Left Damaged | Replace |

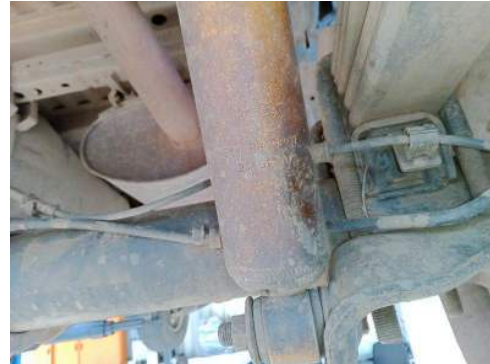
| Damage | Repair Way |
|---|---|
| Shock Absorber Rear Right Deformed | Replace |

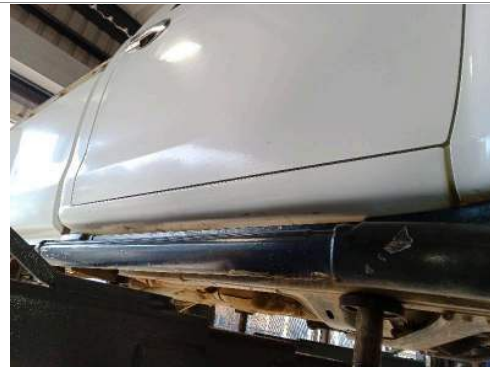
| Damage | Repair Way |
|---|---|
| Sill Panel Right Residual Traces of Repair | Repair |

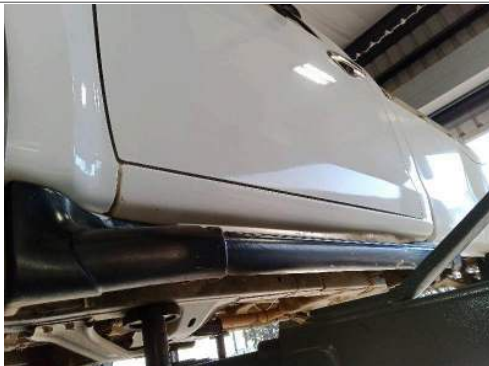
| Damage | Repair Way |
|---|---|
| Sill Panel Left Residual Traces of Repair | Repair |

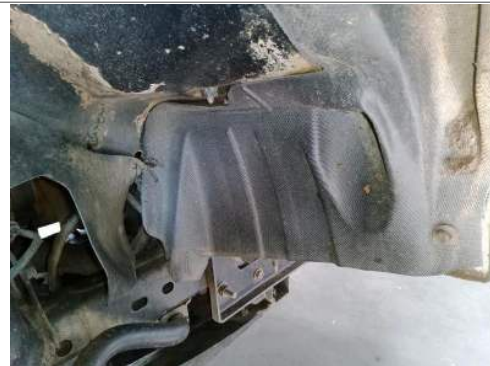
| Damage | Repair Way |
|---|---|
| Front Fender Right / Inner Tray Damaged | Replace |
