## CONDITION REPORT

Report No:  
2016958074  
DATE  
25/07/2025

| Manufacturer | CHEVROLET | Registration Number | JCL625MP |
| Model | CORSA 1.4 CLUB UTILITY PU [2010-2012] | Register Number | |

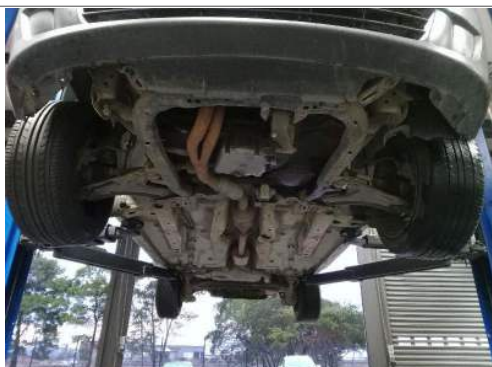
Front chassis

| Damage | Repair Way |
|---|---|
| Chassis Damaged | Repair |

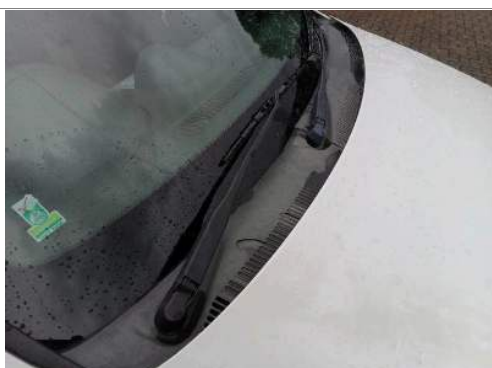
| Damage | Repair Way |
|---|---|
| Body and Exterior | Wiper valance damaged |

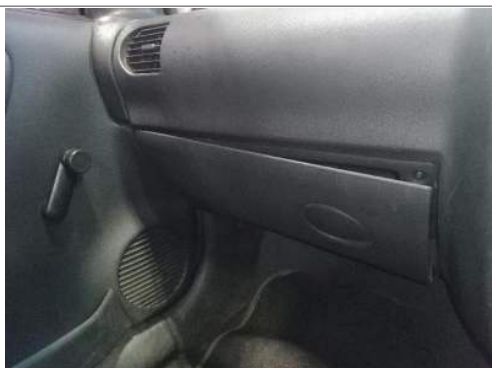
| Damage | Repair Way |
|---|---|
| Center Console / Cubbyhole + Lid Damaged | Repair |

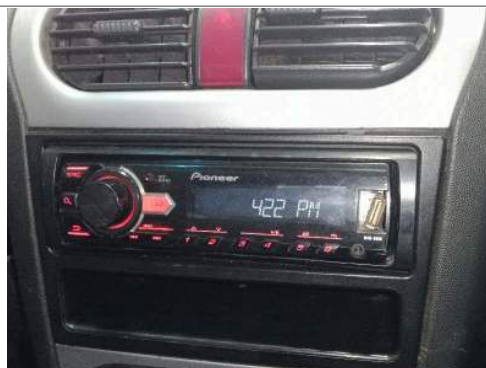
| Damage | Repair Way |
|---|---|
| Radio/CD/USB Damaged | Replace |

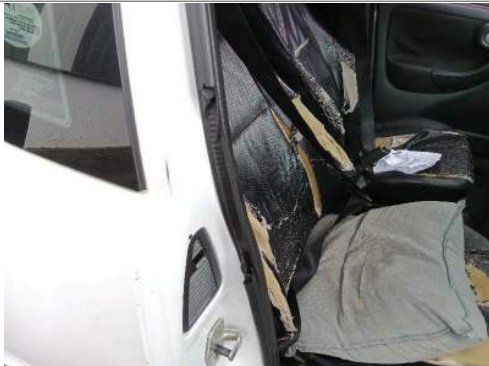
| Damage | Repair Way |
|---|---|
| Door Sealing Rubber Front Right Damaged | Replace |

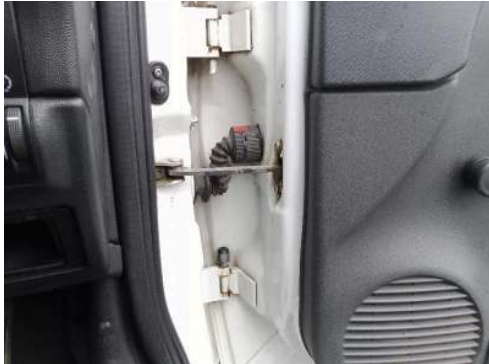
| Damage | Repair Way |
|---|---|
| Doorstopper Front Right Defective | Replace |

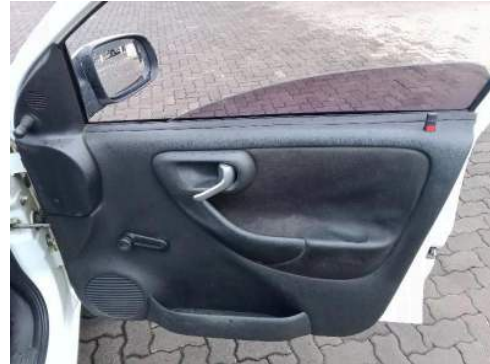
| Damage | Repair Way |
|---|---|
| Door Panel Front Right Damaged | Replace |

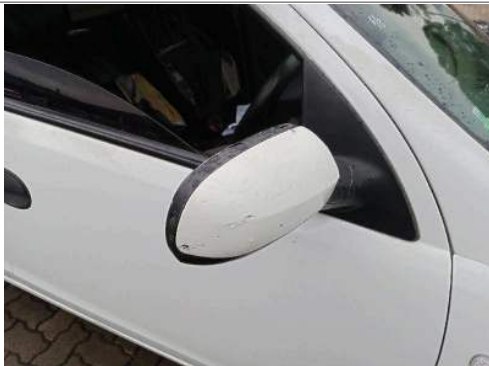
| Damage | Repair Way |
|---|---|
| Side Mirror Right Paintwork • Scratched | Repair |

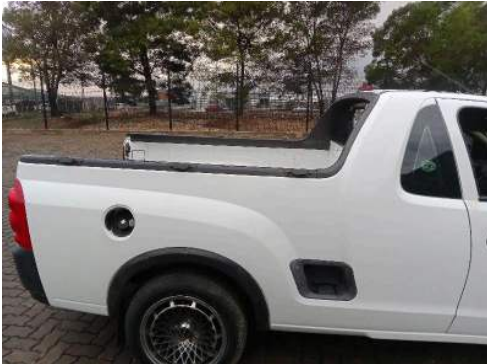
| Damage | Repair Way |
|---|---|
| Rear Fender Right Paintwork • Scratched | Repair |

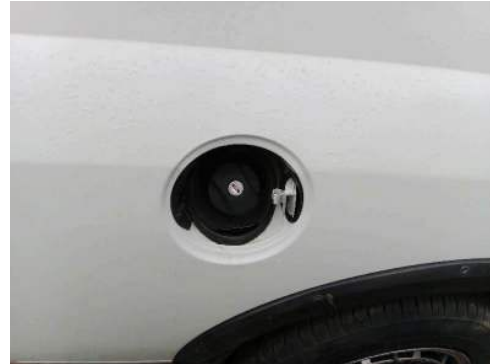
| Damage | Repair Way |
|---|---|
| Fuel Flap Damaged | Replace |

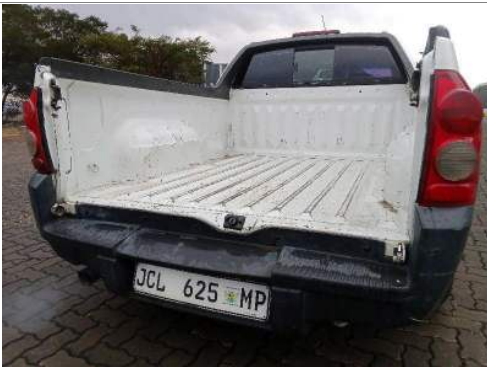
| Damage | Repair Way |
|---|---|
| Rear bumper Damaged | Repair |

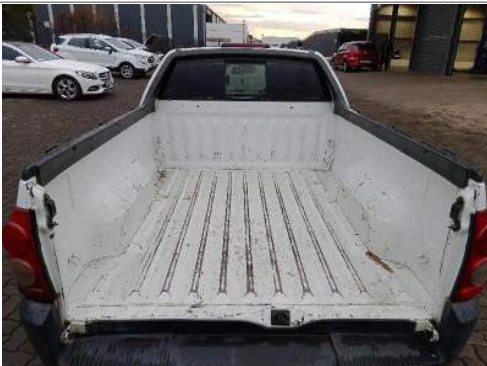
| Damage | Repair Way |
|---|---|
| Load Body Damaged | Repair |

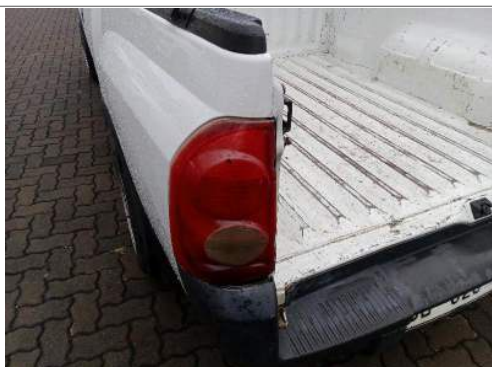
| Damage | Repair Way |
|---|---|
| Tail Light Left Damaged | Replace |

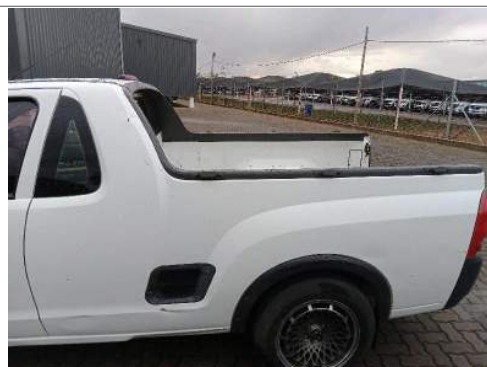
| Damage | Repair Way |
|---|---|
| Rear Fender Left Damaged | Repair |

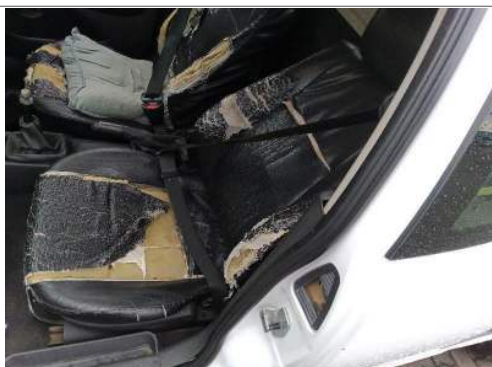
| Damage | Repair Way |
|---|---|
| Seat Front Left Damaged | Repair |

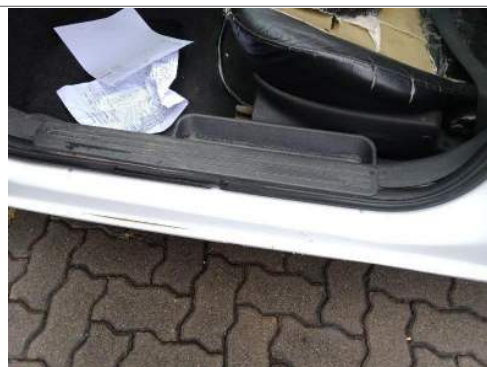
| Damage | Repair Way |
|---|---|
| Door Sealing Rubber Front Left Damaged | Replace |

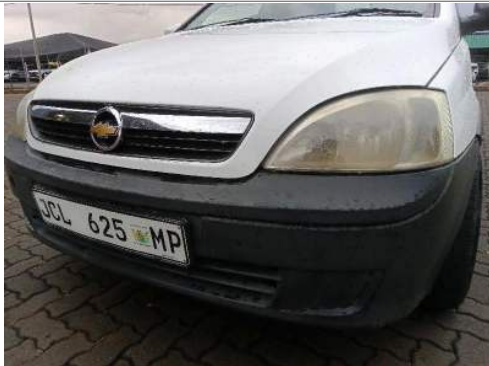
| Damage | Repair Way |
|---|---|
| Front Bumper Damaged | Repair |

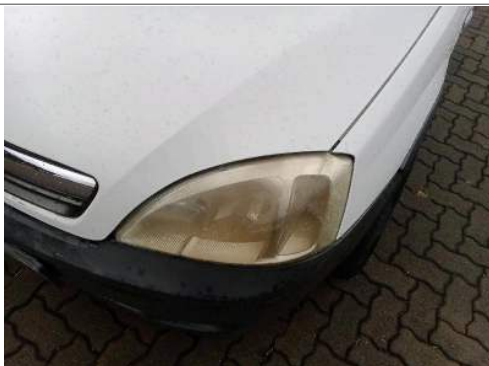
| Damage | Repair Way |
|---|---|
| Headlight Left Damaged | Replace |

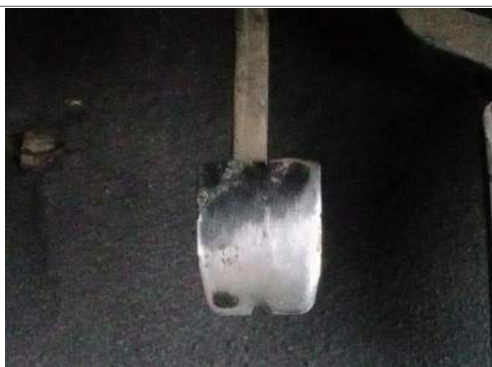
| Damage | Repair Way |
|---|---|
| Brake Pedal Rubber Missing | Replace |

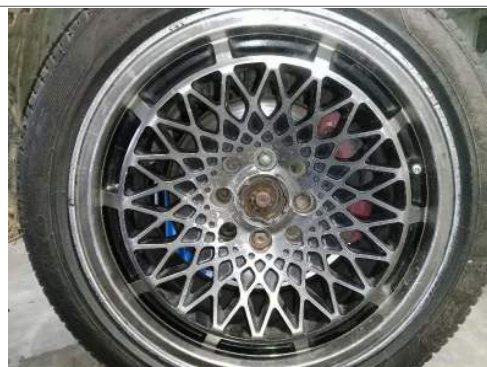
| Damage | Repair Way |
|---|---|
| Bolt(s) / Nut(s) Rear Wheel Right Missing | Replace |

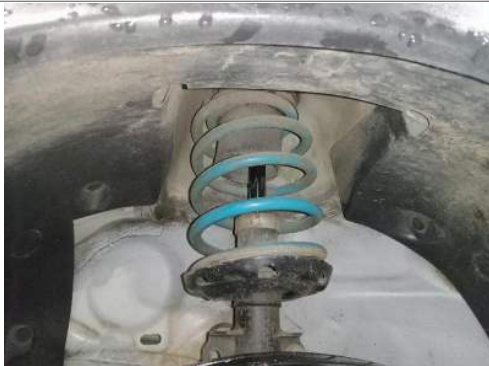
| Damage | Repair Way |
|---|---|
| Spring Front Left Defective | Replace |

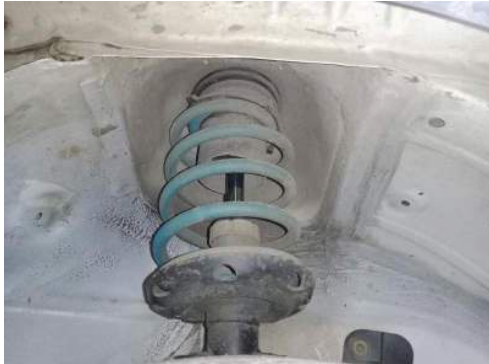
| Damage | Repair Way |
|---|---|
| Spring Front Right Defective | Replace |

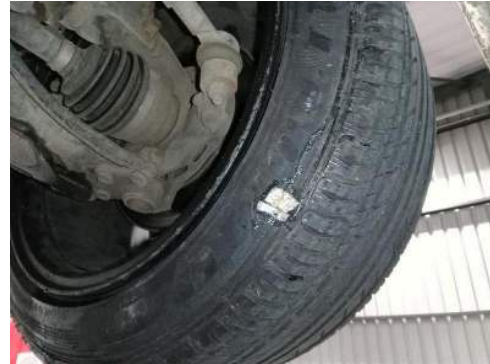
| Damage | Repair Way |
|---|---|
| Tyre Front Right Damaged | Replace |

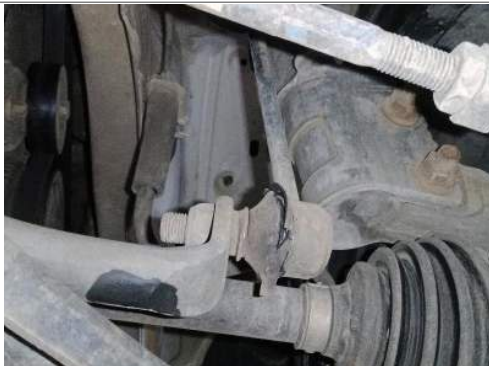
| Damage | Repair Way |
|---|---|
| Stabilizer Mounting Front Right Damaged | Replace |

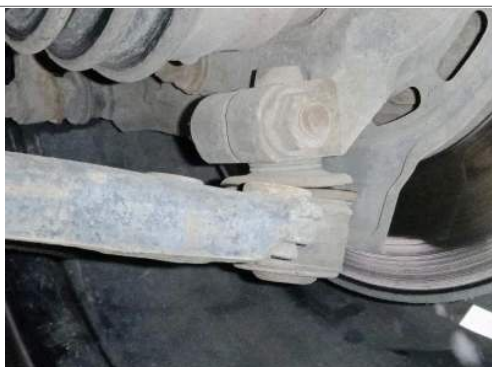
| Damage | Repair Way |
|---|---|
| Ball Joint(s) Front Axle Right Damaged | Replace |

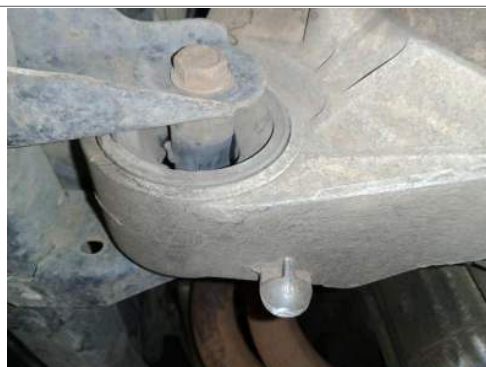
| Damage | Repair Way |
|---|---|
| Gearbox Mountings Cracked | Replace |

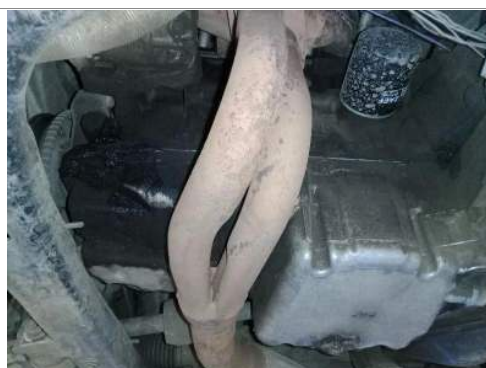
| Damage | Repair Way |
|---|---|
| Engine Noise Excessive | Repair |
| Engine Smoke Excessive | Repair |

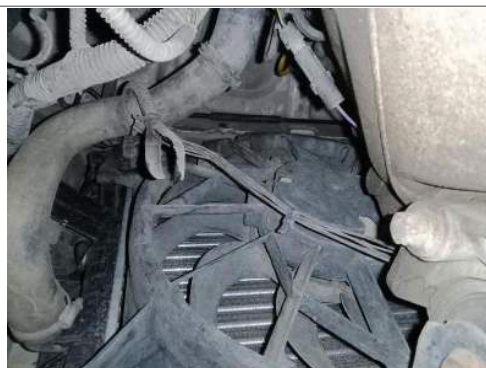
Engine Wiring

| Damage | Repair Way |
|---|---|
| Interior | Loose wiring inside of vehicle |

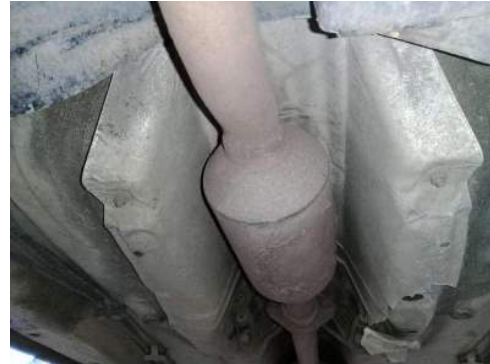
| Damage | Repair Way |
|---|---|
| Catalytic converter Welded | Replace |

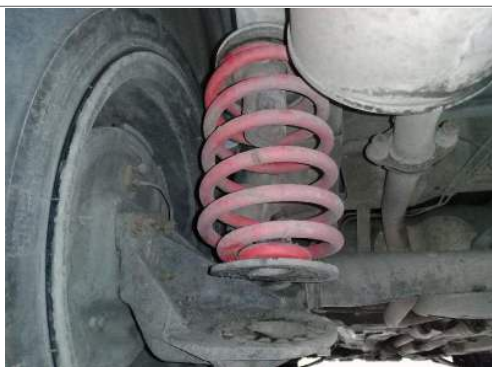
| Damage | Repair Way |
|---|---|
| Spring Rear Left Defective | Replace |

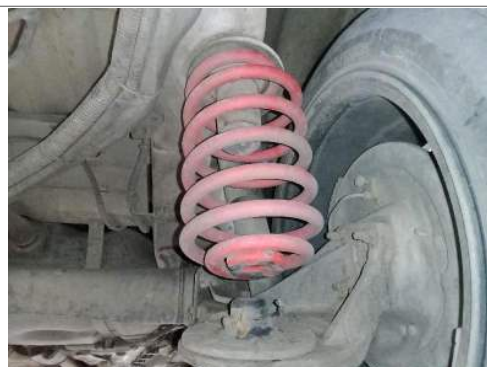
| Damage | Repair Way |
|---|---|
| Spring Rear Right Defective | Replace |

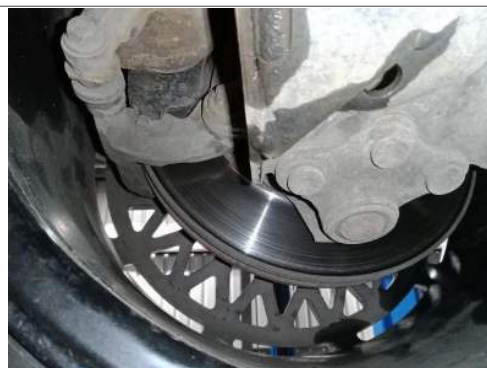
| Damage | Repair Way |
|---|---|
| Brake disc 1. Axle right Defective | Replace |

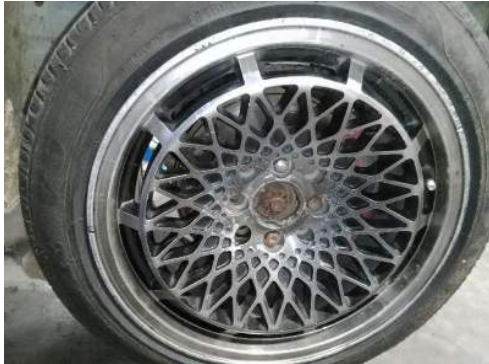
| Damage | Repair Way |
|---|---|
| Bolt(s) / Nut(s) Front Wheel Right Missing | Replace |

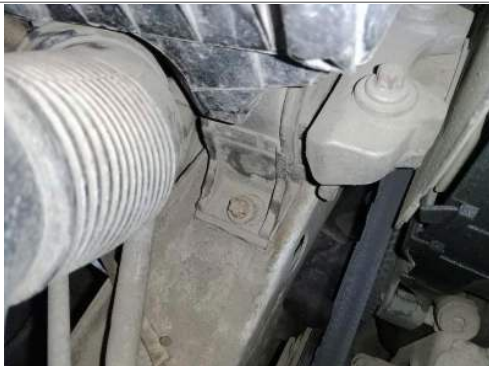
| Damage | Repair Way |
|---|---|
| Engine mountings Loose / Excessive Play | Replace |
