## CONDITION REPORT

2017305034

| Manufacturer | NISSAN | Registration Number | LLV585MP |
| Model | NP200 1.6 8V BASE +AC PU [2011-2019] | Register Number | |

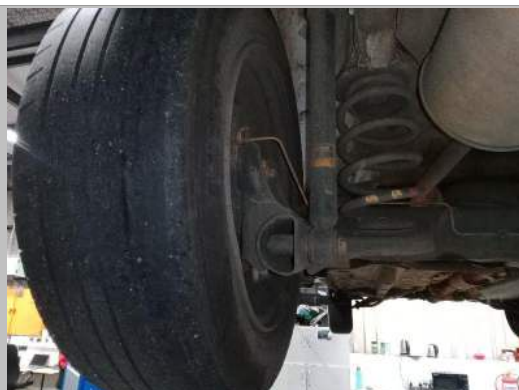
LR TYRE TREAD

| Damage | Repair Way |
|---|---|
| Tyre Rear Left Damaged | Replace |

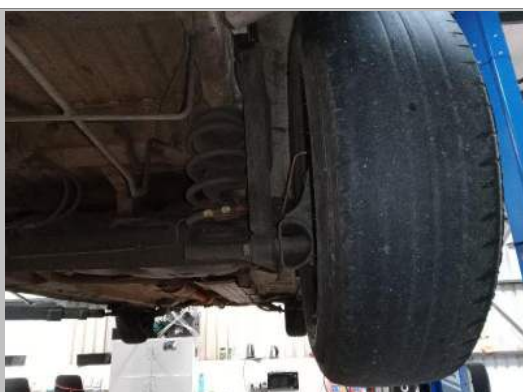
RR TYRE TREAD

| Damage | Repair Way |
|---|---|
| Tyre Rear Right Worn | Replace |

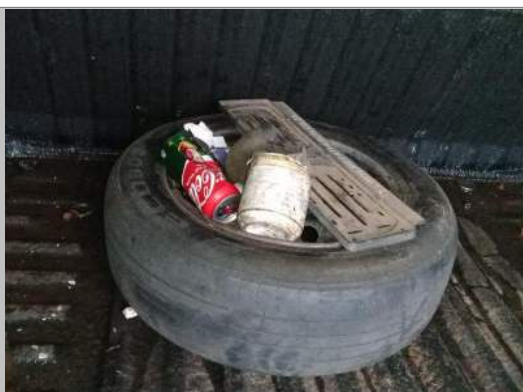
Spare Wheel

| Damage | Repair Way |
|---|---|
| Spare Tyre Damaged | Replace |

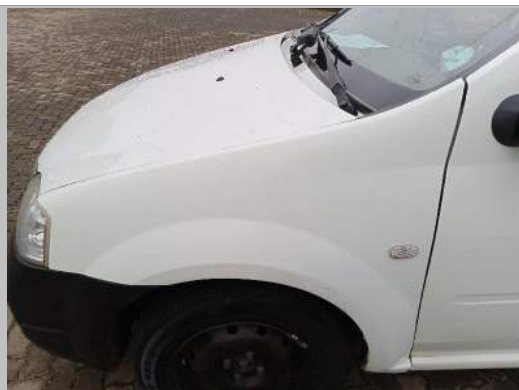
| Damage | Repair Way |
|---|---|
| Front Fender Left Damaged | Repair |

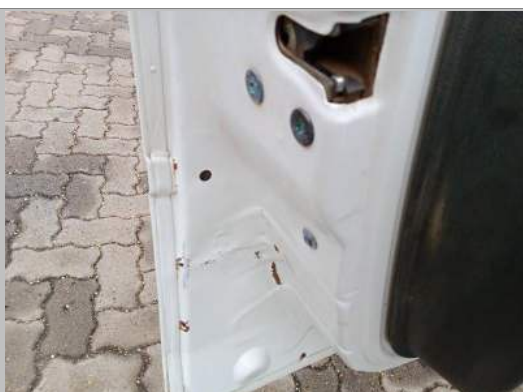
| Damage | Repair Way |
|---|---|
| Door Front Left Residual Traces of Repair | Repair |

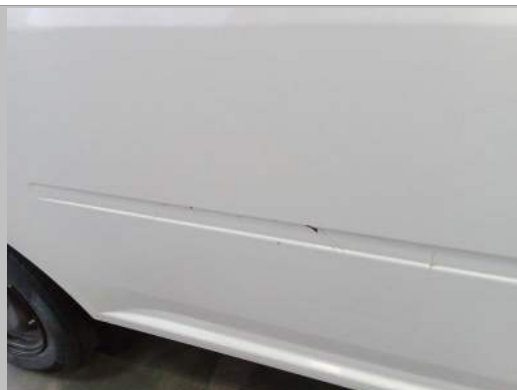
| Damage | Repair Way |
|---|---|
| Rear Fender Right Paintwork • Scratched | Repair |

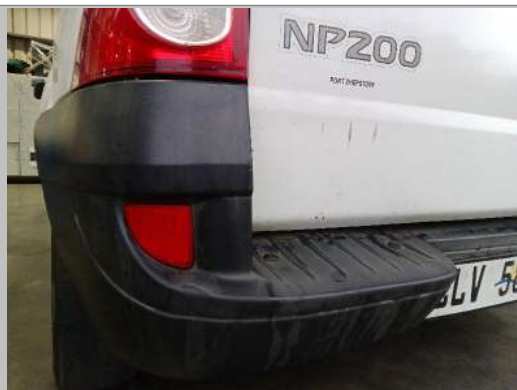
| Damage | Repair Way |
|---|---|
| Rear bumper Damaged | Repair |

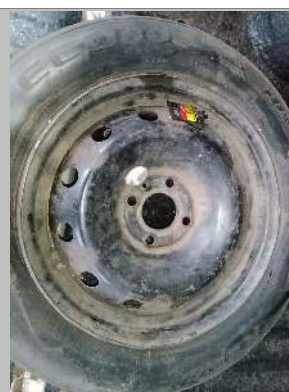
| Damage | Repair Way |
|---|---|
| Rim Spare Wheel Dented | Repair |

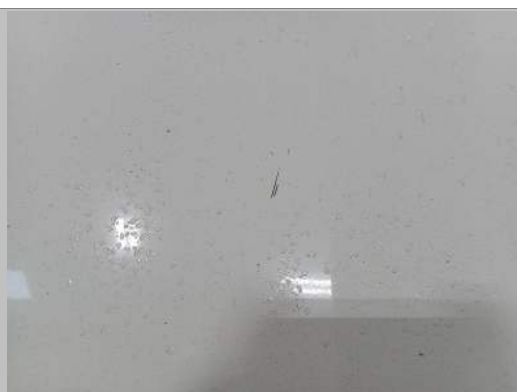
| Damage | Repair Way |
|---|---|
| Bonnet Paintwork • Scratched | Repair |

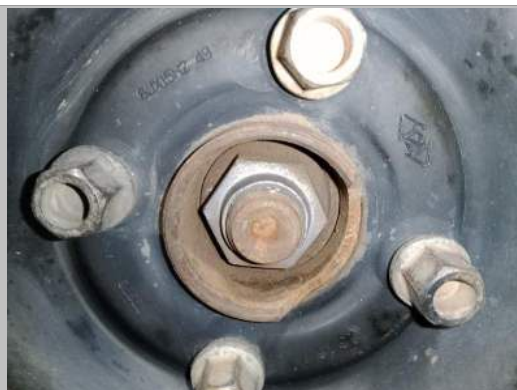
| Damage | Repair Way |
|---|---|
| Brake Drum 2. Axle left Damaged | Replace |

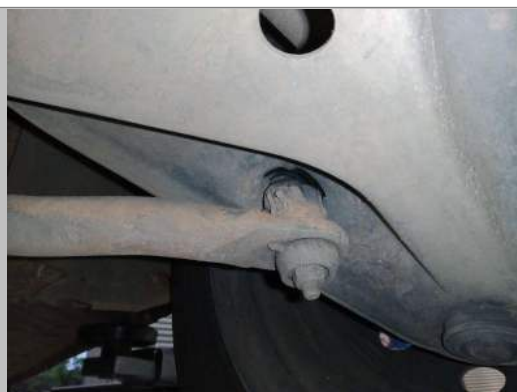
| Damage | Repair Way |
|---|---|
| Stabilizer Mounting Front Left Damaged | Replace |

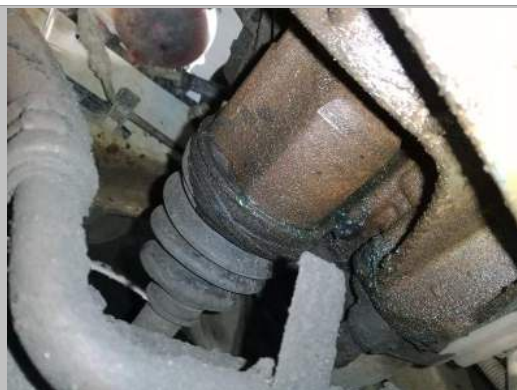
| Damage | Repair Way |
|---|---|
| CV Joint(s) Boot(s) Front Left (inner/outer) Damaged | Replace |

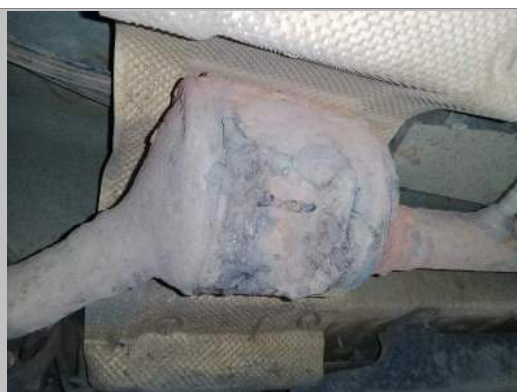
| Damage | Repair Way |
|---|---|
| Catalytic converter Damaged | Replace |

Undercarriage: Front catalytic converter missing. Engine splash plate missing.

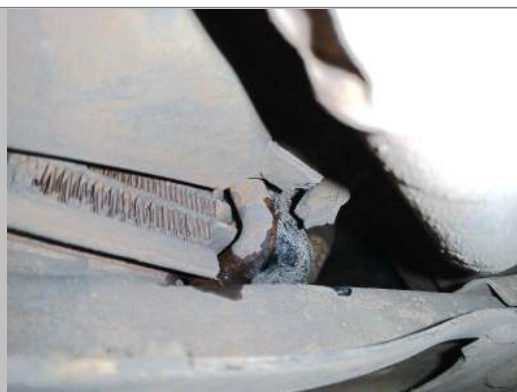
| Damage | Repair Way |
|---|---|
| Radiator Water Leak | Replace |

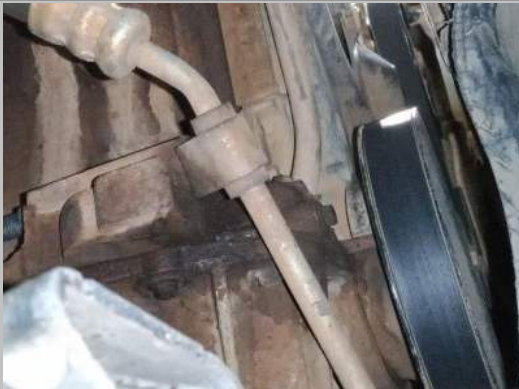
| Damage | Repair Way |
|---|---|
| Engine Oil Sweat | Repair |

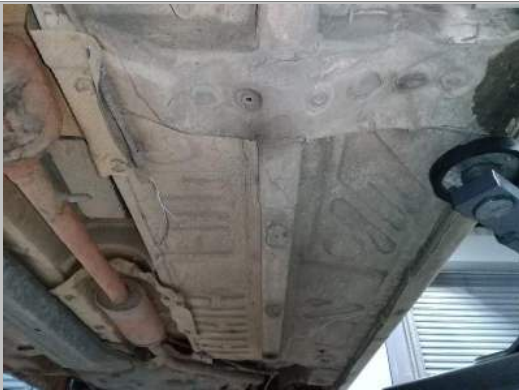
| Damage | Repair Way |
|---|---|
| Chassis Damaged | Repair |

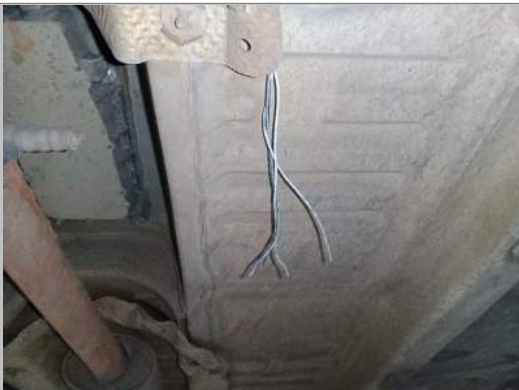
| Damage | Repair Way |
|---|---|
| Engine Wiring Defective | Repair |

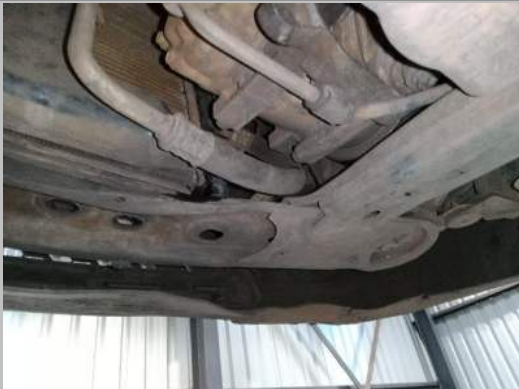
Radiator Cradle Dented  
Engine Performance Insufficient  
Engine Noise Idling / Hunting  
Gearbox Noise Excessive  
Jack Missing  
Wheel Spanner Missing  
Triangle Missing  
Foreign substance on oil cap  
Aircon condenser dented  
Front bumper stiffener damaged

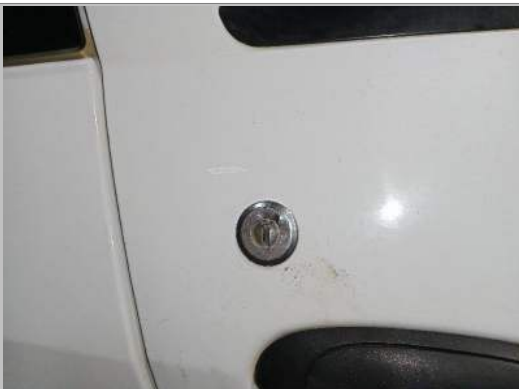
| Damage | Repair Way |
|---|---|
| Door Lock Front Right Damaged | Replace |
