MFC Auction House  
M57 Pretoria Rd, Glenmarais, KEMPTON PARK  
Gauteng

DEKRA MFC  
M57 Pretoria Rd - 1619  
KEMPTON PARK - GT  
08610 33572

| Manufacturer | RENAULT | Registration Number | CX11VNGP |
| Model | SANDERO 1.6I STEPWAY 5-DR [2013-2015] | Register Number | |

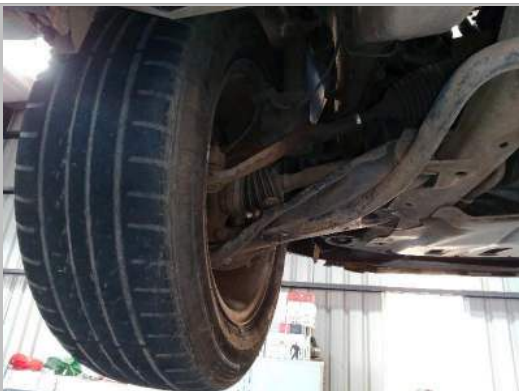
LF TYRE TREAD

| Damage | Repair Way |
|---|---|
| Tyre Front Left Worn | Replace |

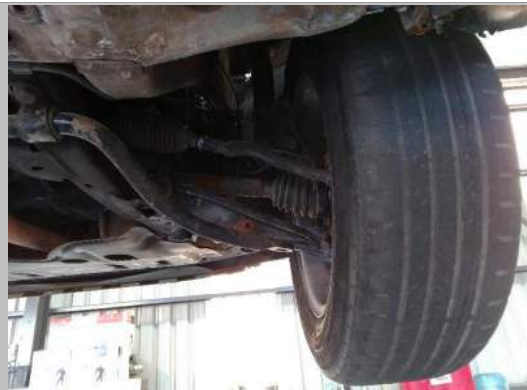
RF TYRE TREAD

| Damage | Repair Way |
|---|---|
| Tyre Front Right Worn | Replace |

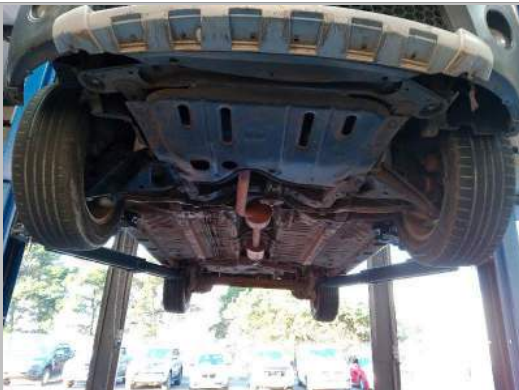
Front chassis

| Damage | Repair Way |
|---|---|
| Chassis Damaged | Repair |

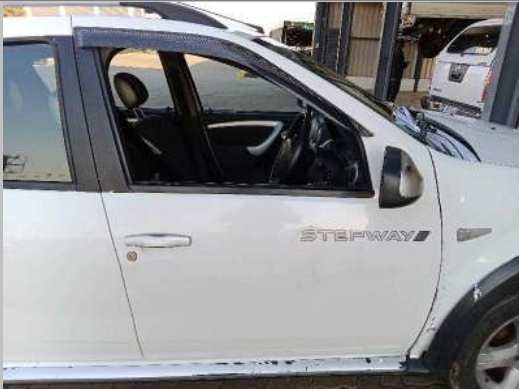
| Damage | Repair Way |
|---|---|
| Door Front Right Damaged | Repair |

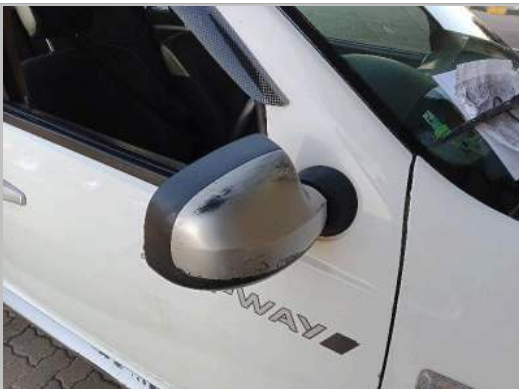
| Damage | Repair Way |
|---|---|
| Side Mirror Right Paintwork • Scratched | Repair |

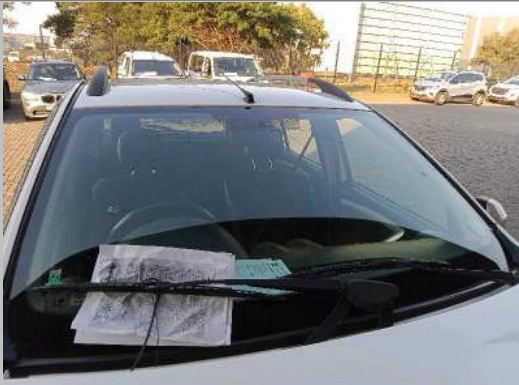
| Damage | Repair Way |
|---|---|
| Windscreen Cracked | Replace |

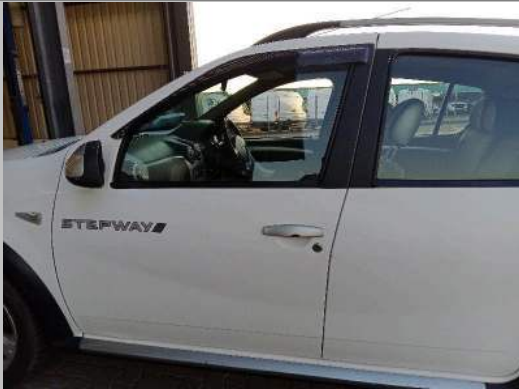
| Damage | Repair Way |
|---|---|
| Door Front Left Damaged | Repair |

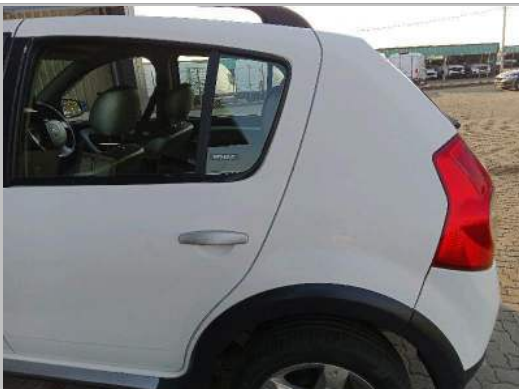
| Damage | Repair Way |
|---|---|
| Rear Fender Left Paintwork • Scratched | Repair |

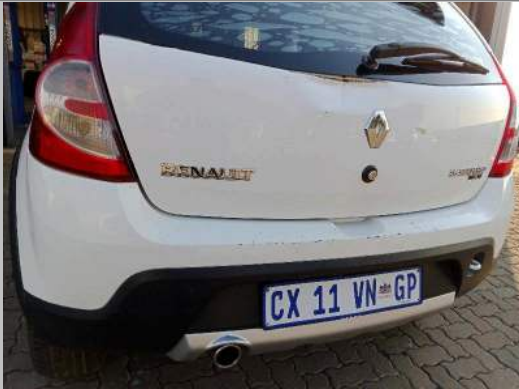
| Damage | Repair Way |
|---|---|
| Rear bumper Damaged | Repair |

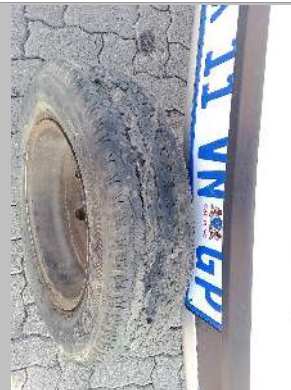
| Damage | Repair Way |
|---|---|
| Spare Tyre Damaged | Replace |

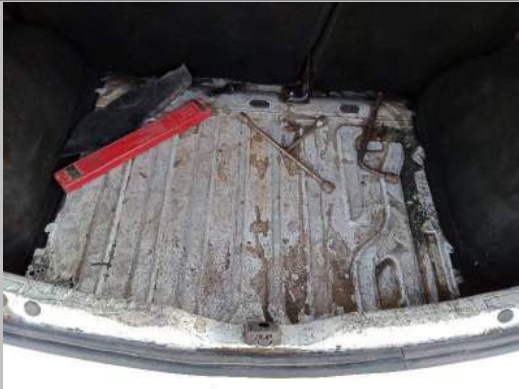
| Damage | Repair Way |
|---|---|
| Inner Boot Floor Pan and Spare Wheel Well Damaged | Repair |

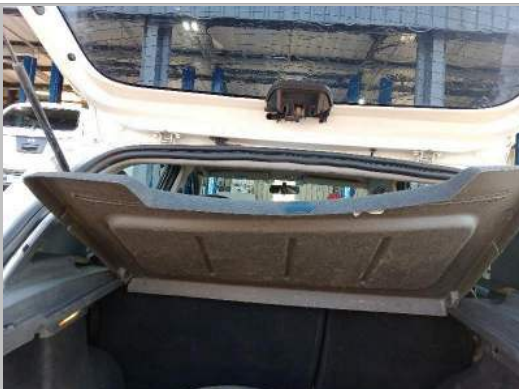
| Damage | Repair Way |
|---|---|
| Parcel Tray Damaged | Repair |

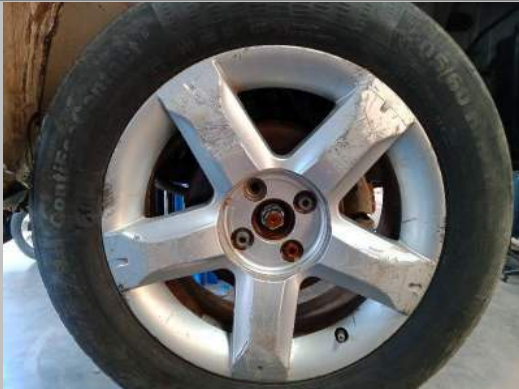
| Damage | Repair Way |
|---|---|
| Bolt(s) / Nut(s) Front Wheel Right Missing | Replace |

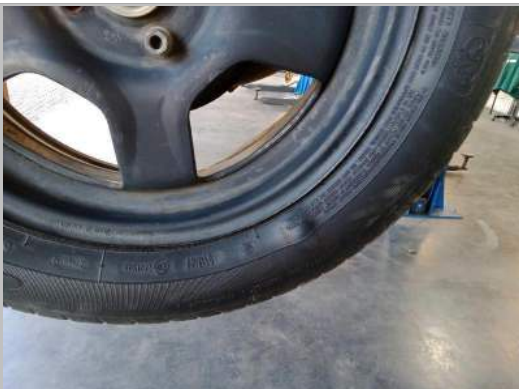
| Damage | Repair Way |
|---|---|
| Tyre Rear Right Damaged | Replace |

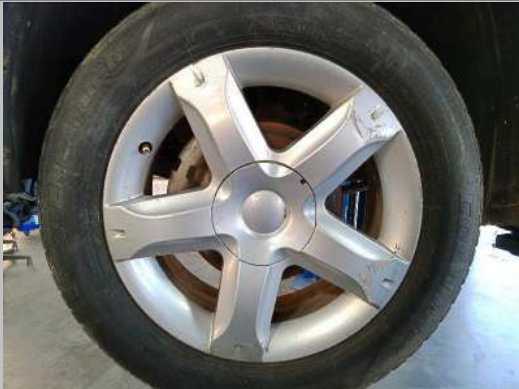
| Damage | Repair Way |
|---|---|
| Rim Front Left Scratched | Repair |

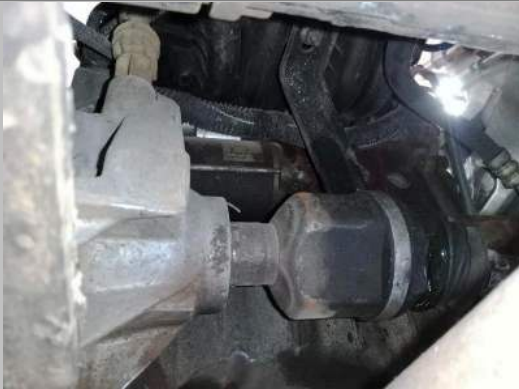
| Damage | Repair Way |
|---|---|
| CV Joint(s) Front Right (inner/outer) Defective | Repair |

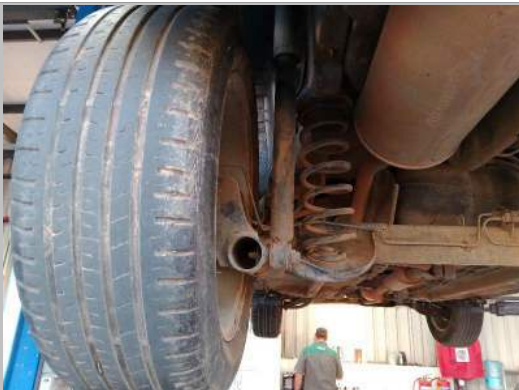
| Damage | Repair Way |
|---|---|
| Tyre Rear Left Damaged | Replace |
