MFC Auction House  
M57 Pretoria Rd, Glenmarais, KEMPTON PARK  
Gauteng

| Manufacturer | TOYOTA | Registration Number | HT43VDGP |

## CONDITION REPORT

Report No: 2016739385

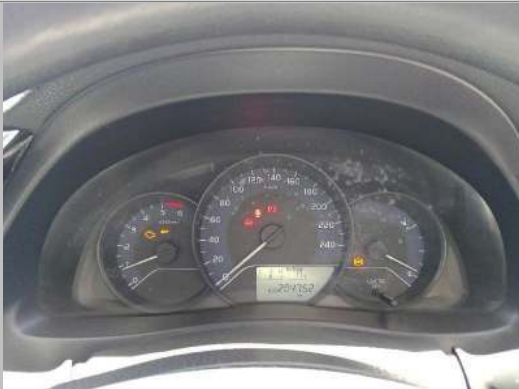
DASHBOARD (W/ ENGINE RUNNING)

| Damage | Repair Way |
|---|---|
| Warning lights illuminated on dashboard | Repair |

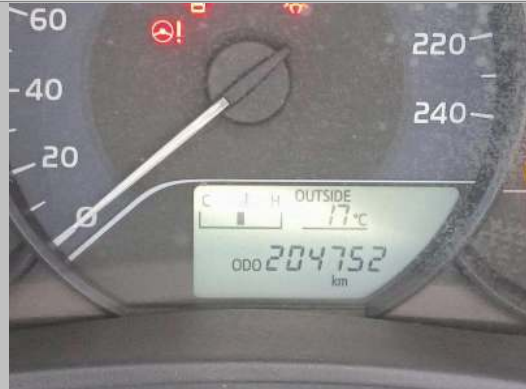
ODOMETER

| Damage | Repair Way |
|---|---|
| Electrical instruments and components | Speedometer not working |

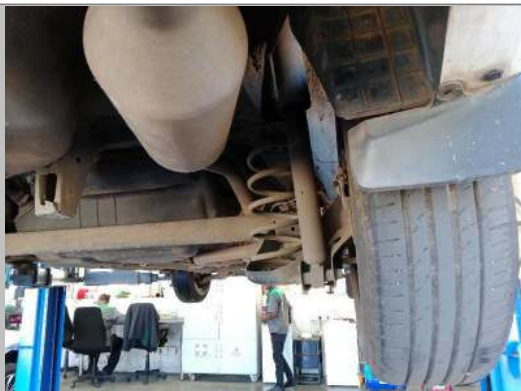
RR TYRE TREAD

| Damage | Repair Way |
|---|---|
| Tyre Rear Right Defective | Replace |

| | Size | Load/Speed Index | Manufacture | Model | Type* | Production Date | Tread Depth (mm) |
|---|---|---|---|---|---|---|---|
| Rear Right | 195/65 R15 | 91V | Nexen | Nblue | V | 2921 | 1 mm |

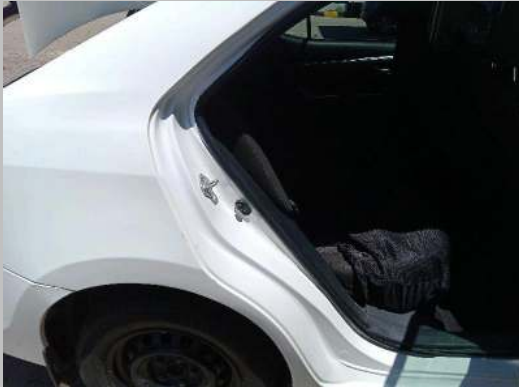
| Damage | Repair Way |
|---|---|
| C • Pillar Right Residual Traces of Repair | Repair |

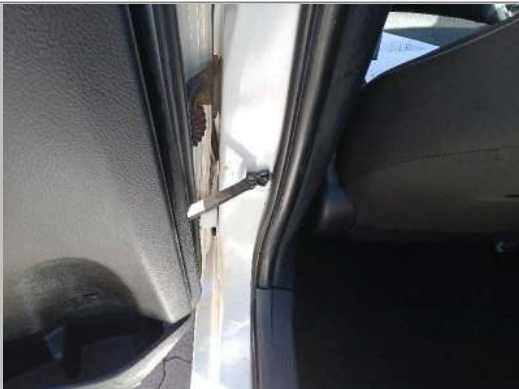
| Damage | Repair Way |
|---|---|
| Doorstopper Rear Left Defective | Replace |

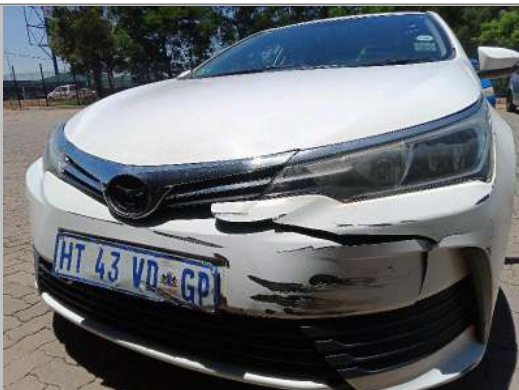
| | Damage | Repair Way |
|---|---|---|
| | Front Bumper Damaged | Replace |

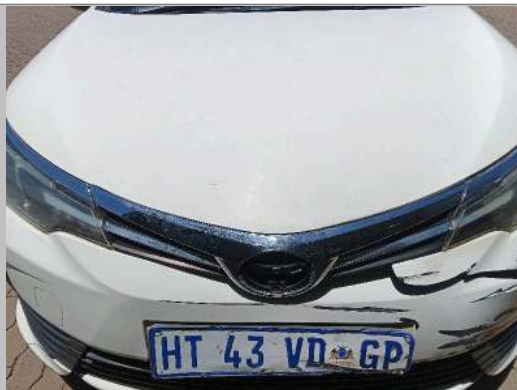
| | Damage | Repair Way |
|---|---|---|
| | Grill Damaged | Replace |

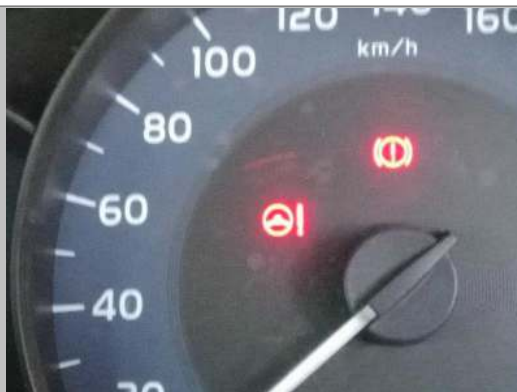
| Damage | Repair Way |
|---|---|
| Steering Malfunction | Repair |

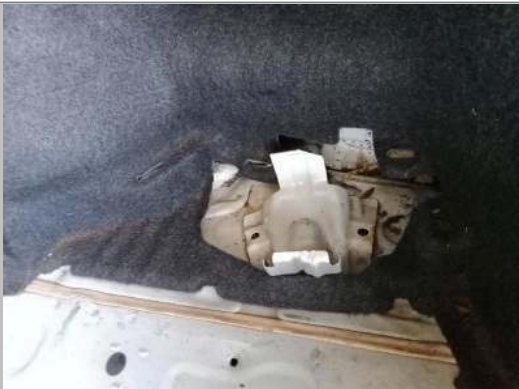
| Damage | Repair Way |
|---|---|
| Inner Boot Floor Pan and Spare Wheel Well Damaged | Repair |
| Body and Exterior | Signs of impact damage to rear of vehicle. |

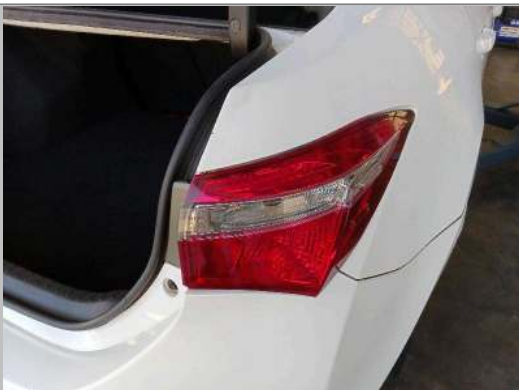
| | Damage | Repair Way |
|---|---|---|
| | Tail Light Right Defective | Replace |

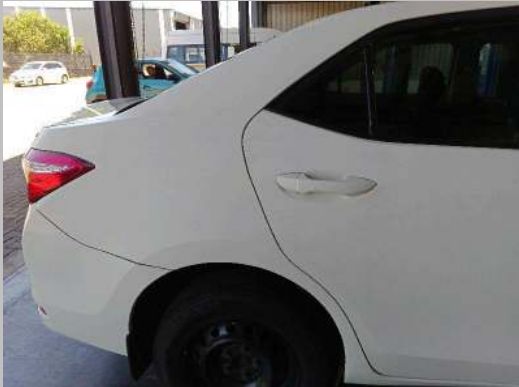
| Damage | Repair Way |
|---|---|
| Rear Fender Right Residual Traces of Repair | Repair |

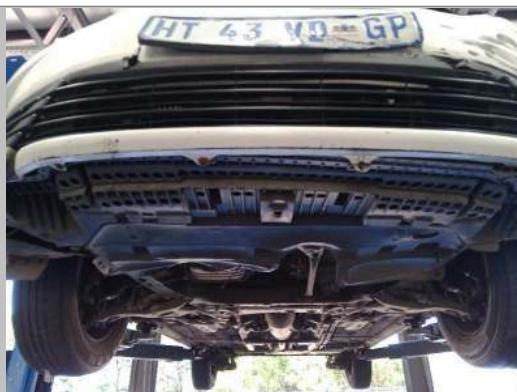
| Damage | Repair Way |
|---|---|
| Belly plates Damaged | Replace |

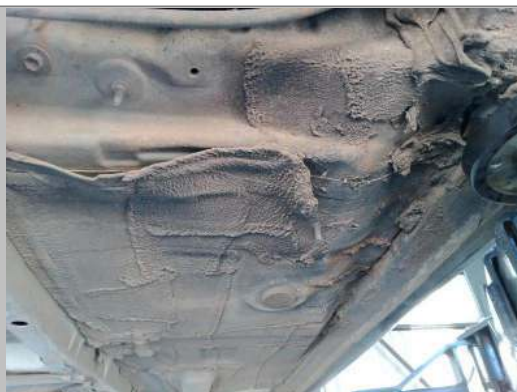
| Damage | Repair Way |
|---|---|
| Chassis Damaged | Repair |
| Body and Exterior | Vehicle is a cut and joint on rear left main beam |
