## CONDITION REPORT

2017305777

| Manufacturer | TOYOTA | Registration Number | KD33CLGP |
| Model | COROLLA QUEST 1.8 PLUS [2021-2022] | Register Number | |

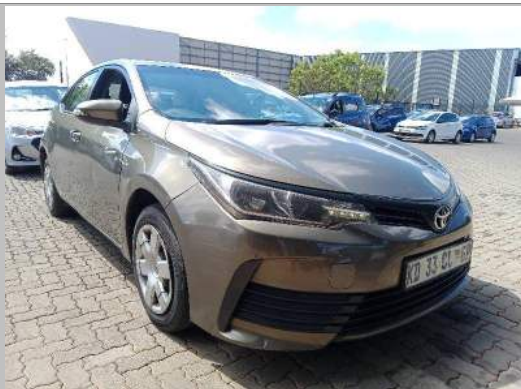
FRONT RIGHT CORNER

Body • Exterior: Signs of hail damage on body panels. Poor residual traces of repair on body panels. Body panels misaligned. Stone chips and spray work on body panels. Dents and scratches on body panels. Signs of impact damage to front of vehicle.

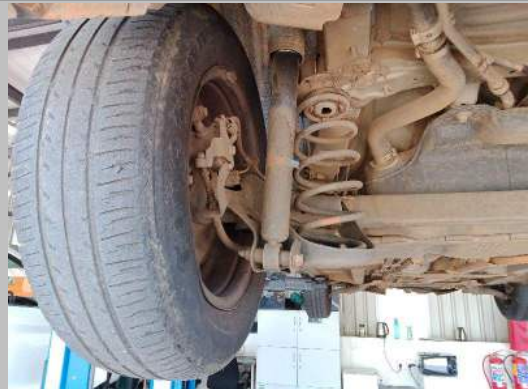
LR TYRE TREAD

| Damage | Repair Way |
|---|---|
| Tyre Rear Left Damaged | Replace |
| Front right and rear left tyres regrooved | Replace |

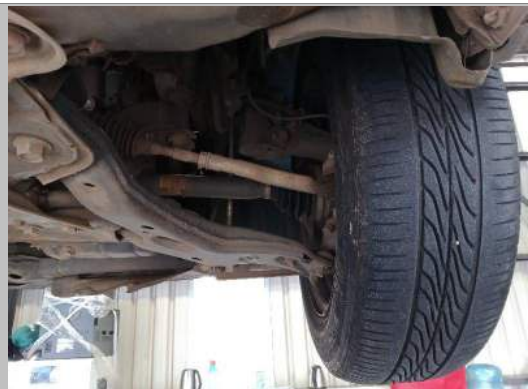
RF TYRE TREAD

| Damage | Repair Way |
|---|---|
| Tyre Front Right Damaged | Replace |

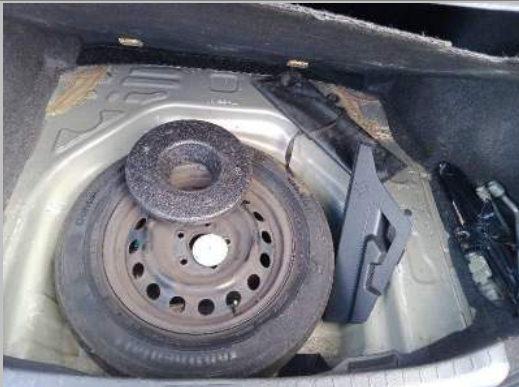
Spare wheel and Accessories

| Damage | Repair Way |
|---|---|
| Spare Tyre Damaged | Replace |

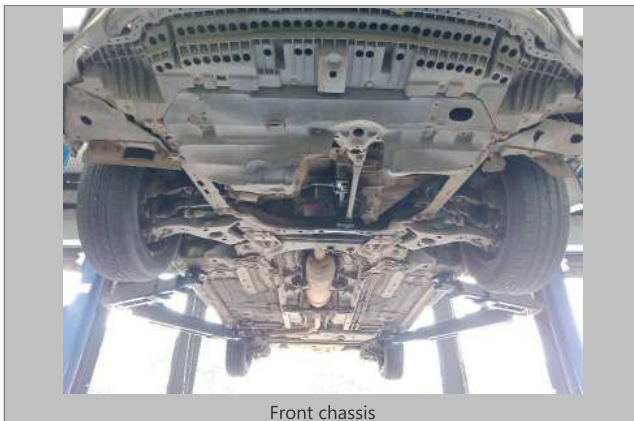
Front chassis

| Damage | Repair Way |
|---|---|
| Chassis Damaged | Repair |

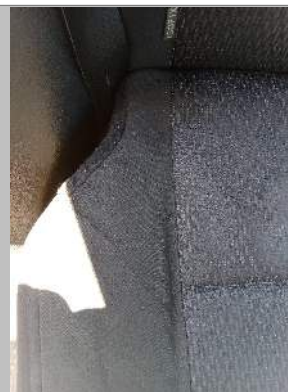
| Damage | Repair Way |
|---|---|
| Seat Rear Damaged | Repair |

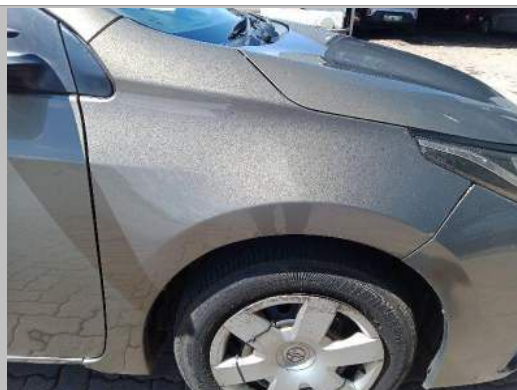
| Damage | Repair Way |
|---|---|
| Front Fender Right Damaged | Repair |

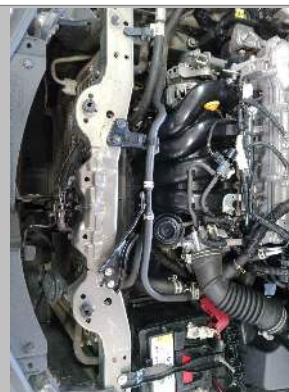
| Damage | Repair Way |
|---|---|
| Bonnet slam plate (Shock tower/ Inner tray) Damaged | Repair |

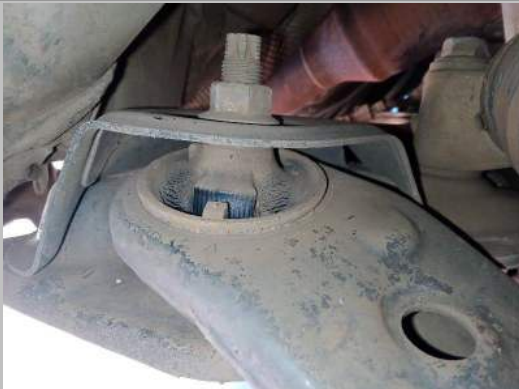
| Damage | Repair Way |
|---|---|
| Control Arm Bush(es) Front Axle Right Cracked | Replace |

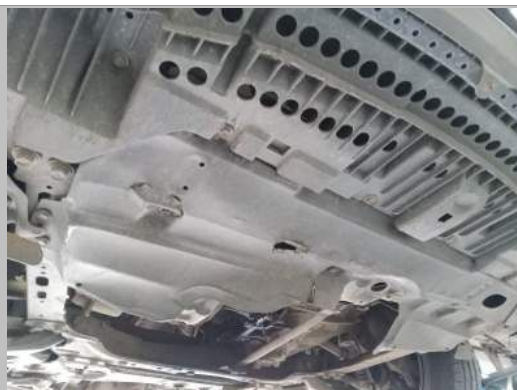
| Damage | Repair Way |
|---|---|
| Belly plates Damaged | Replace |
