CONDITION REPORT

Report No: 2016850176

MFC Auction House  
M57 Pretoria Rd, Glenmarais, KEMPTON PARK  
Gauteng

| Model | HI-ACE 2.5 SESFIKILE 16-S DSL MINIBUS [2021-2024] | Register Number | |

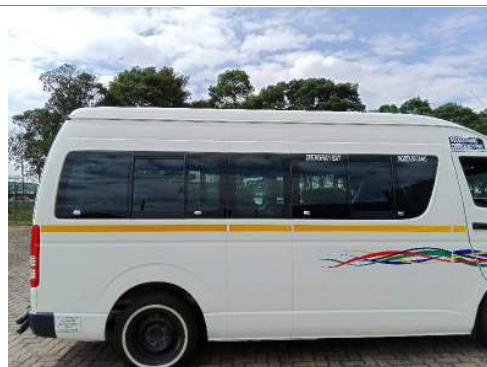
| Damage | Repair Way |
|---|---|
| Rear Fender Right Damaged | Repair |
| Rear Fender Right / Inner Tray Paintwork • Scratched | Repair |

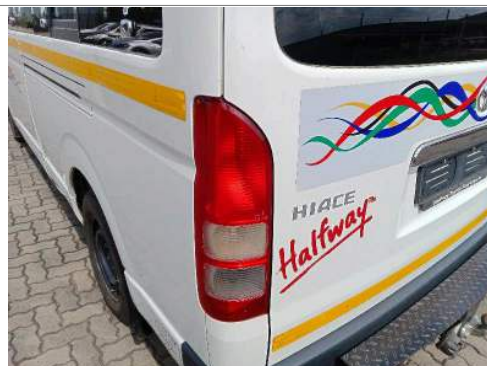
| Damage | Repair Way |
|---|---|
| Tail Light Left Cracked | Replace |

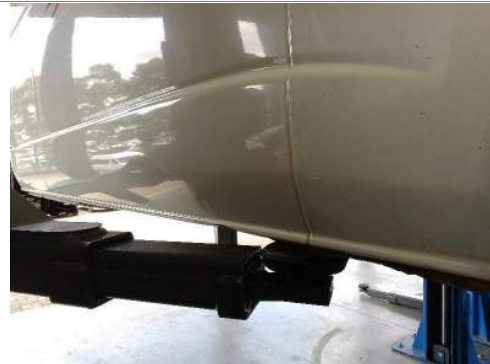
| Damage | Repair Way |
|---|---|
| Sill Panel Right Damaged | Repair |

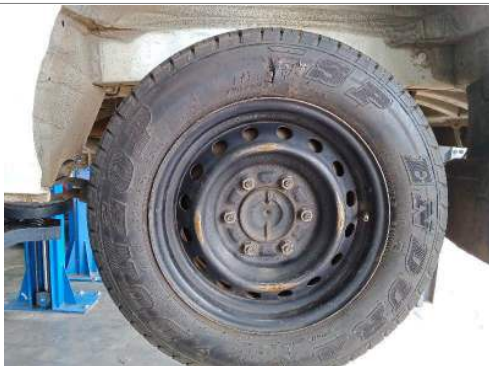
| Damage | Repair Way |
|---|---|
| Rim Rear Left Dented | Repair |

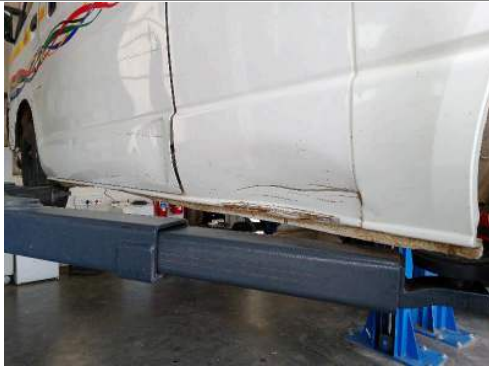
| Damage | Repair Way |
|---|---|
| Sill Panel Left Damaged | Repair |

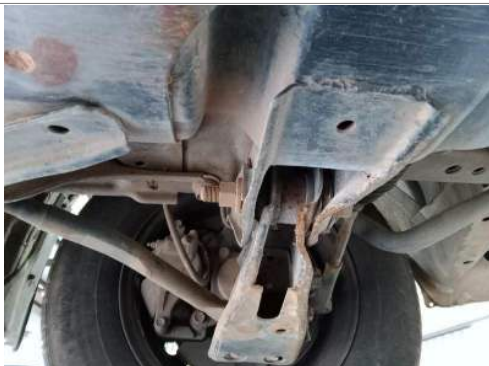
| Damage | Repair Way |
|---|---|
| Control Arm(s) Front Axle Left Damaged | Replace |

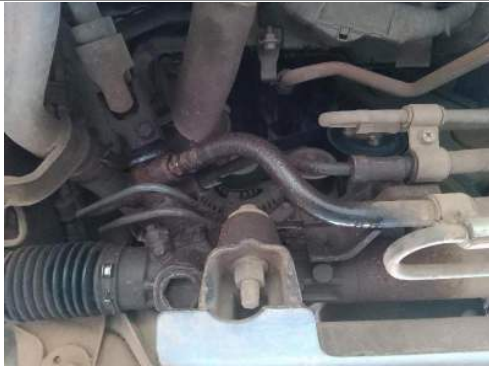
| Damage | Repair Way |
|---|---|
| Hoses Oil Sweat | Replace |

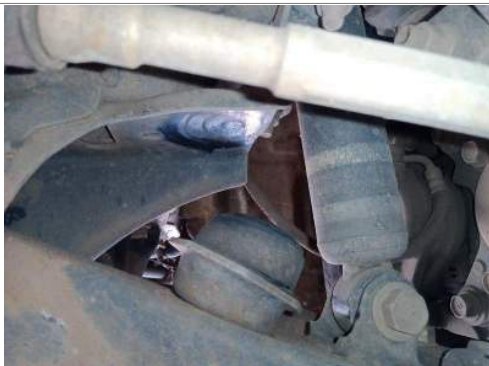
| Damage | Repair Way |
|---|---|
| Rebound Rubber Front Axle Left Cracked | Replace |

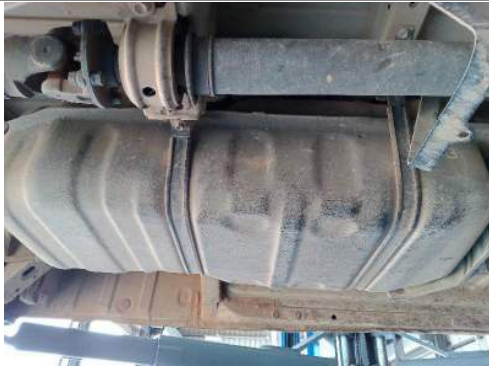
| Damage | Repair Way |
|---|---|
| Fuel Tank Dented | Repair |

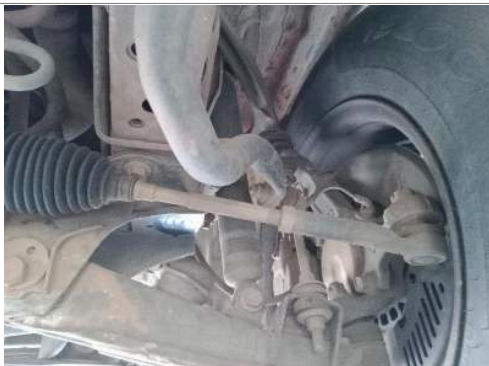
| Damage | Repair Way |
|---|---|
| Stabilizer Mounting Front Left Damaged | Replace |
