CONDITION REPORT

Report No:  
2017306428  
DATE  
02/10/2026

| Manufacturer | TOYOTA | Registration Number | KF05YRGP |
| Model | HI-ACE 2.5 SESFIKILE 16-S DSL MINIBUS [2020-2022] | Register Number | |

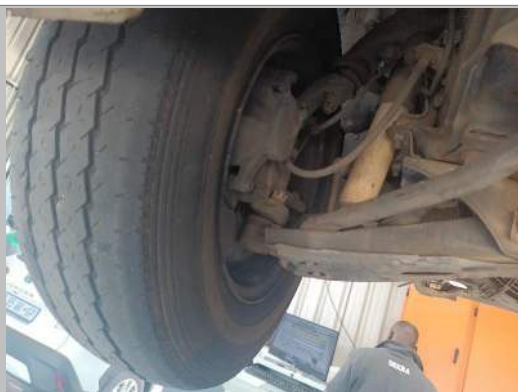
LF TYRE TREAD

| Tyre Front Left Smooth | Replace |

| | Size | Load/Speed Index | Manufacture | Model | Type* | Production Date | Tread Depth (mm) |
|---|---|---|---|---|---|---|---|
| Front Left | 195R15 | 106/104R | Annaite | AC838 | V | 0000 | 0 mm |

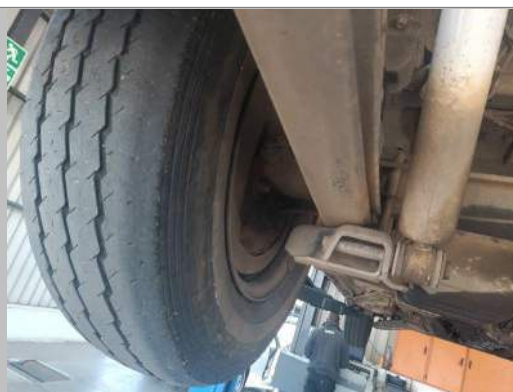
LR TYRE TREAD

| Tyre Rear Left Smooth | Replace |

| | Size | Load/Speed Index | Manufacture | Model | Type* | Production Date | Tread Depth (mm) |
|---|---|---|---|---|---|---|---|
| Rear Left | 195R15 | 106/104R | Annaite | AN900 | V | 0000 | 0 mm |

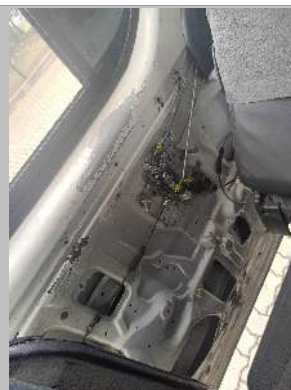
| Boot Panel Left Missing | Replace |

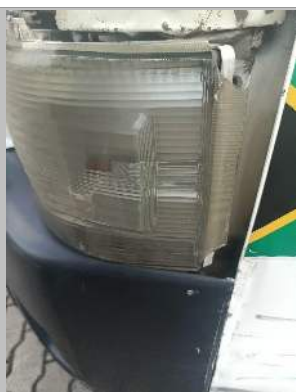
| Headlight Left Damaged | Replace |

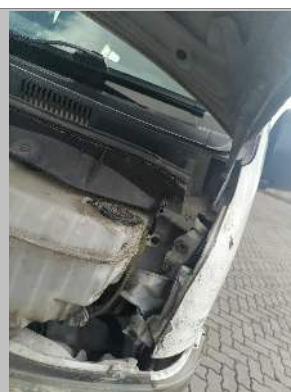
| Bonnet stay and shocks Missing | Replace |

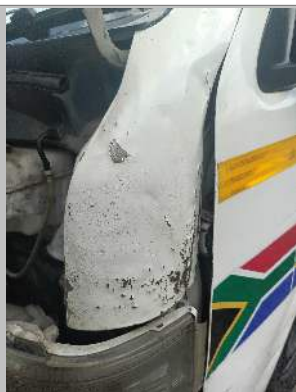
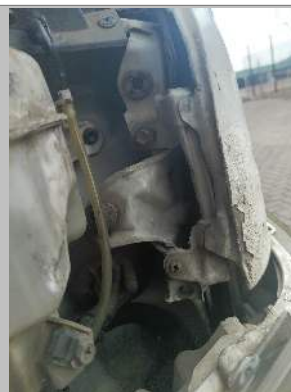
| Front Fender Left Residual Traces of Repair | Replace |
| Front Fender Left / Inner Tray Damaged | Replace |

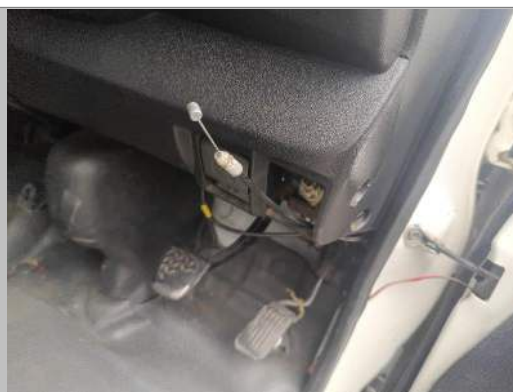
| Bonnet cable Damaged | Repair |

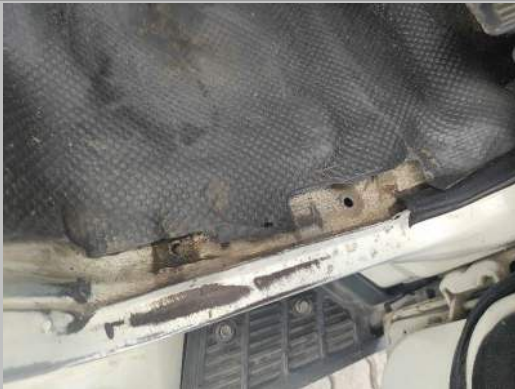
| Door Sealing Rubber Front Right Missing | Repair |

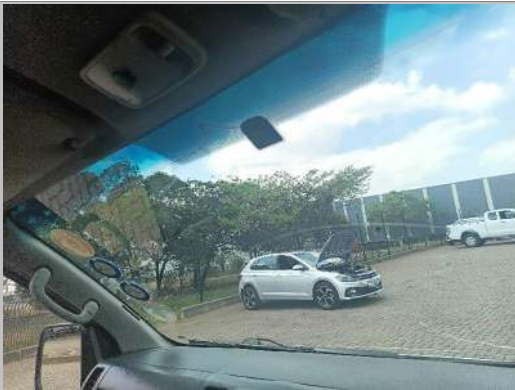
| Interior Mirror Missing | Replace |

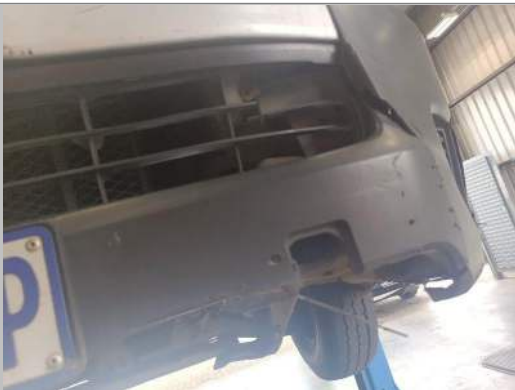
| Front Bumper Damaged | Repair |

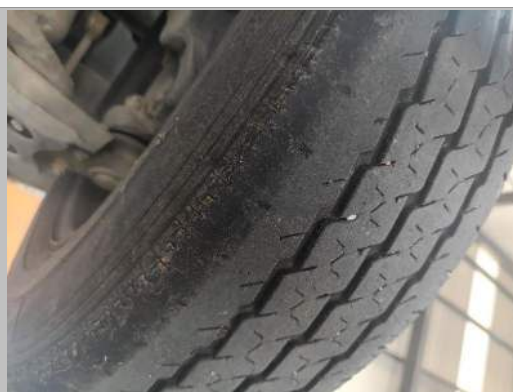
| Tyre Front Right Smooth | Replace |

| | Size | Load/Speed Index | Manufacture | Model | Type* | Production Date | Tread Depth (mm) |
|---|---|---|---|---|---|---|---|
| Front Right | 195R15 | 106/104R | Annaite | AN900 | V | 0725 | 0 mm |

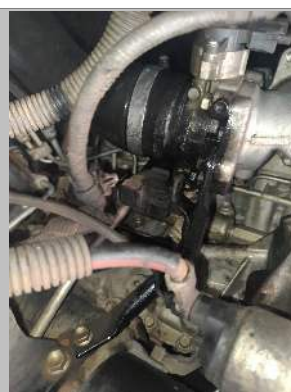
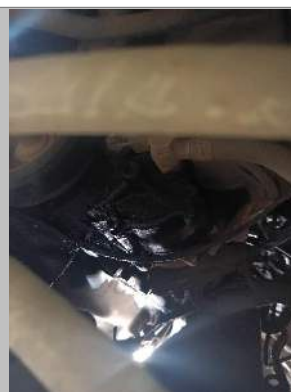
| Engine Oil Leak | Repair |
| Engine Smoke Excessive | Repair |

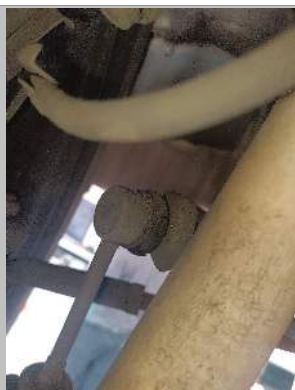
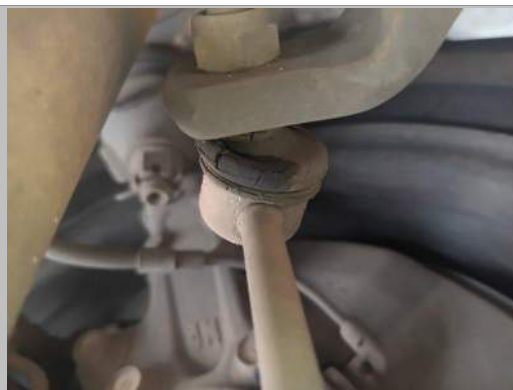
| Stabilizer Mounting Front Left Damaged | Replace |

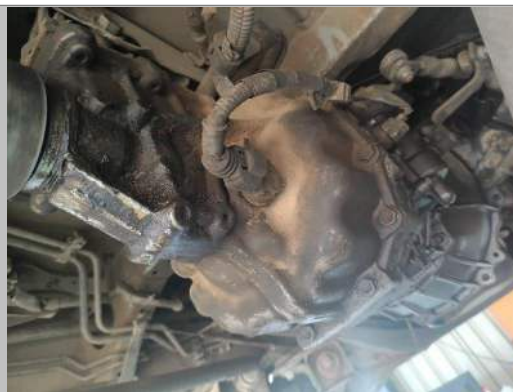
| Gearbox Oil Leak | Repair |

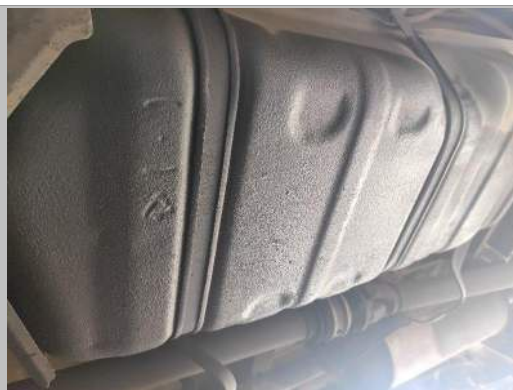
| Fuel Tank Sweat | Repair |

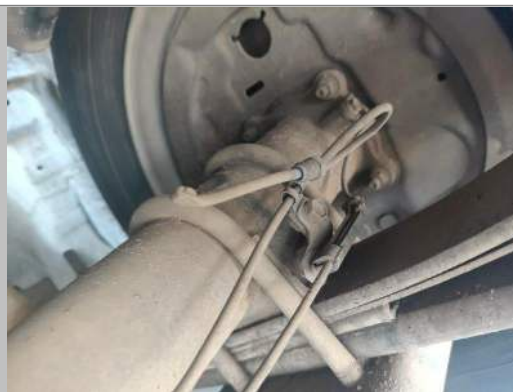
| Brake Piping Leak | Replace |

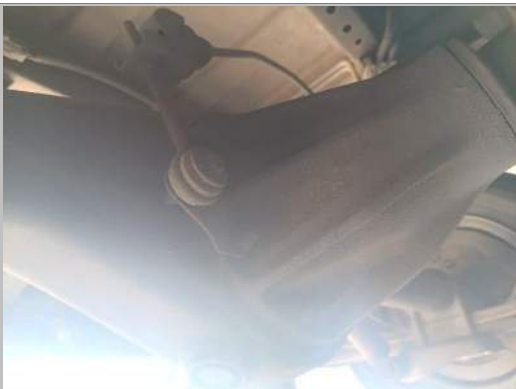
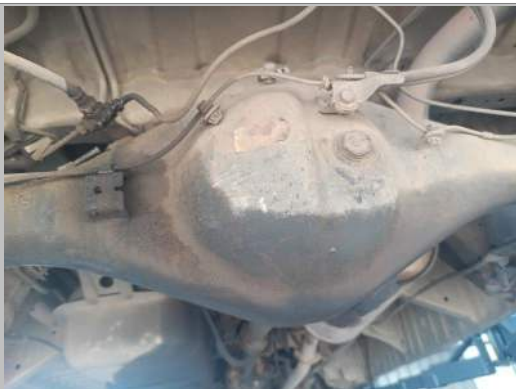
| Differential Oil Sweat | Repair |

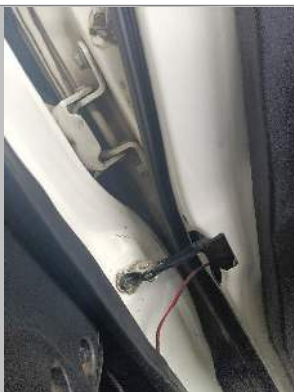
| Door Hinges Front Right Damaged | Repair |
