CONDITION REPORT

Report No:  
2017305374  
DATE  
30/09/2026

| Manufacturer | TOYOTA | Registration Number | KXW151MP |
| Model | HI-ACE 2.5 SESFIKILE 16-S DSL MINIBUS [2021-2024] | Register Number | |

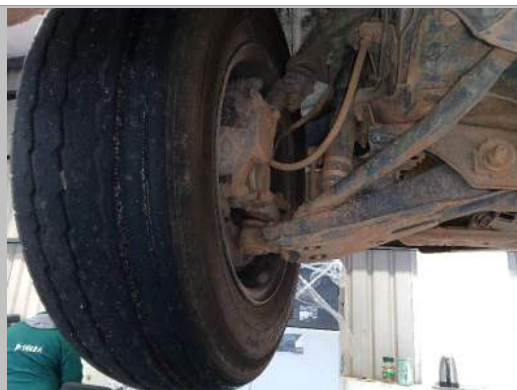
LF TYRE TREAD

| Damage | Repair Way |
|---|---|
| Tyre Front Left Damaged | Replace |

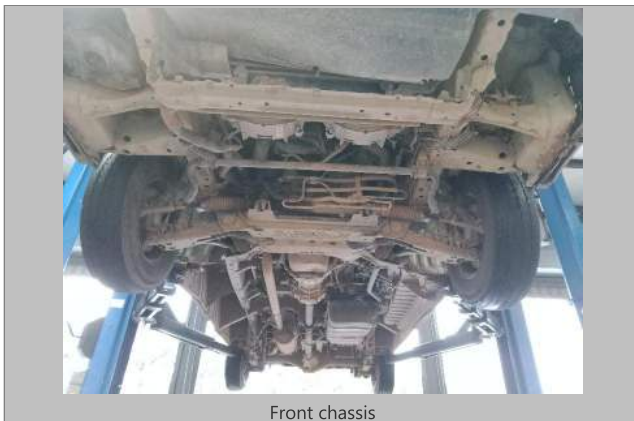
Front chassis

| Damage | Repair Way |
|---|---|
| Chassis Damaged | Repair |

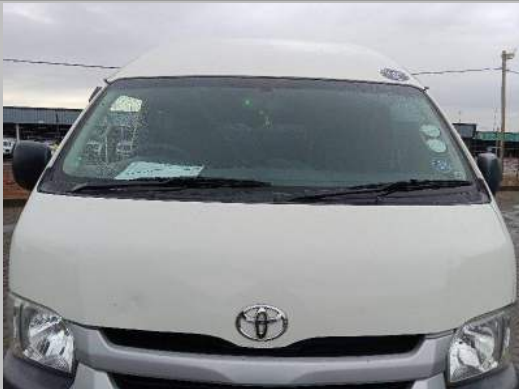
| Damage | Repair Way |
|---|---|
| Bonnet Damaged | Repair |

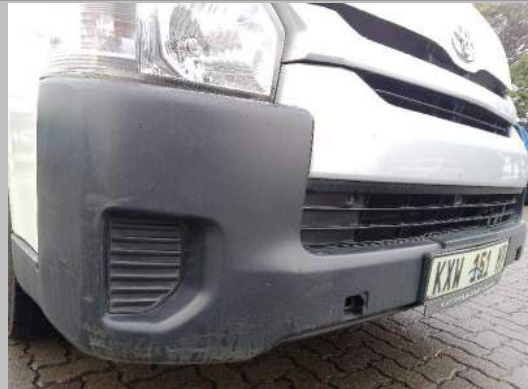
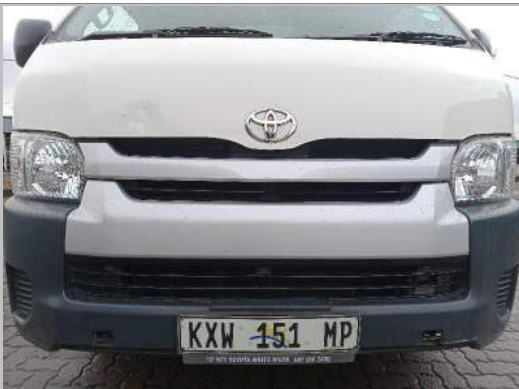
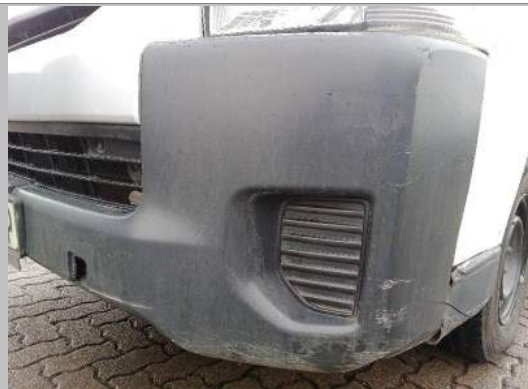
| Damage | Repair Way |
|---|---|
| Front Bumper Damaged | Repair |

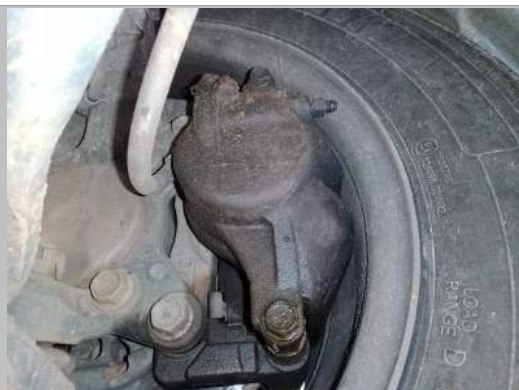
| Damage | Repair Way |
|---|---|
| Caliper 1. Axle right Leak | Repair |

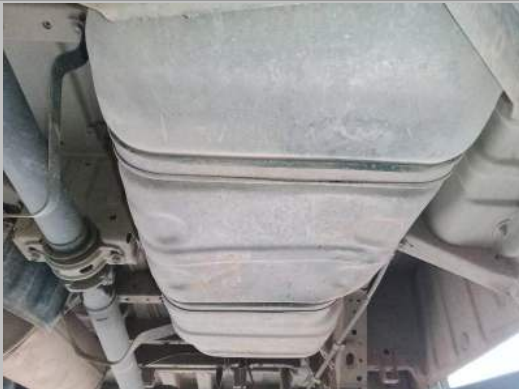
| Damage | Repair Way |
|---|---|
| Fuel Tank Damaged | Replace |

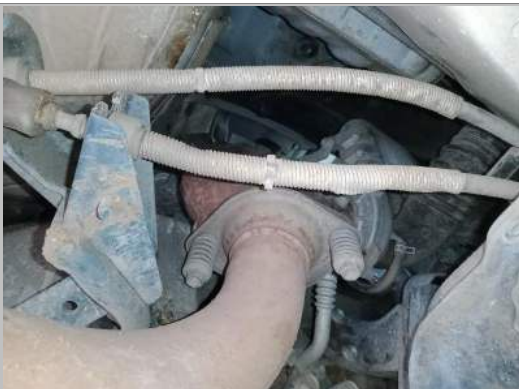
| Damage | Repair Way |
|---|---|
| Catalytic converter Missing | Replace |

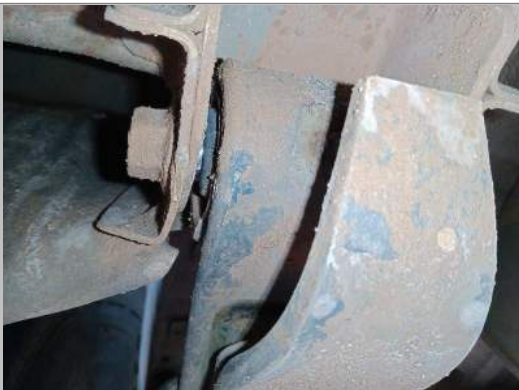
| Damage | Repair Way |
|---|---|
| Mounting Rubber(s) Rear Axle Right Damaged | Replace |
