## CONDITION REPORT

Report No: 2016871664

| Manufacturer | CHEVROLET | Registration Number | HZC416MP |
| Model | CRUZE 1.6 L [2012-2013] | Register Number | |

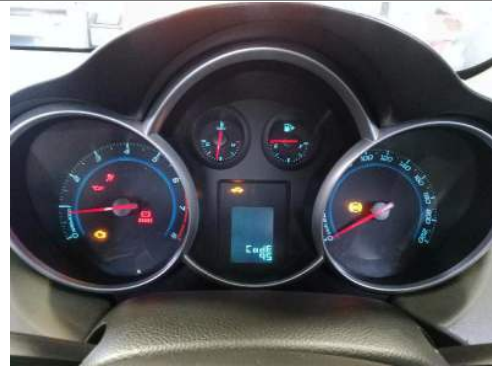
DASHBOARD (W/ ENGINE RUNNING)

| Damage | Repair Way |
|---|---|
| Multiple warning lights illuminated | Repair |

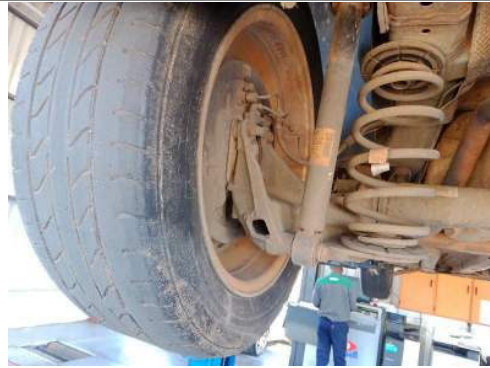
LR TYRE TREAD

| Damage | Repair Way |
|---|---|
| Tyre Rear Left Excessive Wear & Tear | Replace |

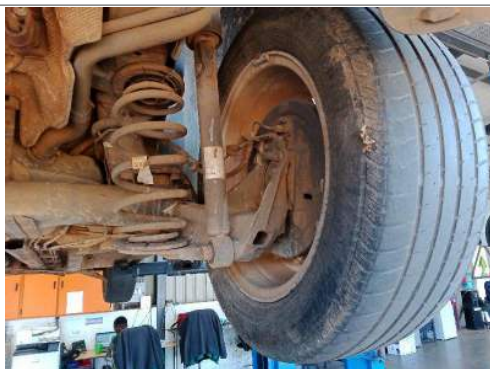
RR TYRE TREAD

| Damage | Repair Way |
|---|---|
| Tyre Rear Right Smooth | Replace |

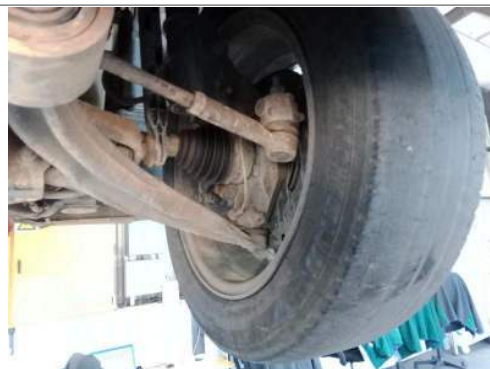
RF TYRE TREAD

| Damage | Repair Way |
|---|---|
| Tyre Front Right Smooth | Replace |

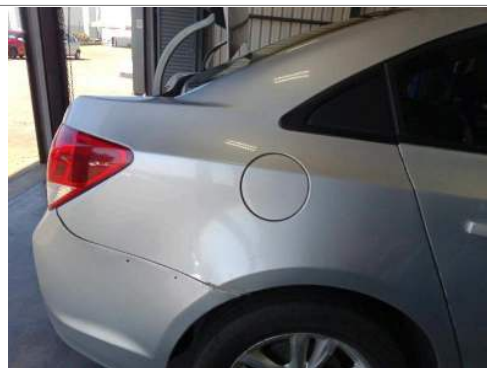
| Damage | Repair Way |
|---|---|
| Rear Fender Right Residual Traces of Repair | Repair |

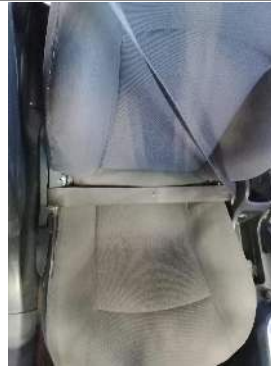
| Damage | Repair Way |
|---|---|
| Seat Front Right Torn / Cut | Repair |

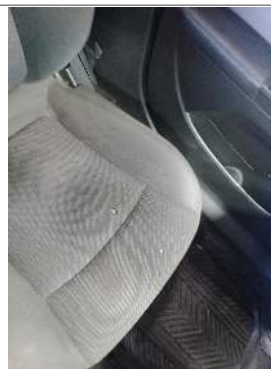
| Damage | Repair Way |
|---|---|
| Seat Front Left Torn / Cut | Repair |

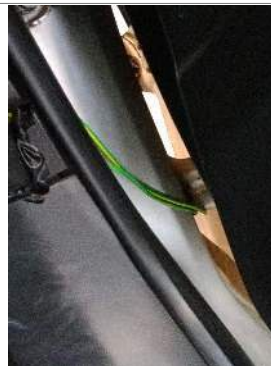
| Damage | Repair Way |
|---|---|
| Wiring connections Defective | Repair |

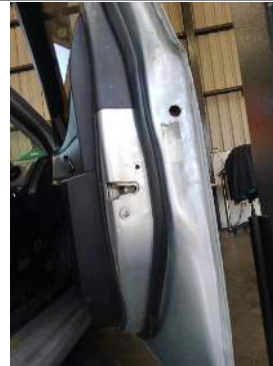
| Damage | Repair Way |
|---|---|
| Door Front Right Residual Traces of Repair | Repair |

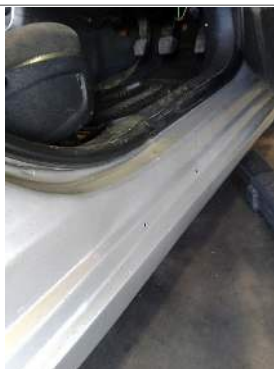
| Damage | Repair Way |
|---|---|
| Sill Panel Right Residual Traces of Repair | Repair |

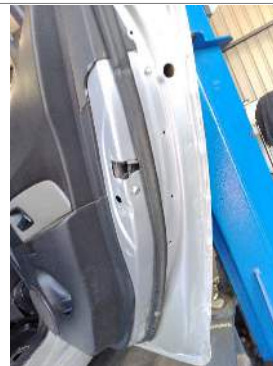
| Damage | Repair Way |
|---|---|
| Door Rear Right Residual Traces of Repair | Repair |

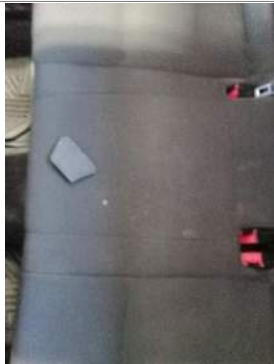
| Damage | Repair Way |
|---|---|
| Seat Rear Torn / Cut | Repair |

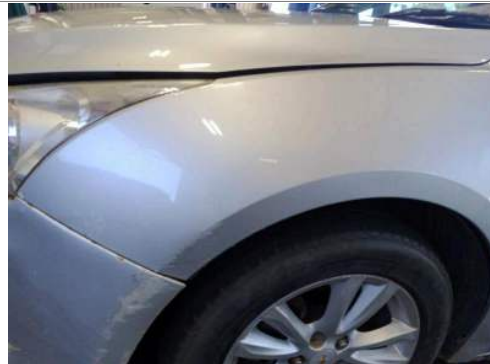
| Damage | Repair Way |
|---|---|
| Front Fender Left Paintwork • Scratched | Repair |

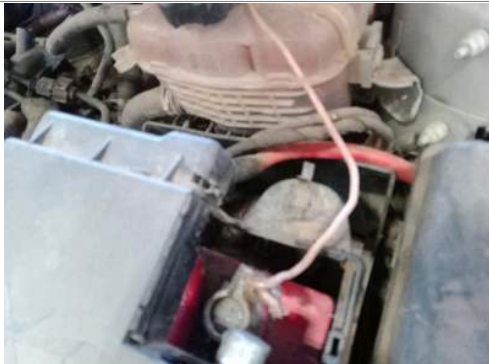
| Damage | Repair Way |
|---|---|
| Engine Wiring Defective | Repair |

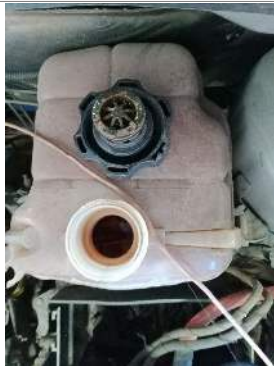
| Damage | Repair Way |
|---|---|
| Water level Insufficient | Repair |

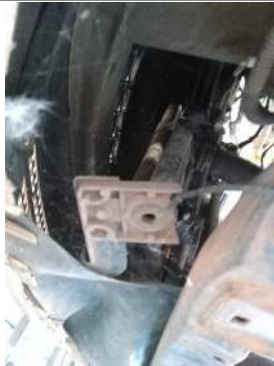
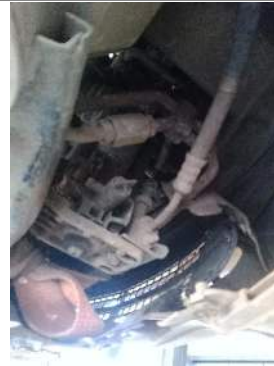
| Damage | Repair Way |
|---|---|
| Radiator Cradle Damaged | Replace |

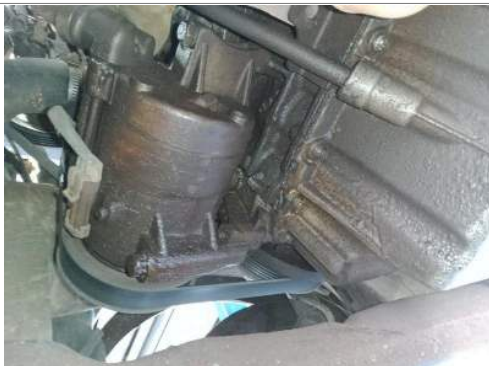
| Damage | Repair Way |
|---|---|
| Engine Performance Insufficient | Repair |
| Engine Noise Excessive | Repair |
